## FIELD INSPECTION REPORT

<b>Project Name:</b>	Mountain Valley Pipeline	<b>Inspector:</b>	Marshall Willis
<b>Inspection Date:</b>	Thursday, February 8, 2024	<b>Project Contact:</b>	Brian Clauto, Cory Chalmers
<b>Spread I: Franklin County</b>	MVP-MLV-AR-32 STA 14230+00 – 14249+00	<b>Weather:</b>	Wet

## FIELD INSPECTION PHOTO LOG

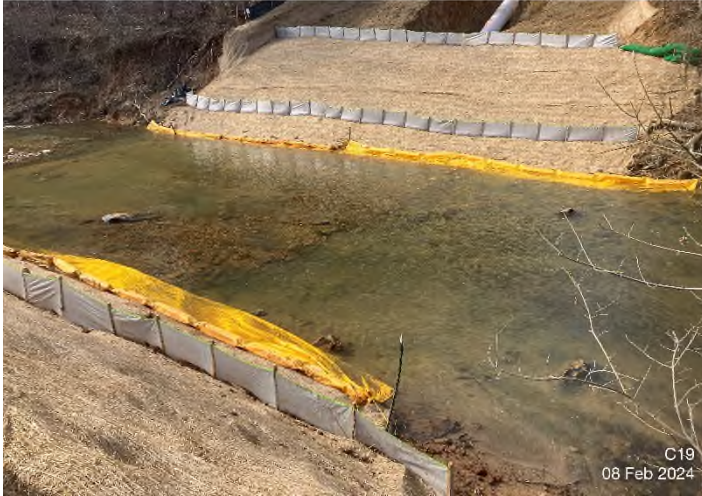
**Figure 1: Stream S-C19** – Curlex improperly installed. Edges should be keyed in per the approved details.

- STA 14233+80: Properly install curlex along stream S-C19. Fabric is not keyed properly.

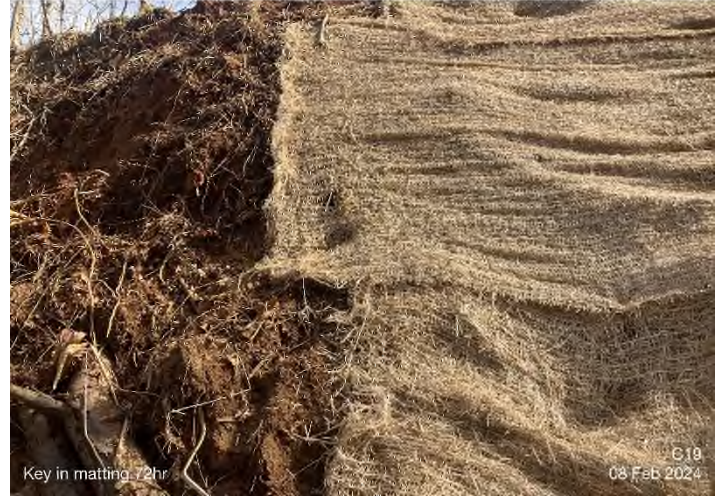
**Figure 2: Stream S-C19** – Curlex improperly installed. Edges should be keyed in per the approved details.

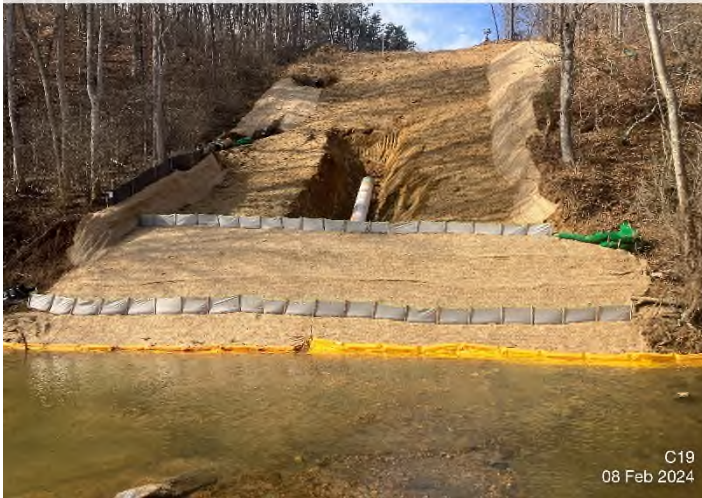
**Figure 3: Stream S-C19** – Curlex improperly installed. Edges should be keyed in per the approved details.

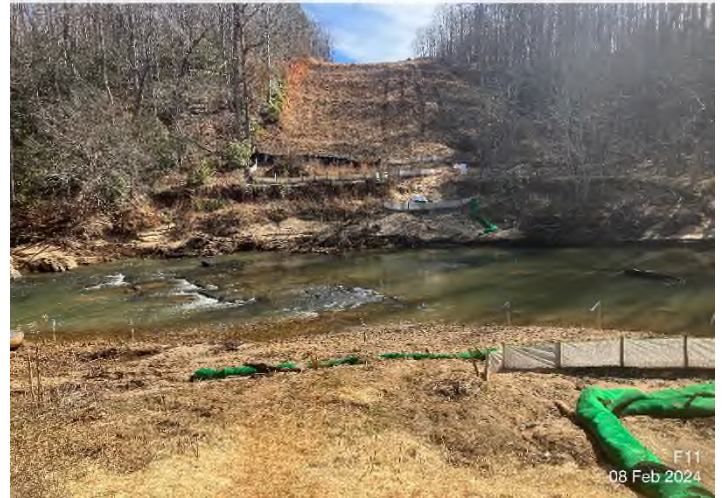
**Figure 4: Stream S-F11** – Controls in place and functioning properly.
