## FIELD INSPECTION REPORT

| Project Name: | Mountain Valley Pipeline | Inspector: | Marshall Willis |
| Inspection Date: | Monday, February 5, 2024 | Project Contact: | Brian Clauto, Cory Chalmers |
| Spread I:<br>Franklin County | MVP-MLV-AR-32<br>STA 14233+00 – 14240+00 | Weather: | Wet |

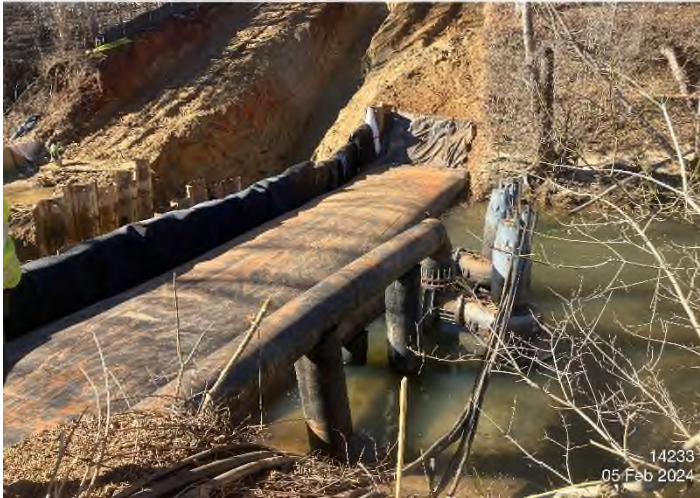
**Figure 1: STA 14233+00** – Controls in place and functioning properly.

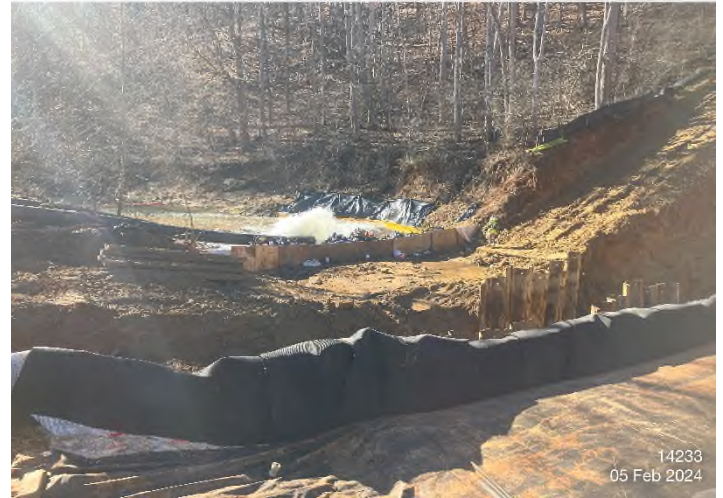
**Figure 2: Stream S-C19** – Controls in place and functioning properly.

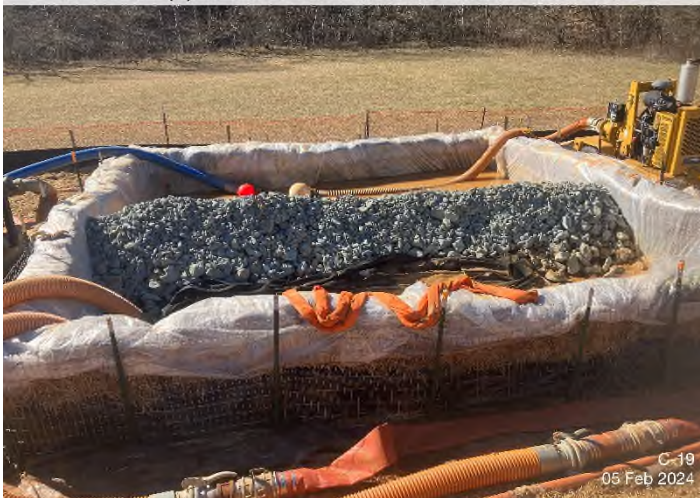
**Figure 3: Stream S-C19** – Controls in place and functioning properly.

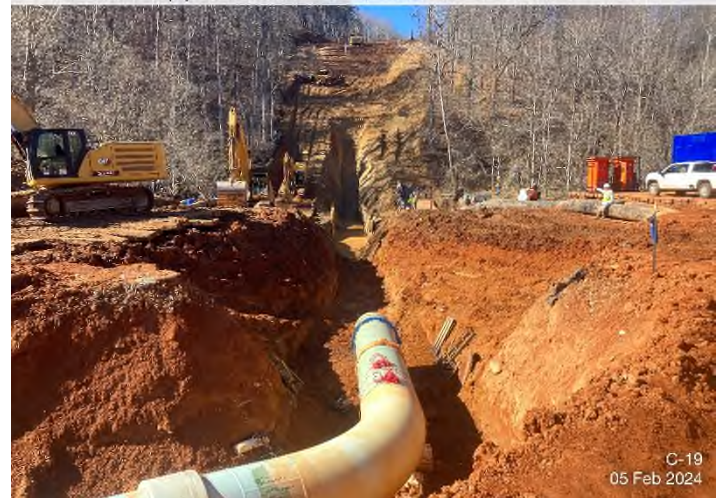
**Figure 4: Stream S-C19** – Controls in place and functioning properly.
