## FIELD INSPECTION REPORT

| Project Name: | Mountain Valley Pipeline | Inspector: | Marshall Willis |
| Spread I:<br>Franklin County | MVP-MLV-AR-32<br>STA 14220+00 – 14249+19 | Weather: | Wet |

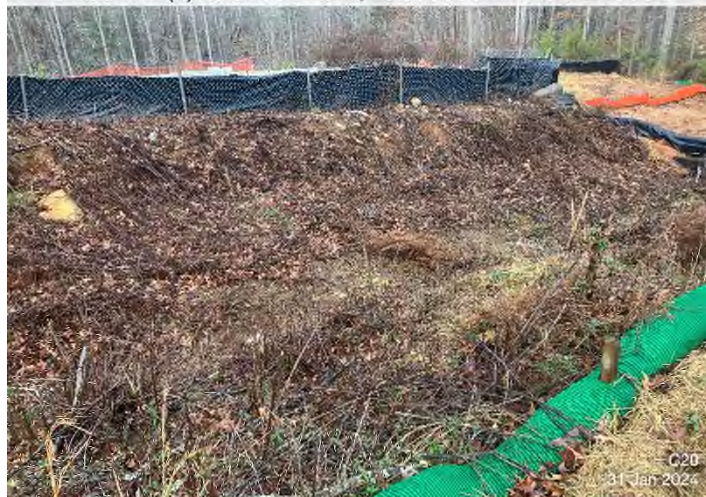
**Figure 1: Stream S-C20** – Controls in place and functioning properly.

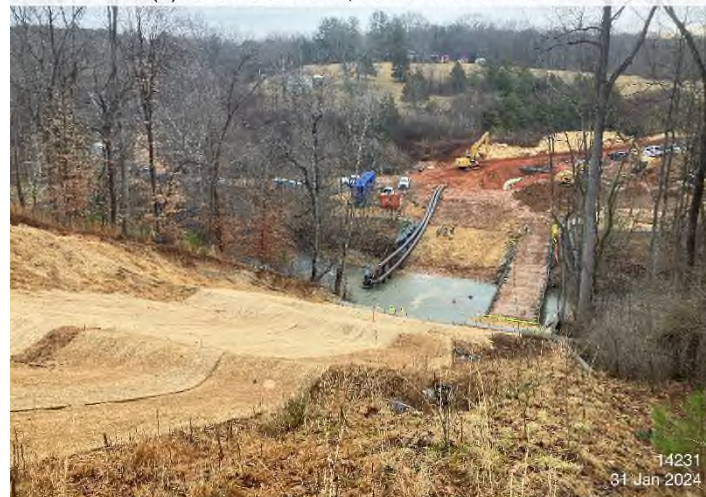
**Figure 2: STA 14231+00** – Controls in place and functioning properly.

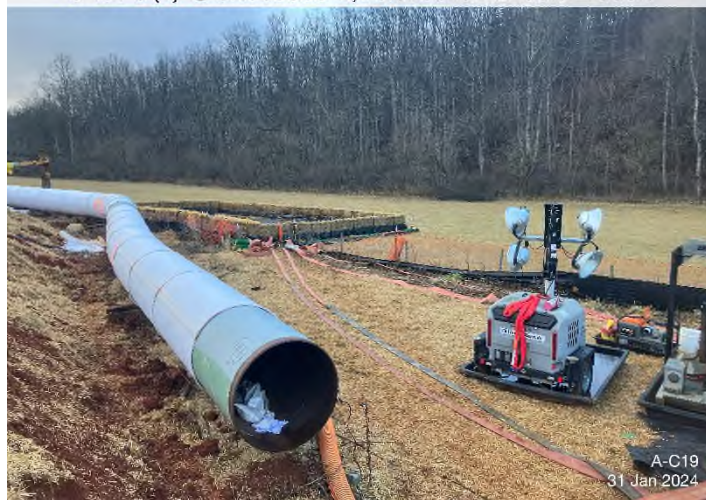
**Figure 3: Stream S-C19** – Controls in place and functioning properly.

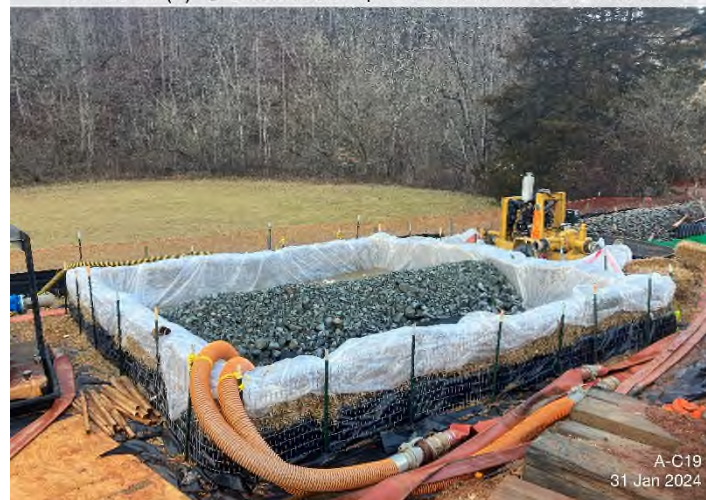
**Figure 4: Stream S-C19** – Controls in place and functioning properly.
