FIELD INSPECTION REPORT

Project Name:	Mountain Valley Pipeline	Inspector:	Marshall Willis
Inspection Date:	Monday, January 29, 2024	Project Contact:	Brian Clauto, Cory Chalmers
Spread I: Franklin County	STA 14070+00 - 14105+26 MVP-FR-309.05 MVP-FR-309.06	Weather:	Wet

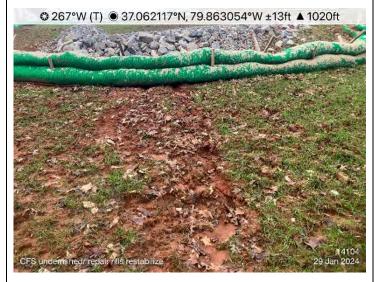
<u>Figure 1</u>: **STA 14102+00 to 14104+00** – CFS undermined. Maintenance needed.

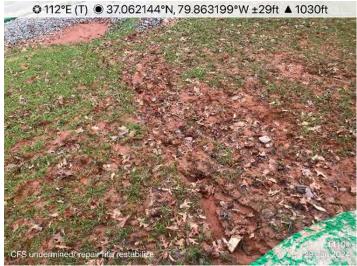
Figure 2: STA 14102+00 to 14104+00 – Repair rilling. Restabilize and reseed as needed.

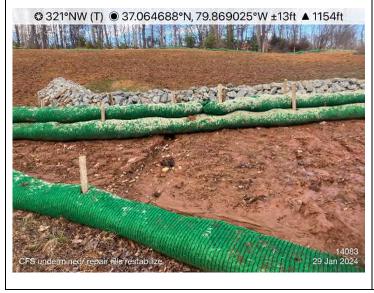
Figure 3: STA 14082+00 to 14083+00 – CFS undermined. Maintenance needed.

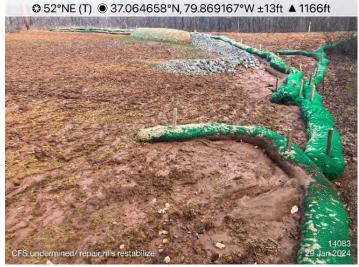
Figure 4: STA 14082+00 to 14083+00 – Repair rilling. Restabilize and reseed as needed.
