Project Name:	Mountain Valley Pipeline	Inspector:	Matthew Grant
Inspection Date:	Tuesday, February 27, 2024	Project Contact:	Brian Clauto
Spread H: Montgomery	Sta 12030-12038, 12117, 12190- 12200 ATWS 474, 703, 1375, 1446, 725 AR MN268 01, 279	Weather:	Wet

FIELD INSPECTION PHOTO LOG

Project Name: Mountain Valley Pipeline <u>Date</u>: Tuesday, February 27, 2024

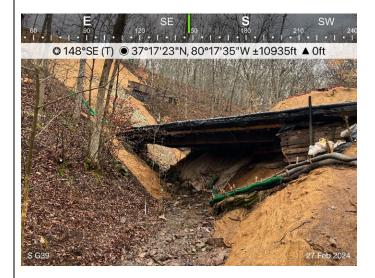
Figure 1: Designated crossing S-G39, ESC's devices in place.

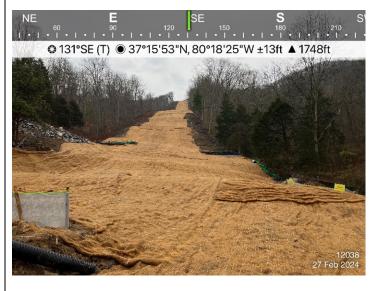
<u>Figure 3</u>: Sta 12038, area is stabilized, and ESC's devices are in place.

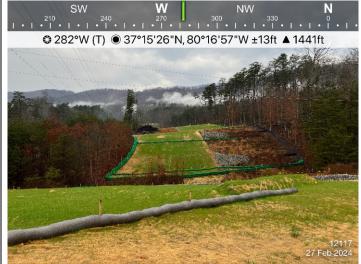
Figure 4: Sta 12117, area is stabilized, and ESC's devices are in place.
