FIELD INSPECTION REPORT

Project Name:	Mountain Valley Pipeline	Inspector:	Marshall Willis
Inspection Date:	Friday, March 1, 2024	Project Contact:	Brian Clauto, Cory Chalmers
Spread I: Franklin County	STA 14230+00 - 14249+00 MVP-MLV-AR-32	Weather:	Wet

FIELD INSPECTION PHOTO LOG

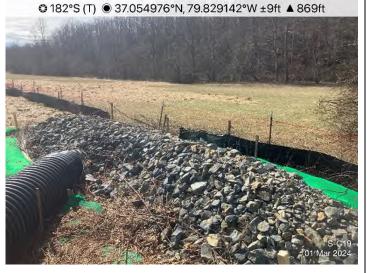
<u>Figure 3</u>: **Stream S-C19** – Controls installed and functioning properly.

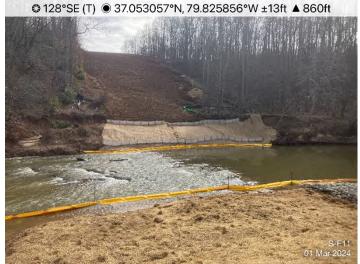
Figure 4: **Stream S-F11** – Controls installed and functioning properly.
