FIELD INSPECTION REPORT

| Project Name: | Mountain Valley Pipeline | Inspector: | Marshall Willis |
| Spread I: Franklin County | STA 14230+00 – 14249+00 MVP-MLV-AR-32 | Weather: | Wet |

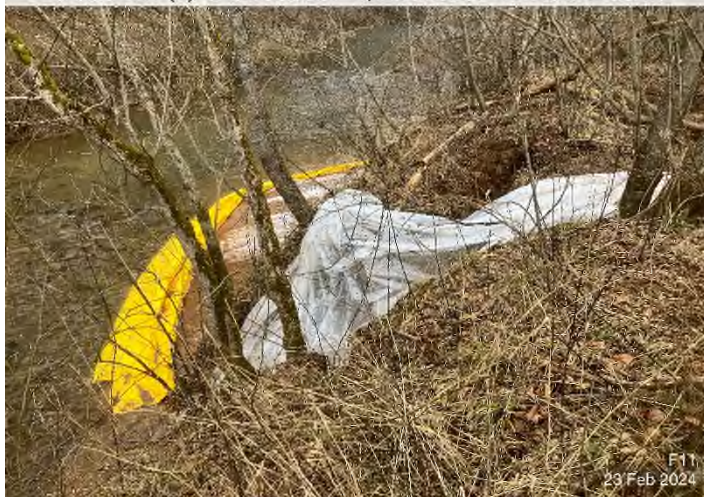
- Magodee Creek (S-C19): Retrieve sediment discharges impacting resource and sediment deposited off LOD in upland areas. Sediment deposit caused from bank failure and overwhelming of dewatering structure for S-F11.

Figure 1: Stream S-C19 – Bank failure caused by dewatering structure. Sediment deposited with Magodee Creek.

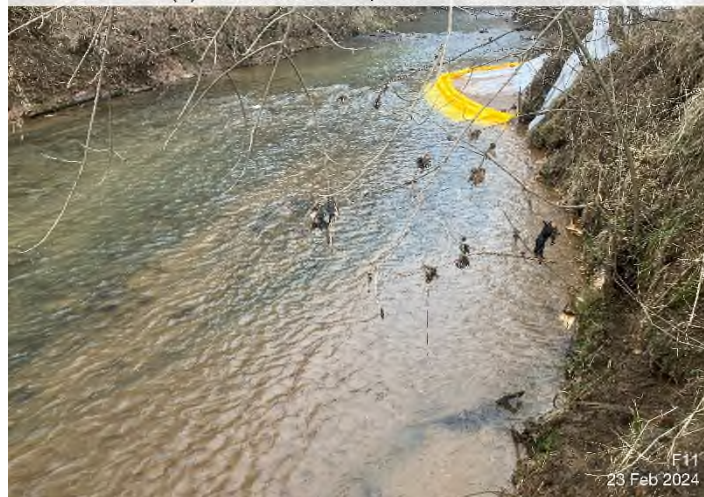
Figure 2: Stream S-C19 – Bank failure caused by dewatering structure. Sediment deposited with Magodee Creek.

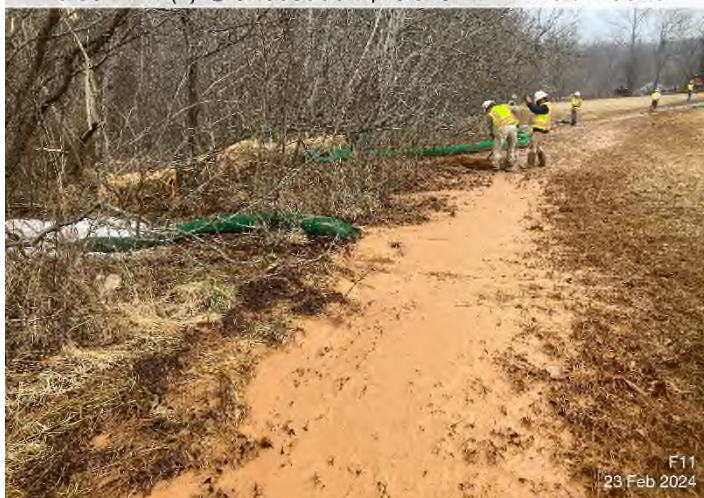
Figure 3: Stream S-C19 – Sediment deposited off ROW from overwhelmed dewatering structures for S-F11.

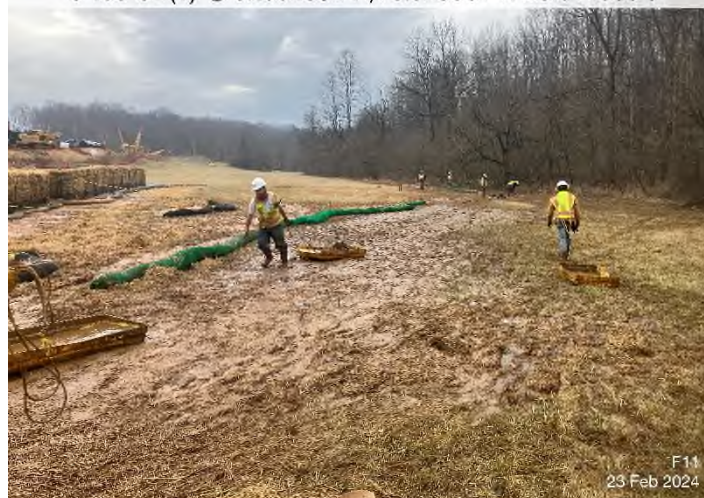
Figure 4: Stream S-C19 – Sediment deposited off ROW from overwhelmed dewatering structures for S-F11.
