## FIELD INSPECTION REPORT

| Project Name: | Mountain Valley Pipeline | Inspector: | Marshall Willis |
| Spread I:<br>Franklin County | STA 14230+00 – 14249+00<br>MVP-MLV-AR-32 | Weather: | Wet |

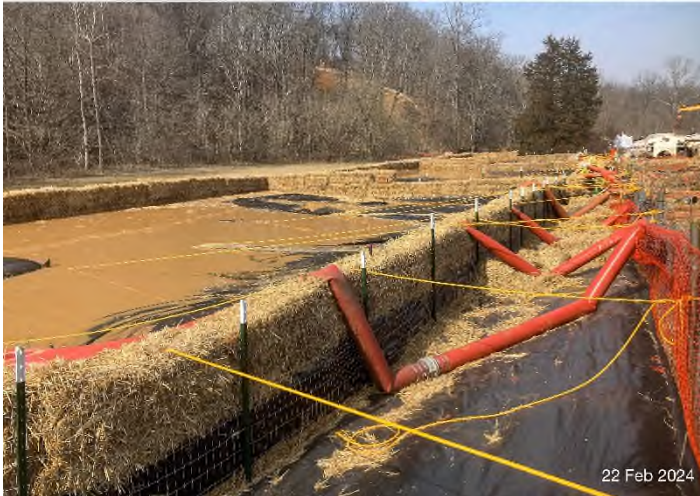
**Figure 1: Stream S-F11** – Controls in place and functioning properly.

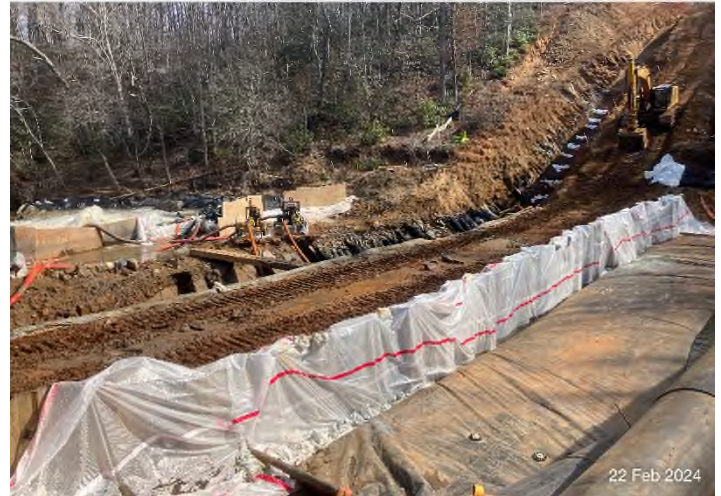
**Figure 2: Stream S-F11** – Controls in place and functioning properly.

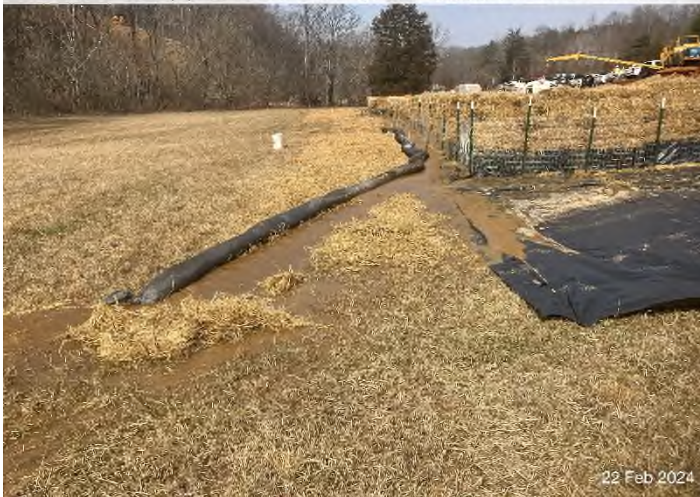
**Figure 3: Stream S-F11** – Controls in place and functioning properly.

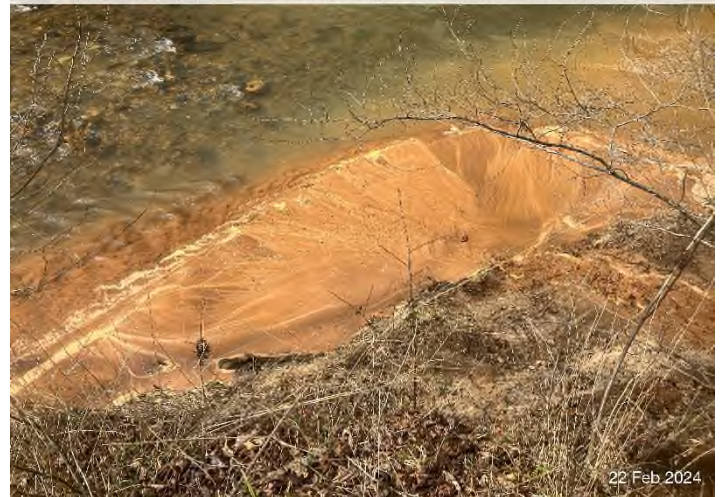
- Magodee Creek (S-C19): Retrieve sediment impacting resource. Sediment deposit caused from bank failure down gradient of dewatering structure for S-F11.

**Figure 4: Stream S-C19** – Bank failure down gradient of new dewatering location for S-F11 crossing. Sediment deposited into Magodee Creek.

**Deadline:** Within 24-Hour of Notification
