FIELD INSPECTION REPORT

Project Name:	Mountain Valley Pipeline	Inspector:	Marshall Willis
Inspection Date:	Wednesday, February 21, 2024	Project Contact:	Brian Clauto, Cory Chalmers
Spread I: Franklin County	STA 14230+00 – 14249+00 MVP-MLV-AR-32	Weather:	Wet

FIELD INSPECTION PHOTO LOG

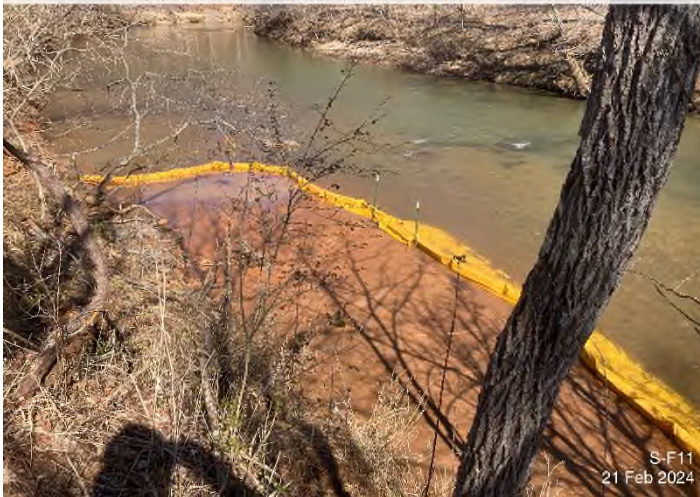
Figure 3: Stream S-F11 – Sediment deposited into the Blackwater River downstream of the ROW crossing. Caused by bank failure due to dewatering operations.

- Blackwater River (S-F11): Retrieve sediment impacting resource. Sediment deposit caused from bank failure down gradient of dewatering structure.

Deadline: Within 24-Hour of Notification

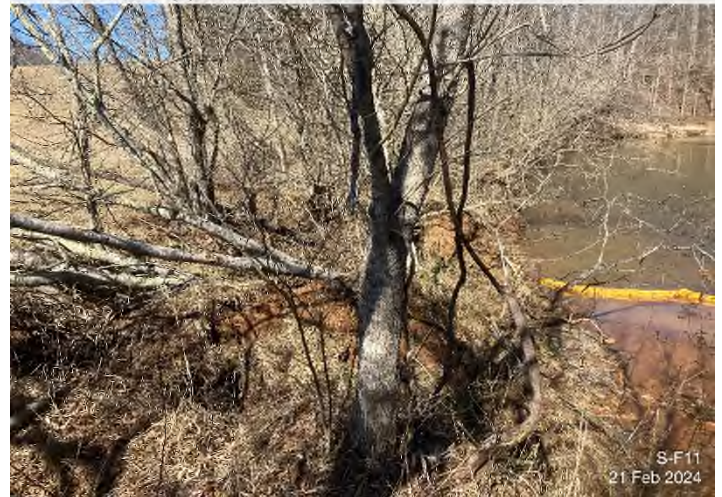
Figure 4: Stream S-F11 – Bank failure down gradient of the dewatering operation.
