## FIELD INSPECTION REPORT

| Project Name: | Mountain Valley Pipeline | Inspector: | Marshall Willis |
| Spread H:<br>Montgomery County | STA 12543+00 – 12549+00<br>MVP-MN-278.01 | Weather: | Wet |

## FIELD INSPECTION PHOTO LOG

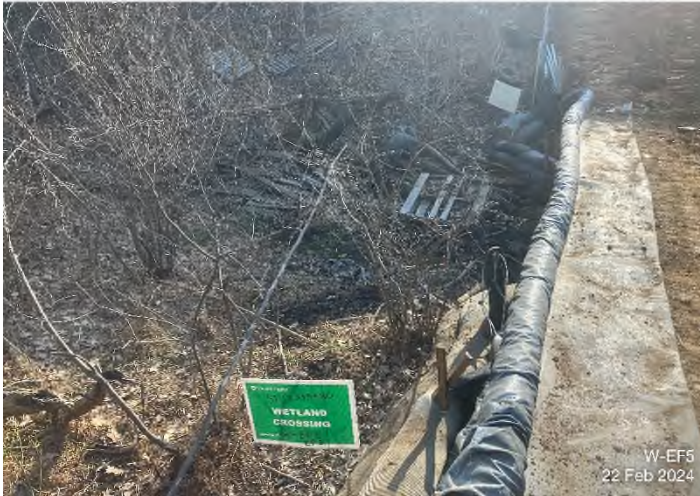
**Figure 1: Wetland W-EF5** – Controls in place and functioning properly.

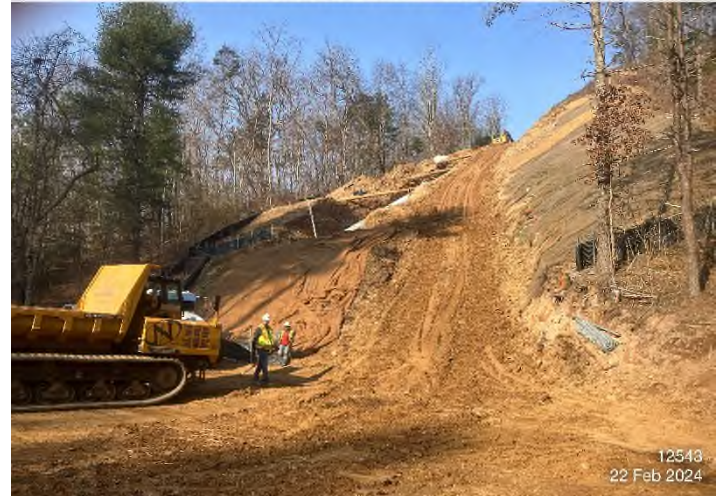
**Figure 2: STA 12543+00** – Controls in place and functioning properly.

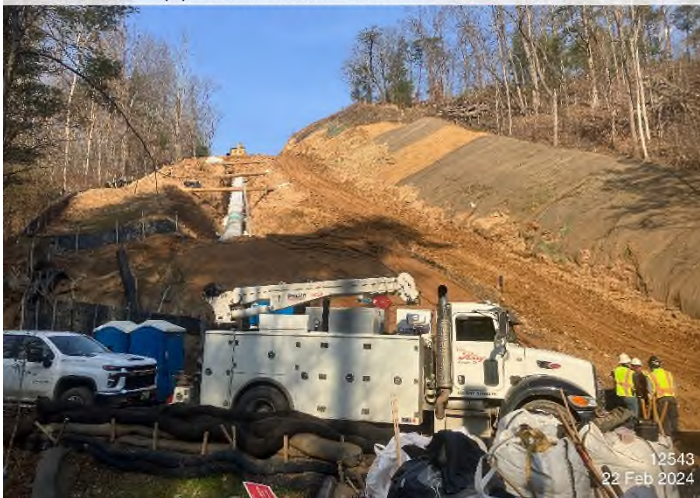
**Figure 3: STA 12543+00** – Controls in place and functioning properly.

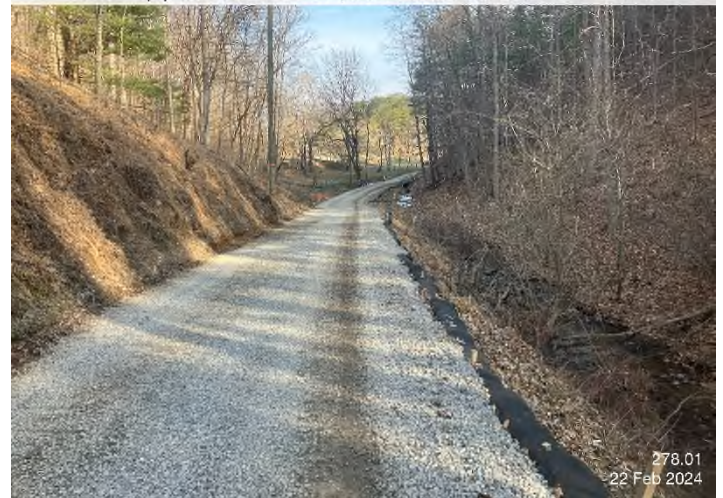
**Figure 4: MVP-MN-278.01** – Controls in place and functioning properly along access road.
