FIELD INSPECTION REPORT

Project Name:	Mountain Valley Pipeline	Inspector:	Marshall Willis
Inspection Date:	Thursday, February 22, 2024	Project Contact:	Brian Clauto, Cory Chalmers
Spread H: Montgomery County	STA 12543+00 – 12549+00 MVP-MN-278.01	Weather:	Dry

FIELD INSPECTION PHOTO LOG

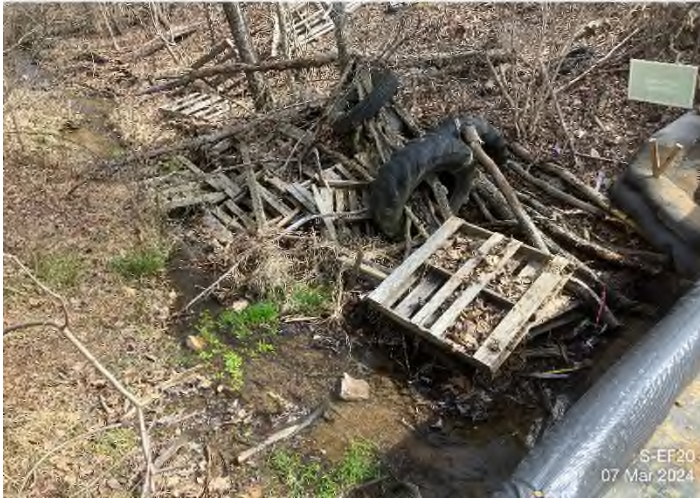
Figure 1: Stream S-EF20A – Controls in place and functioning properly.

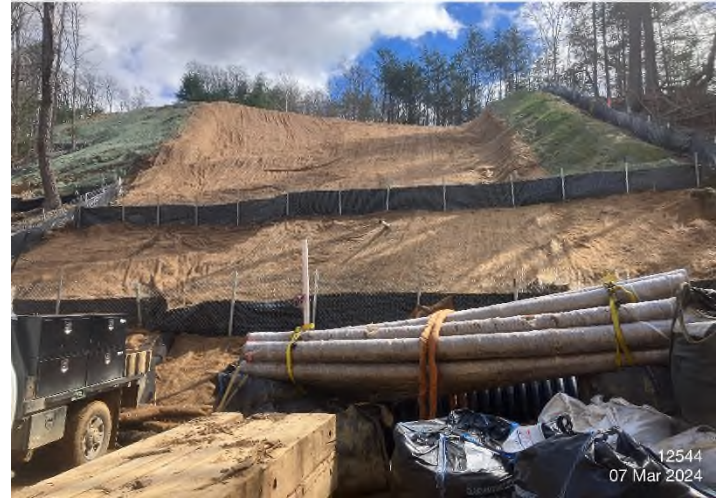
Figure 2: STA 12544+00 – Controls in place and functioning properly.

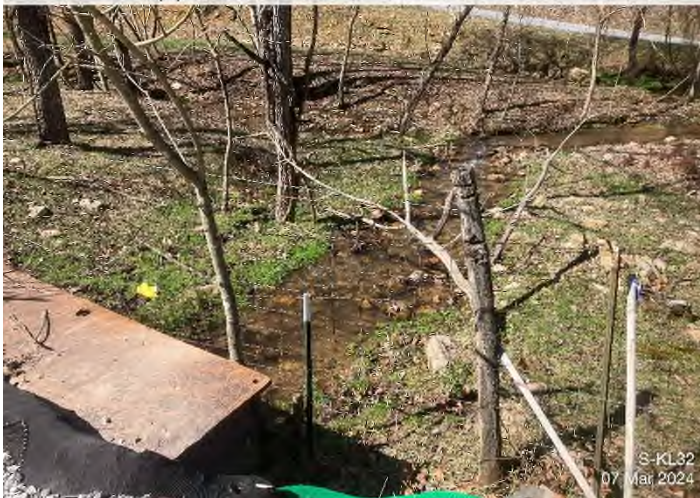
Figure 3: Stream S-KL32 – Controls in place and functioning properly.

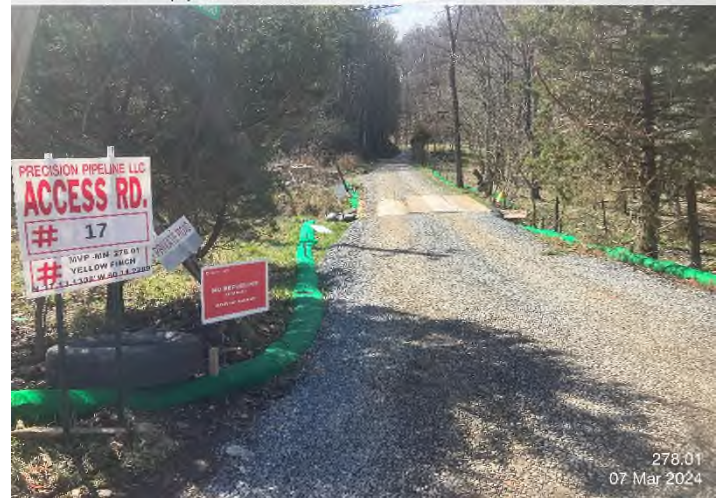
Figure 4: MVP-MN-278.01 – Controls in place and functioning properly along access road.
