## FIELD INSPECTION REPORT

<b>Project Name:</b>	Mountain Valley Pipeline	<b>Inspector:</b>	Marshall Willis
<b>Inspection Date:</b>	Tuesday, March 12, 2024	<b>Project Contact:</b>	Brian Clauto, Cory Chalmers
<b>Spread I: Franklin County</b>	STA 13784+00 – 13853+45 MVP-FR-300 MVP-FR-303.01	<b>Weather:</b>	Dry

## FIELD INSPECTION PHOTO LOG

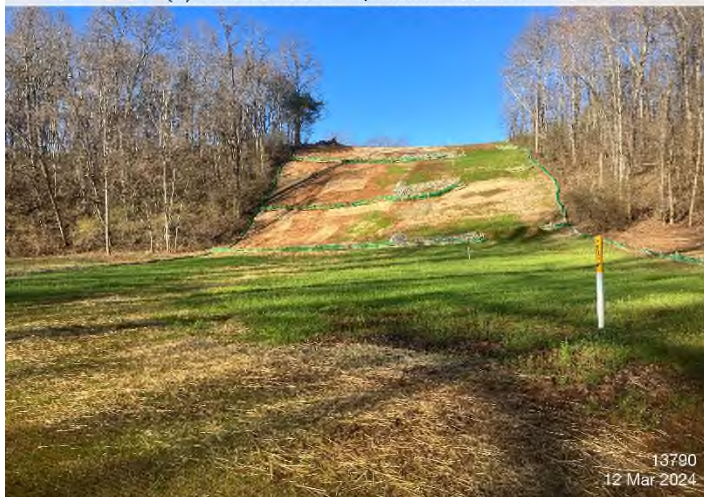
**Figure 1: STA 13790+00** – Controls in place and functioning properly.

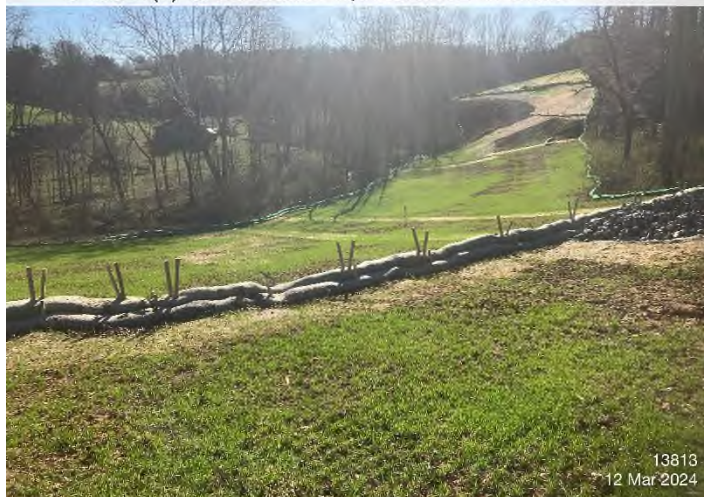
**Figure 2: STA 13813+00** – Controls in place and functioning properly.

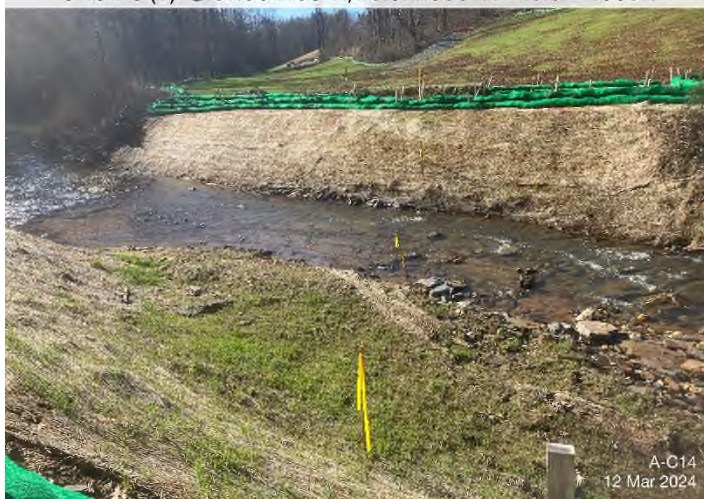
**Figure 3: Stream S-C14** – Controls in place and functioning properly.

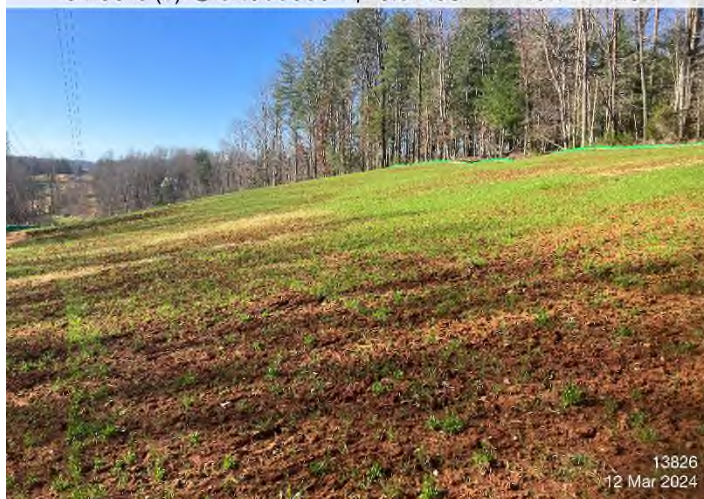
**Figure 4: STA 13826+00** – Controls in place and functioning properly.
