Project Name:	Mountain Valley Pipeline	Inspector:	Matthew Grant
Inspection Date:	Tuesday, March 12, 2024	Project Contact:	Brian Clauto
Spread I: Franklin	Sta 13780-13850 FR 300 ATWS 569A 575A	Weather:	Dry

## FIELD INSPECTION PHOTO LOG

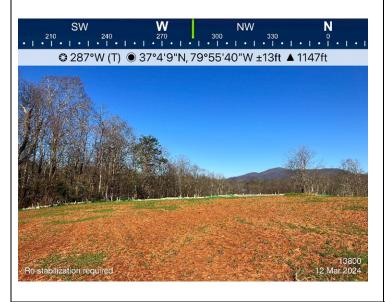
Figure 1: Sta 13800 area requires re stabilization.

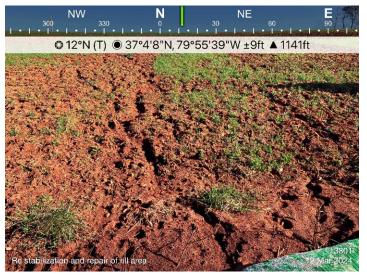
Figure 2: Sta 13801 area requires additional stabilization and rill repair.

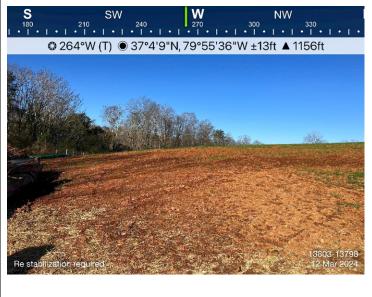
Figure 3: Multiple areas from 13803 to 13798 require re stabilization.
