# EVOH Deployment Suitability Assessment No. 1 Bristol Integrated Solid Waste Management Facility Solid Waste Permit No. 588

2655 Valley Drive  
Bristol, VA 24201

**SCS ENGINEERS**

02218208.05 | April 11, 2024

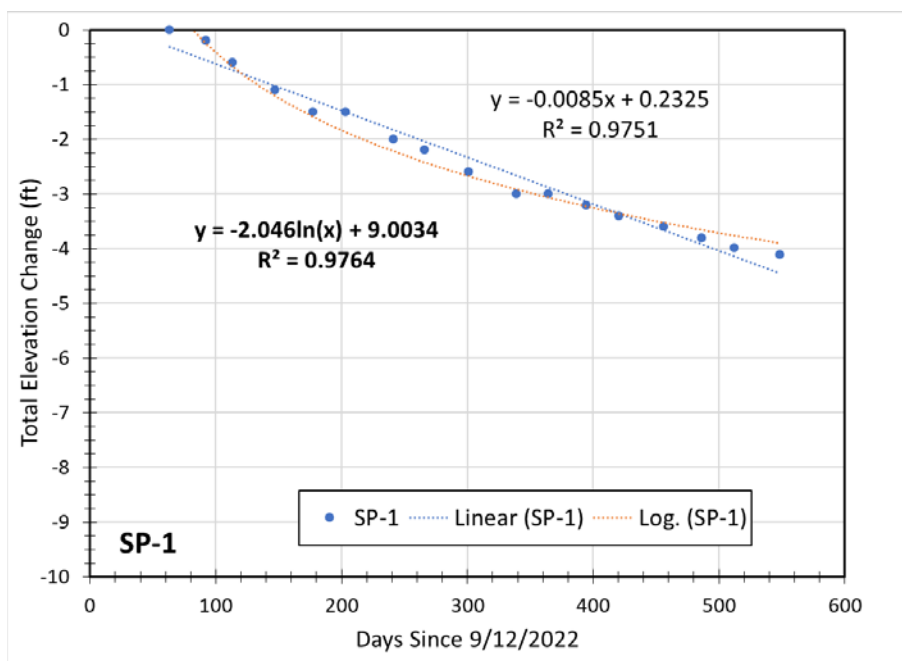
Figure 2 - Settlement Plate 1

Figure 2 shows the plot of total elevation change versus elapsed time for SP-1. Linear and logarithmic trendlines were fitted to the data, and the coefficients of determination ( $R^2$ ) were computed. SP-1 is the only location to show a greater  $R^2$  for the logarithmic trendline, which may be related to its location. SP-1 is located in the southwest corner of the quarry, atop a bench in the sidewall with approximately 67 feet of underlying waste. The sidewall bench and small waste depth separates the SP-1 area from nearby portions of the landfill experiencing elevated temperatures. However, SP-1 has recorded significant settlement (6.2% strain since installation), likely due to the surrounding soil placement during the construction of the sidewall odor mitigation system.

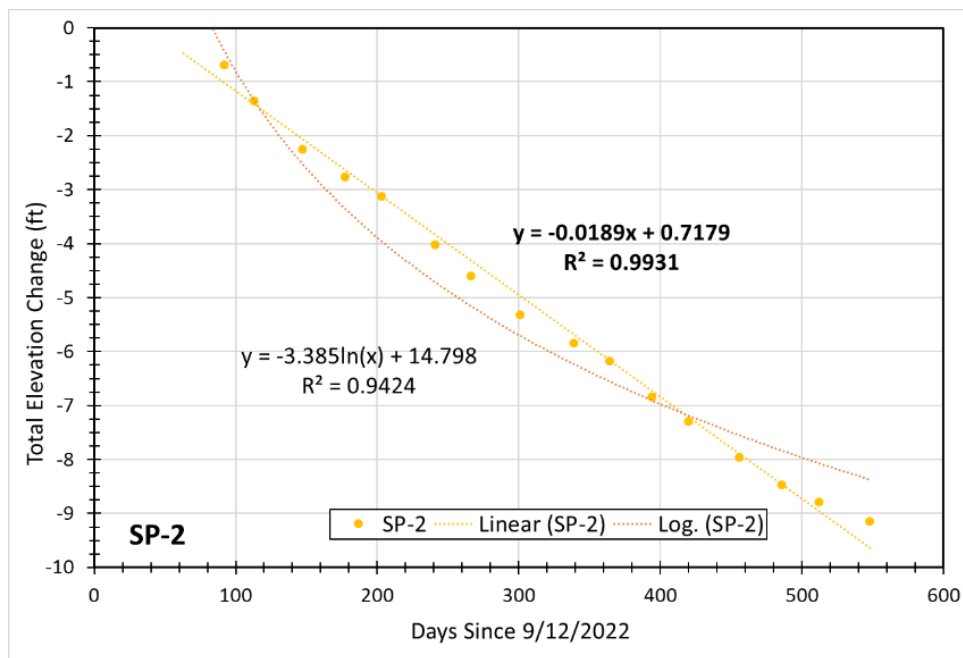
Figure 3 - Settlement Plate 2

SP-2 is located near the southern central edge of the quarry. The elevation data for SP-2 shows ongoing steady settlement at an estimated current strain rate of 2.2% (Figure 3). The SP-2 data strongly follows a linear trendline ( $R^2 > 0.99$ ).

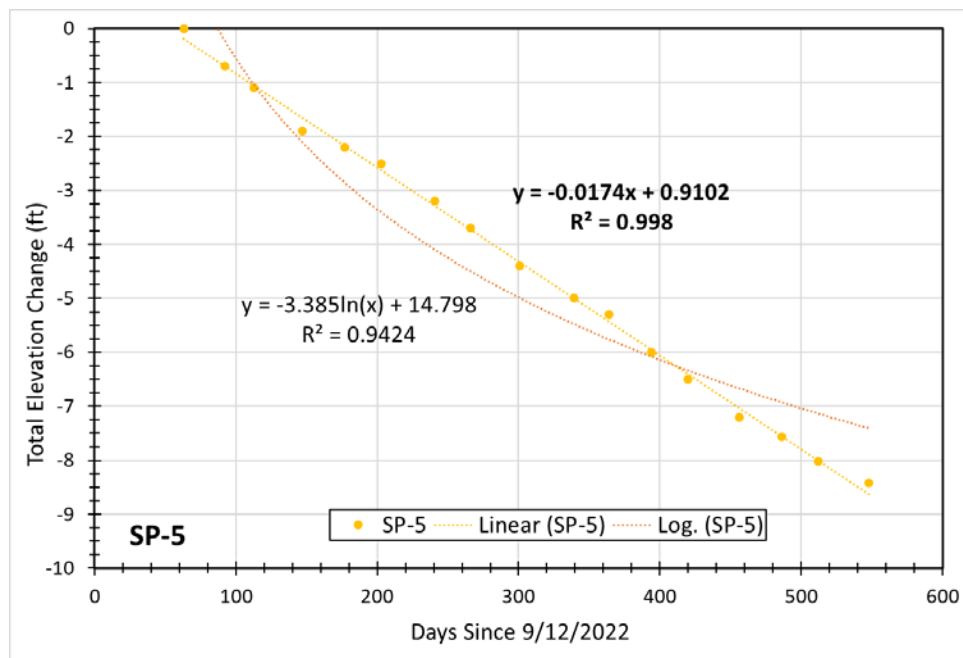
Figure 4 - Settlement Plate 5

Applying a linear trendline to the data for SP-5 produces an  $R^2$  equal to 0.998, indicating the strongest linear fit of all the settlement plate data (Figure 4). Settlement appears steadily ongoing at SP-5, and the nearby temperature probe TP-4 continues to show elevated temperatures.

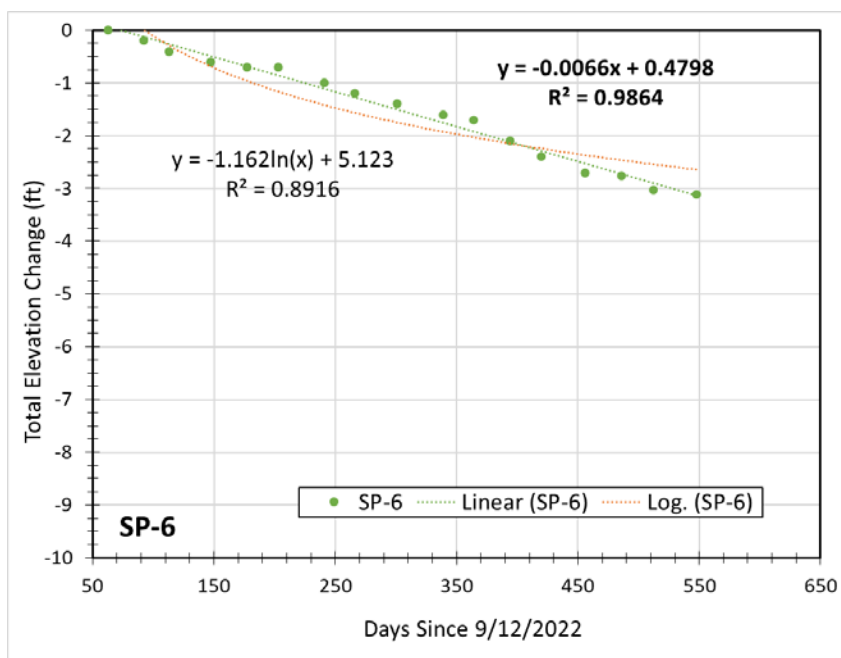
Figure 5 - Settlement Plate 6

The data for settlement plates 6 and 8 fit linear trendlines (Figure 5 and Figure 6). The elevated temperatures measured by TP-4, 100 feet east of SP-6, suggests that SP-6 will continue to settle significantly. SP-8 is positioned north of the highest temperature area and may stabilize prior to the southern settlement plates. The logarithmic trendline for SP-8 gives an  $R^2$  of 0.96 versus 0.99 for the linear trendline. SP-7 was excluded from the analysis due to suspected damage, and SP-9 was excluded due to unavailable data.

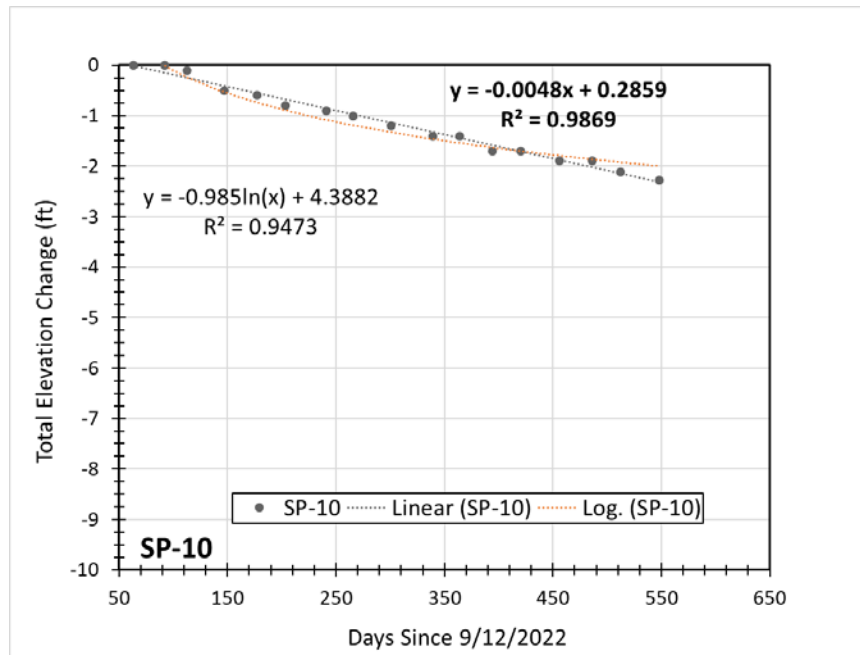
Figure 7 - Settlement Plate 10

SP-10, SP-11, and SP-12 are positioned in the north end of the quarry. The northernmost temperature probe (TP-9) indicates lower, more stable temperatures in this area relative to the south. The elevation data from these settlement plates shows less overall settlement and lower strain rates (less than 1% per year) relative to the southern plates (Figure 7 through Figure 9). The temperature and elevation data together suggest the northern area may be transitioning to secondary compression, but settlement remains linear with respect to time. Elevation variability,

potentially due to vertical accuracy limitations of the GPS measurements, appears more noticeable for these settlement plates due to the smaller settlement rates.

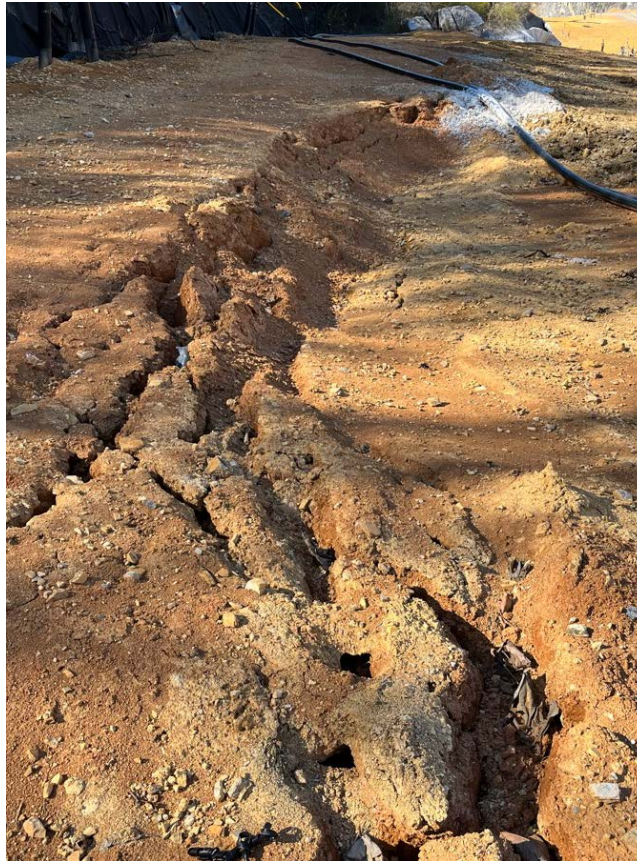
Figure 10 - Scarp and Settlement Cracks

Personnel working in the quarry continue to observe surface cracks due to settlement exceeding 1-inch width. Settlement cracks and a scarp were observed during March in the southern region of the quarry between settlement plates SP-1 and SP-4, approximately 20 to 40 feet from the sidewall. The cracks and scarp extended along a linear region, approximately 100 feet long, which follows an abrupt change in the base grade elevations and corresponding waste thickness.

Figure 10 shows a photo of the settlement cracks and scarp, facing northwards. Settlement cracks measuring approximately 2 to 4 inches are visible in the foreground. The scarp, visible in the background, measures approximately 3 feet. Figure 11 shows the same scarp, facing westwards.

The observed surface cracks and scarp indicate that criteria 3 is not satisfied.

The scarp is located above the edge of a bench in the rock wall created by quarry operations. The bench remained in place when the facility was converted to a landfill. SCS estimates that the waste thickness transitions from approximately 10 feet to 136 feet over a horizontal distance of 42 feet. If waste at both thicknesses settles at a similar, nonzero strain rate, it creates a differential in elevations. SCS believes that this differential waste thickness is the cause of these cracks at the surface.
