## FIELD INSPECTION REPORT

| Project Name: | Mountain Valley Pipeline | Inspector: | Marshall Willis |
| Spread H:<br>Roanoke County | STA 12938+19 – 12960+00<br>MVP-RO-287 | Weather: | Rainy |

## FIELD INSPECTION PHOTO LOG

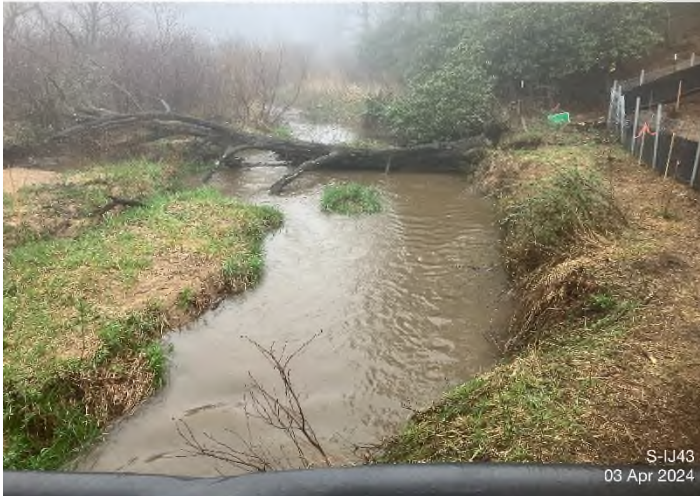
**Figure 1: Stream S-IJ43** – Controls installed and functioning properly.

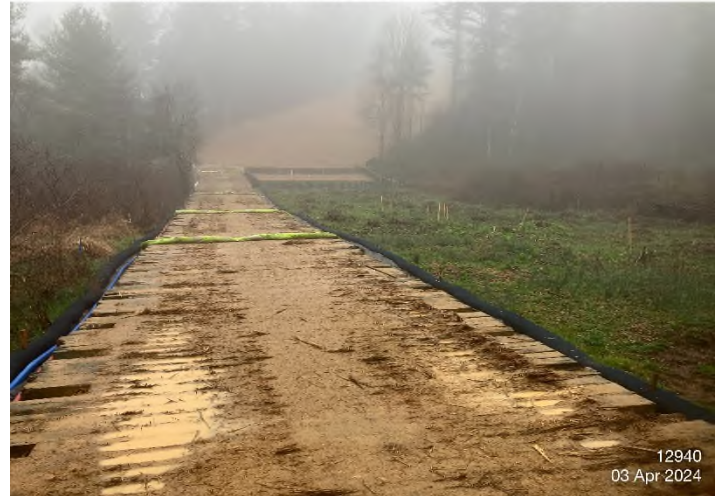
**Figure 2: Wetland W-IJ36** – Controls installed and functioning properly.

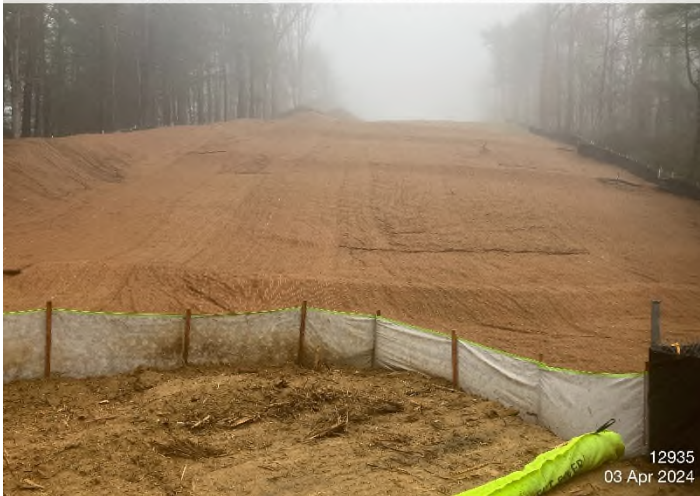
**Figure 3: STA 12935+00** – Controls installed and functioning properly.

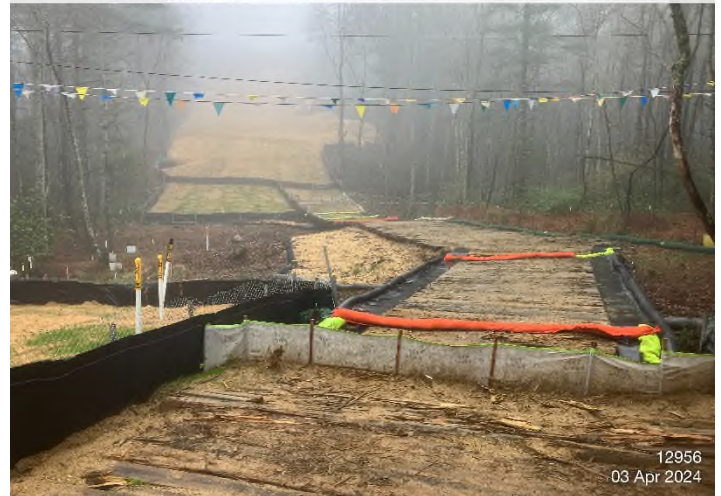
**Figure 4: STA 12956+00** – Controls installed and functioning properly.
