## FIELD INSPECTION REPORT

| Project Name: | Mountain Valley Pipeline | Inspector: | Marshall Willis |
| Spread H:<br>Franklin County | STA 13415+51 – 13425+01 | Weather: | Dry |

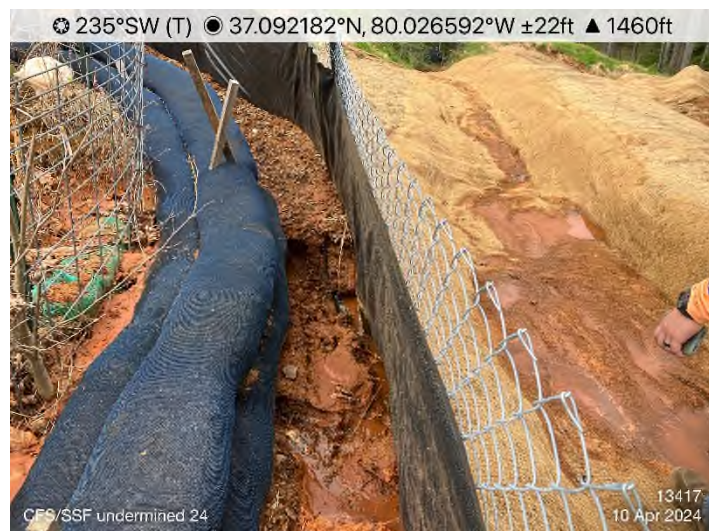
- STA 13417+00: CFS and SSF undermined.

**Figure 1: STA 13417+00** – Repair undermined CFS and SSF.

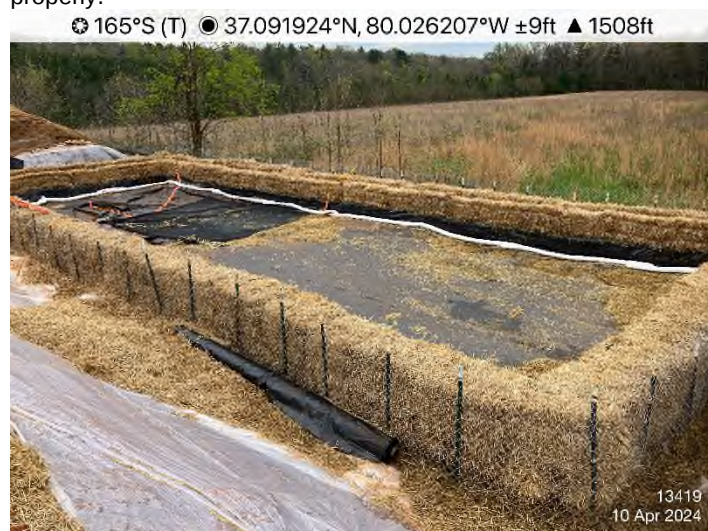
**Figure 2: STA 13419+00** – Controls in place and functioning properly.

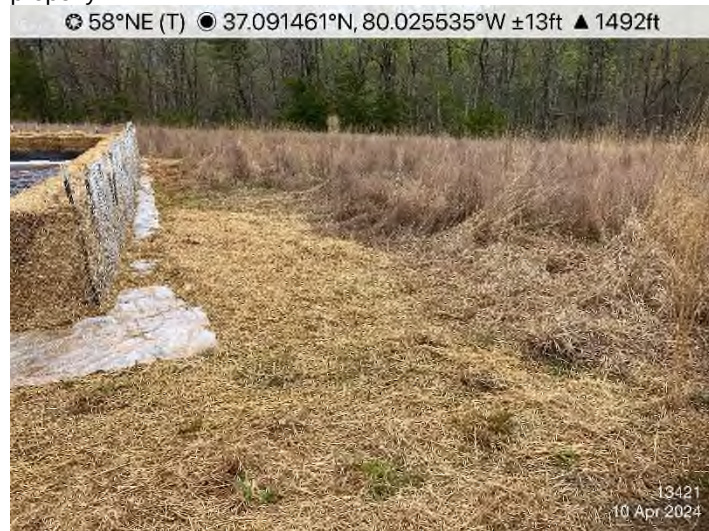
**Figure 3: STA 13421+00** – Controls in place and functioning properly.

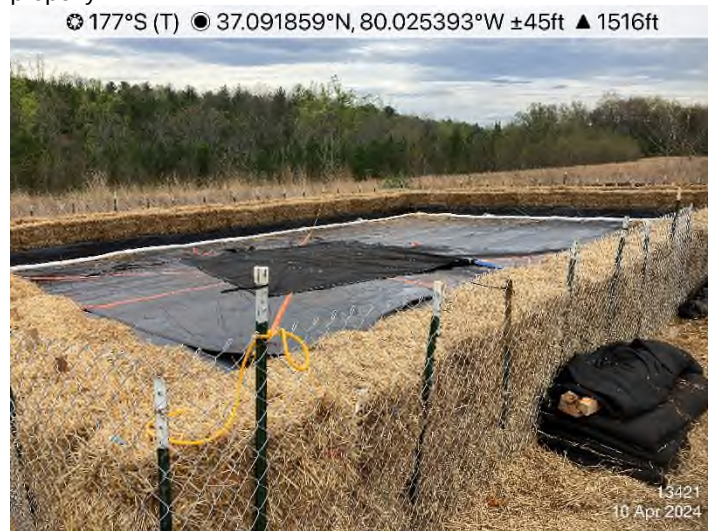
**Figure 4: STA 13421+00** – Controls in place and functioning properly.
