FIELD INSPECTION REPORT

Project Name:	Mountain Valley Pipeline	Inspector:	Marshall Willis
Inspection Date:	Friday, April 12, 2024	Project Contact:	Brian Clauto, Cory Chalmers
Spread I: Franklin County	STA 14758+16 – 14845+65 MVP-FR-323	Weather:	Wet

FIELD INSPECTION PHOTO LOG

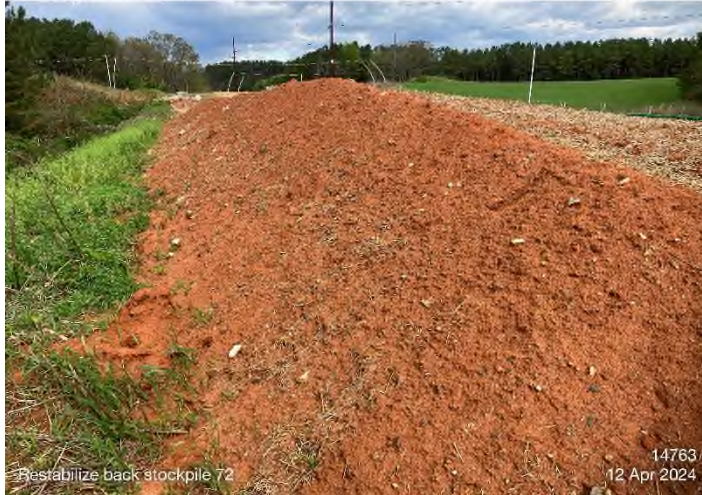
14763
12 Apr 2024

Figure 1: STA 14763+00 – Restabilize stockpile.

Restabilize back stockpile 72

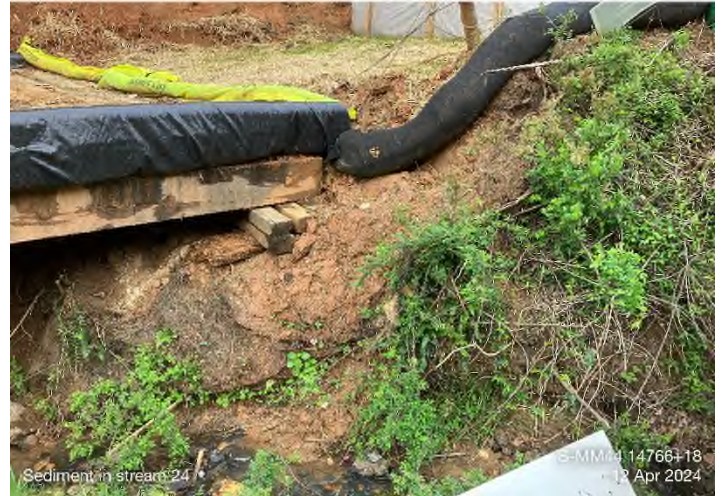
S-MM44 14766+18
12 Apr 2024

- STA 14766+18: Repair/restabilize bank and remove minor sediment from stream S-MM44.
- STA 14824+51: Waterbar unable to discharge off ROW above Stream S-A15.

Figure 2: STA 14766+18 – Repair/restabilize bank and remove sediment impacting S-MM44.

Sediment in stream 24

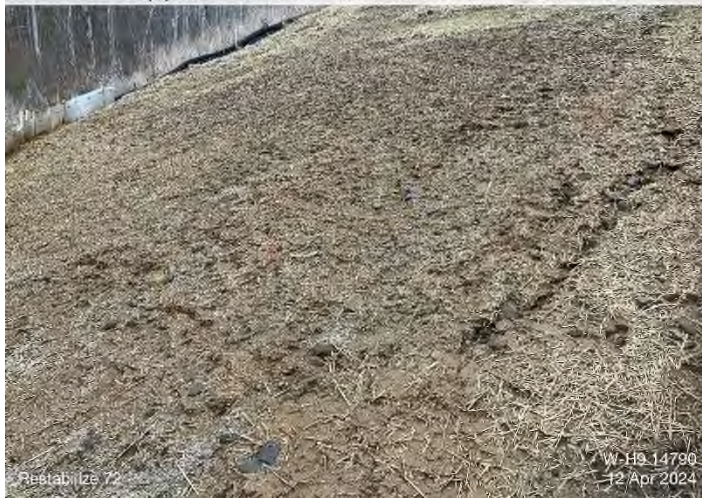
W-H9 14790
12 Apr 2024

Figure 3: STA 14790+00 – Restabilize and repair rilling above Wetland W-H9.

Restabilize 72

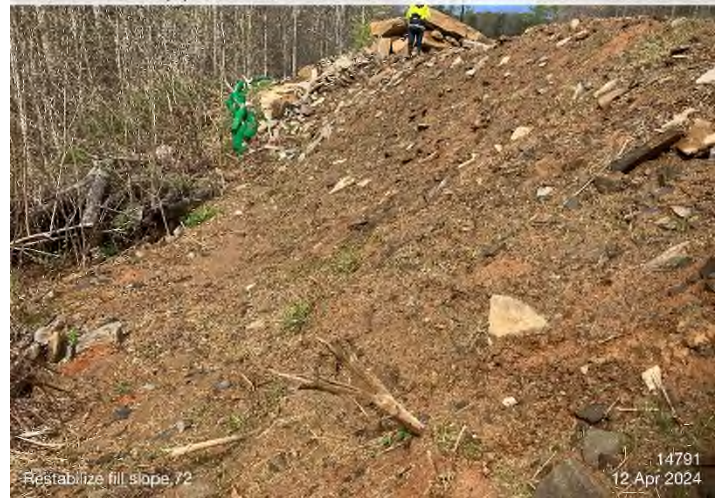
14791
12 Apr 2024

Figure 4: STA 14791+00 – Restabilize fill slope.

Restabilize fill slope 72

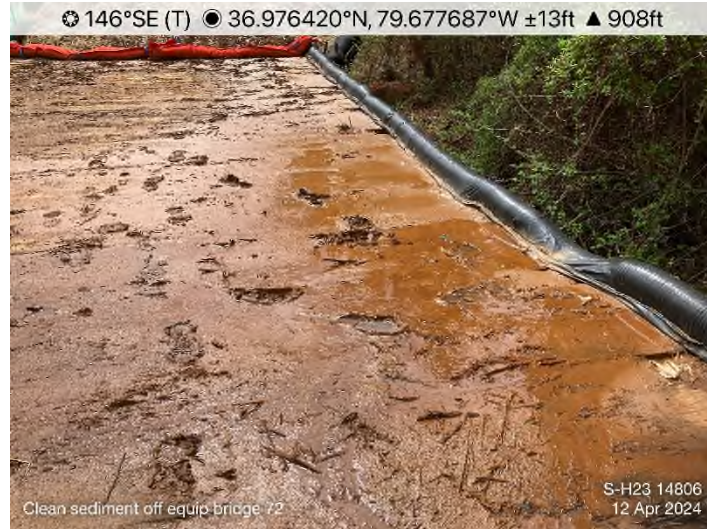
Figure 5: STA 14806+00 – Remove sediment accumulation from equipment bridge crossing over Stream S-H23.

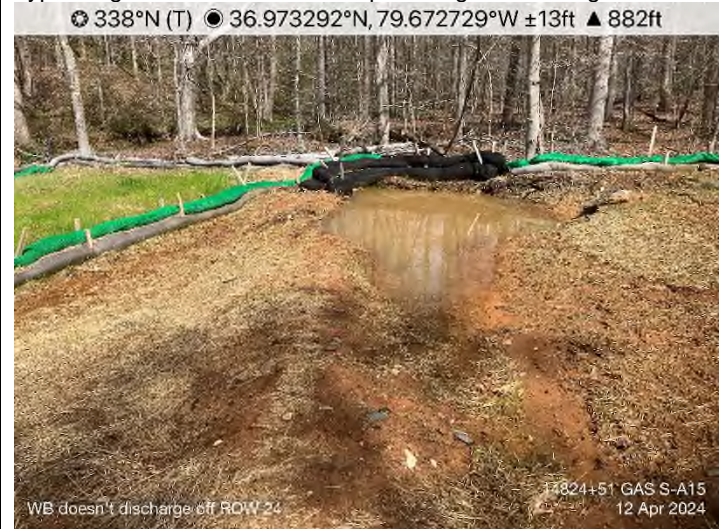
Figure 6: STA 14824+51 – Waterbar is unable to discharge off ROW above Stream S-A15. Outlet is higher than WB causing bypassing endtreatment and compounding WB drainages.
