## FIELD INSPECTION REPORT

| <b>Project Name:</b> | Mountain Valley Pipeline | <b>Inspector:</b> | Marshall Willis |
| <b>Spread I:<br/>Franklin County</b> | STA 13820+00 – 13863+01<br>MVP-FR-302<br>MVP-FR-303.01 | <b>Weather:</b> | Rainy |

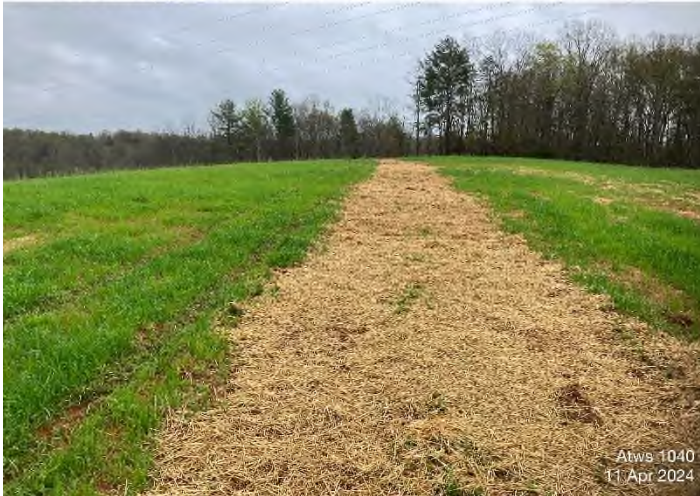
**Figure 1: ATWS 1040** – Controls in place and functioning properly.

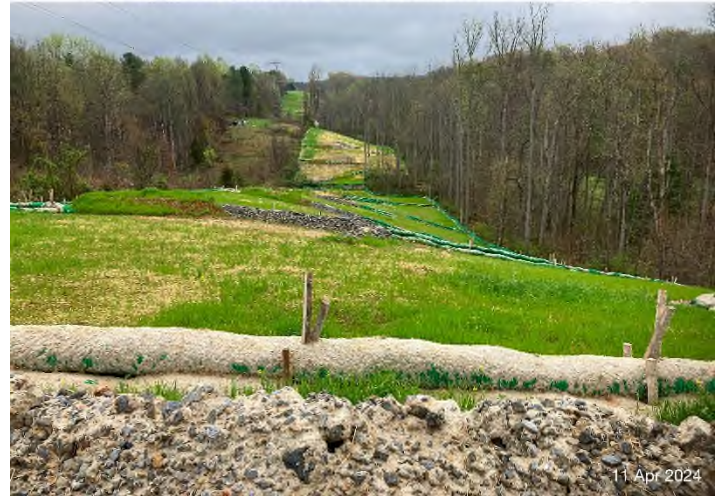
**Figure 2: STA 13852+00** – Controls in place and functioning properly.

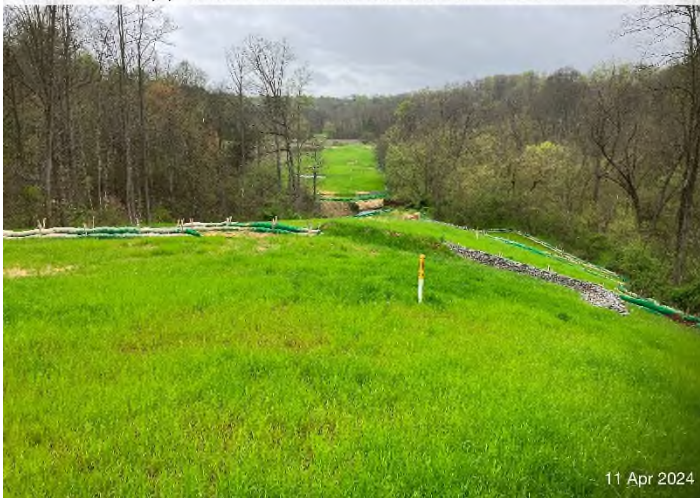
**Figure 3: STA 13860+00** – Controls in place and functioning properly.

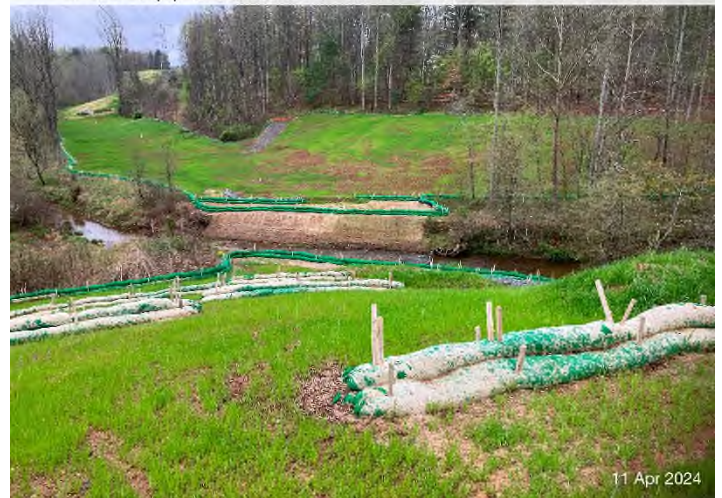
**Figure 4: STA 13831+00** – Controls in place and functioning properly.
