## FIELD INSPECTION REPORT

| Project Name: | Mountain Valley Pipeline | Inspector: | Marshall Willis |
| Spread I:<br>Franklin County | STA 14018+47 – 14062+17<br>MVP-MLV-AR-31 | Weather: | Dry |

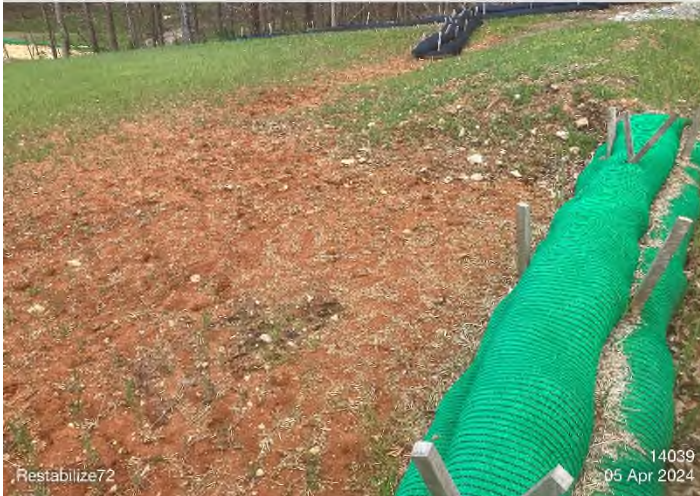
**Figure 1: STA 14039+00** – Repair rilling and restabilize denuded areas.

- STA 14052+58: Repair rills and restabilize denuded areas.
- STA 14039+00: Repair rills and restabilize denuded areas.
-

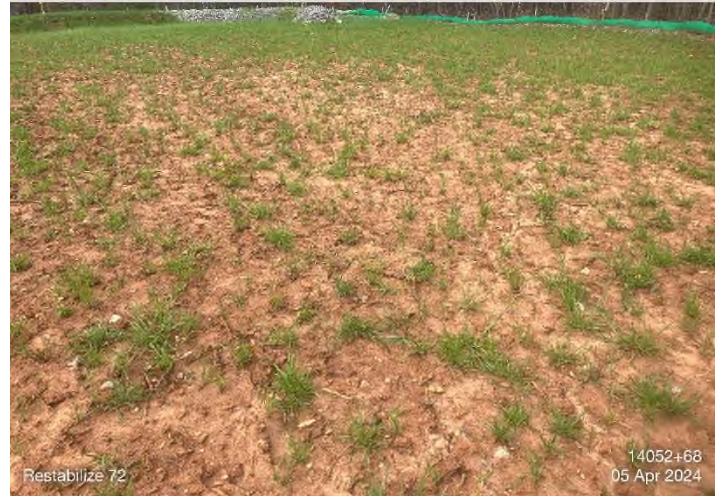
**Figure 2: STA 14052+00** – Repair rilling and restabilize denuded areas.

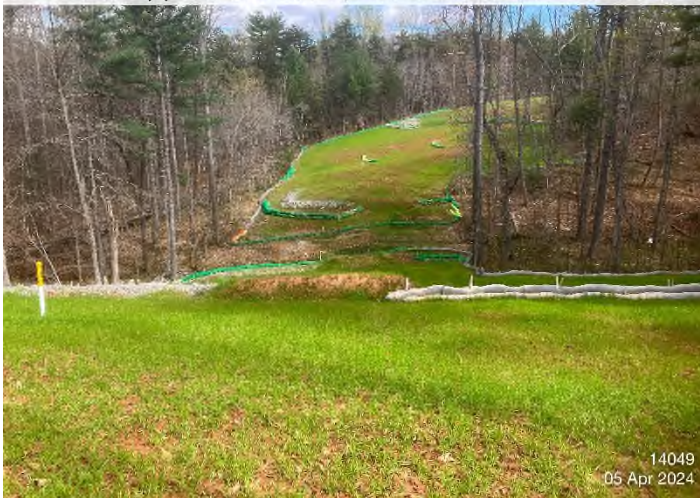
**Figure 3: STA 14049+00** – Controls in place and functioning properly.

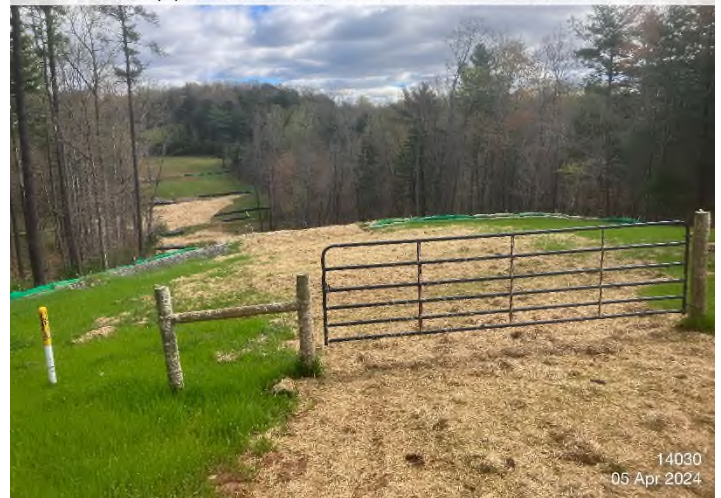
**Figure 4: STA 14030+00** – Controls in place and functioning properly.
