## FIELD INSPECTION REPORT

| Project Name: | Mountain Valley Pipeline | Inspector: | Marshall Willis |
| Spread I:<br>Pittsylvania County | STA 15063+85 – 15142+66<br>MVP-PI-325 | Weather: | Dry |

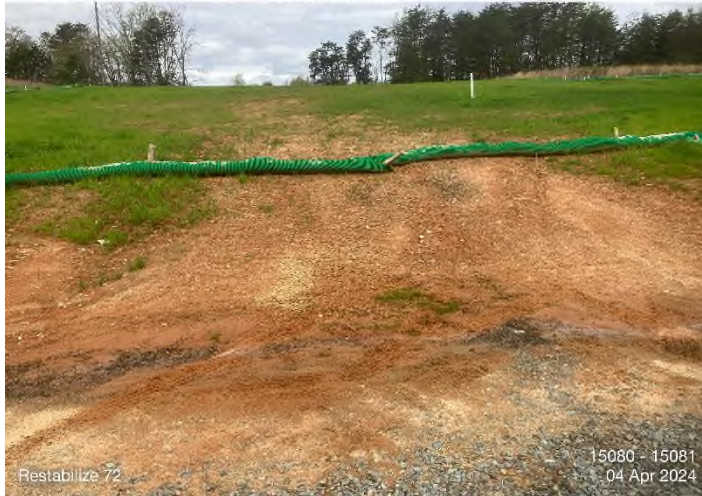
**Figure 1: STA 15080+00 to 15081+00** – Repair rilling and restabilize denuded areas.

- STA 15080+00 to 15081+00: Repair rills and restabilize denuded areas.

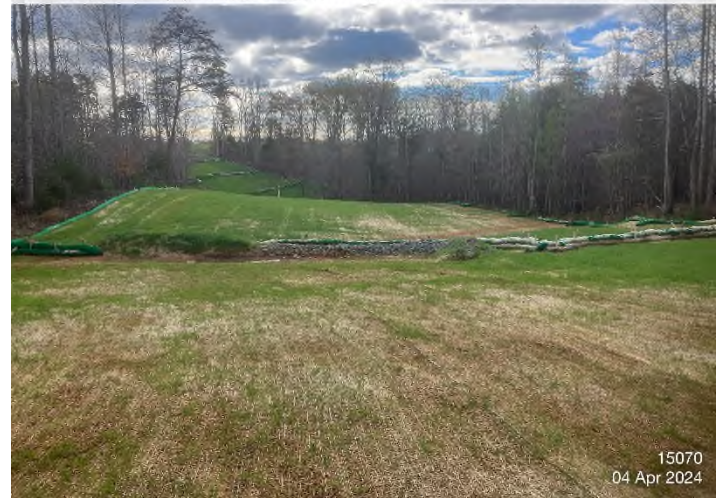
**Figure 2: STA 15070+00** – Controls installed and functioning properly.

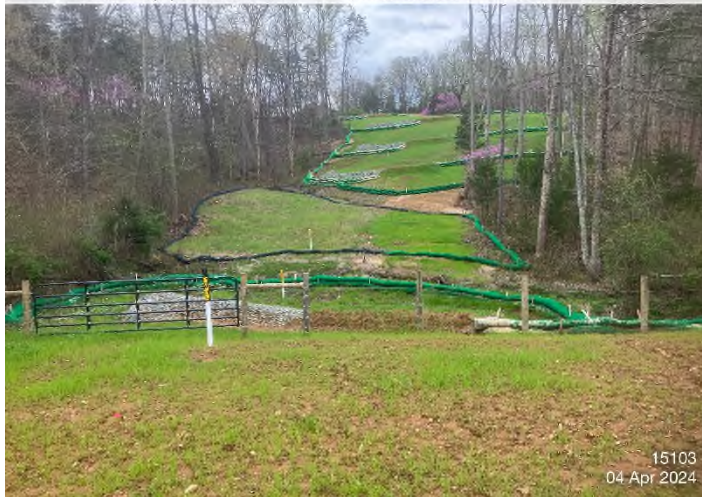
**Figure 3: STA 15103+00** – Controls installed and functioning properly.

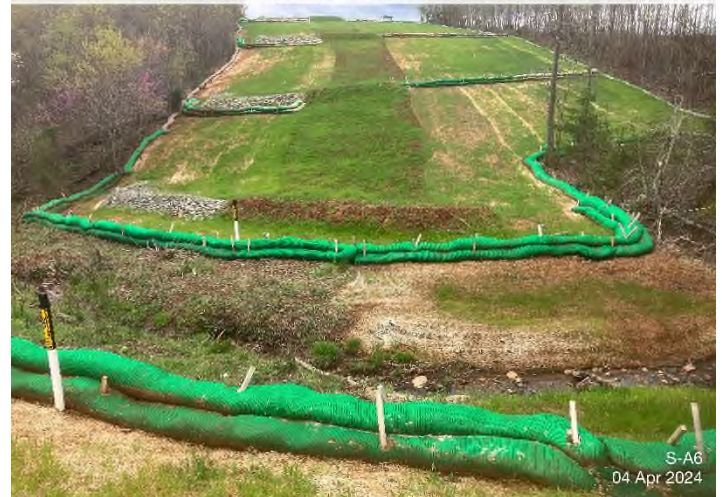
**Figure 4: Stream S-A6** – Controls installed and functioning properly.
