FIELD INSPECTION REPORT

| Project Name: | Mountain Valley Pipeline | Inspector: | Marshall Willis |
| Spread I: Franklin County | STA 14411+04 – 14454+22 MVP-FR-315 | Weather: | Wet |

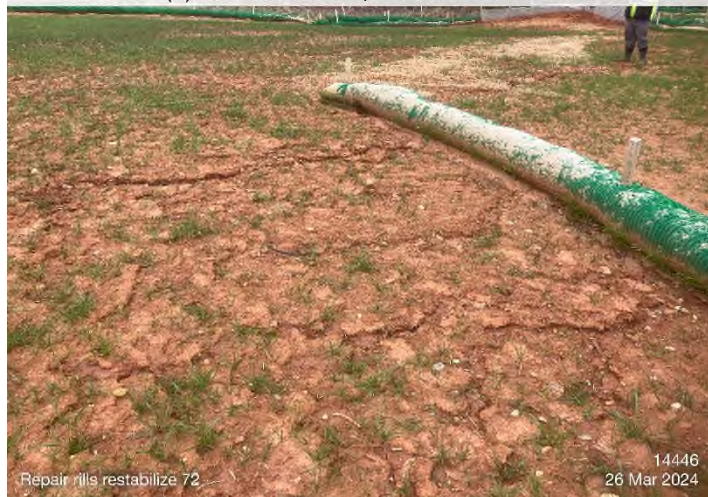
Figure 1: STA 14446+00 – Repair rills and restabilize denuded areas.

- STA 14446+00: Repair rills and restabilize denuded areas.

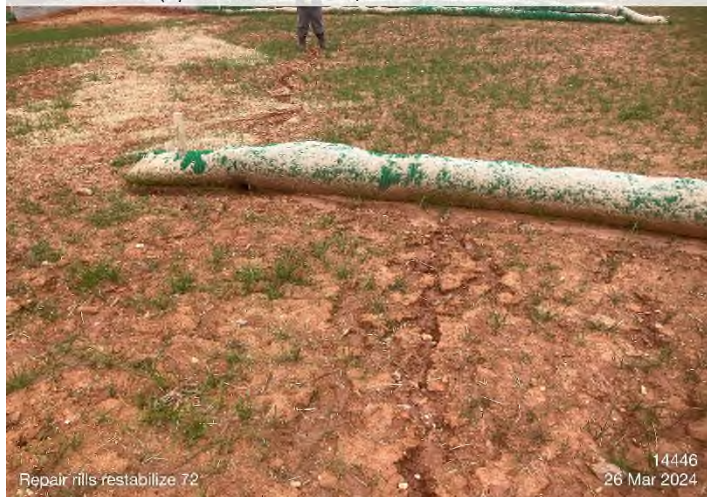
Figure 2: STA 14446+00 – Repair rills and restabilize denuded areas.

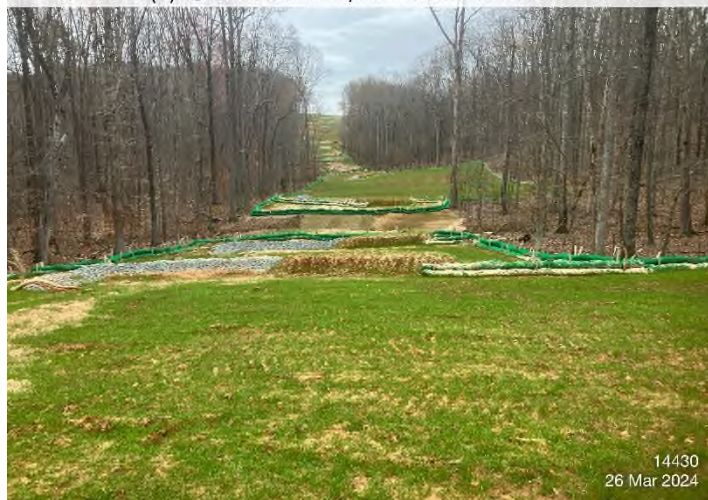
Figure 3: STA 14430+00 – Controls in place and functioning properly.

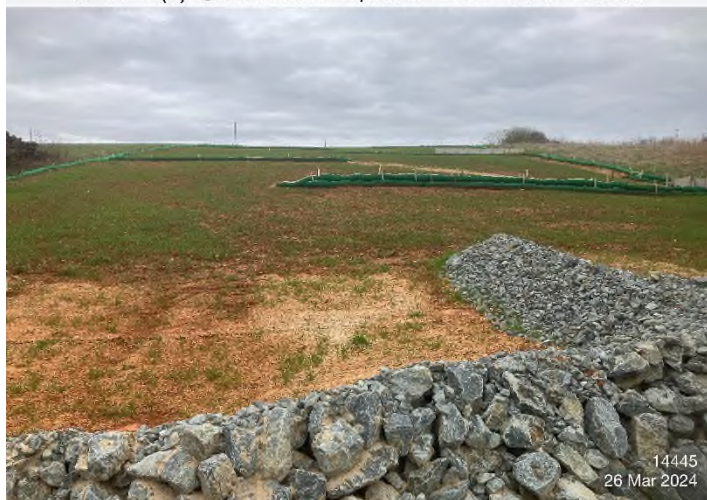
Figure 4: STA 14445+00 – Controls in place and functioning properly.
