FIELD INSPECTION REPORT

Project Name:	Mountain Valley Pipeline	Inspector:	Marshall Willis
Inspection Date:	Thursday, May 9, 2024	Project Contact:	Brian Clauto, Cory Chalmers
Spread I: Pittsylvania County	STA 15480+67 – 15619+48	Weather:	Wet

FIELD INSPECTION PHOTO LOG

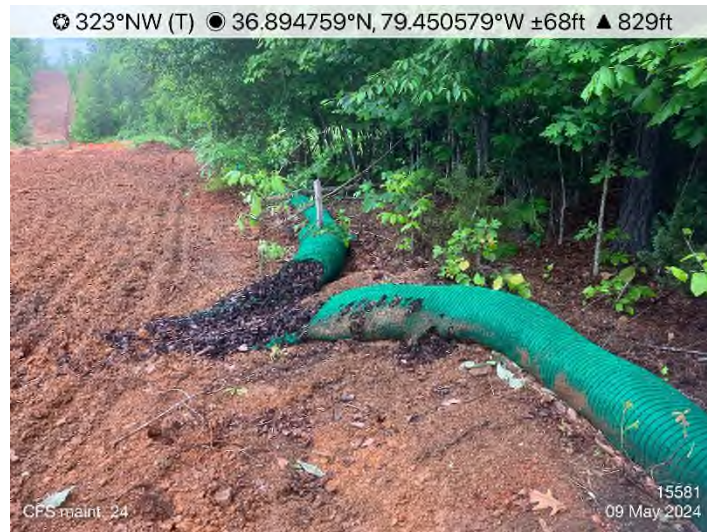
Figure 1: STA 15581+00 – CFS repair needed.

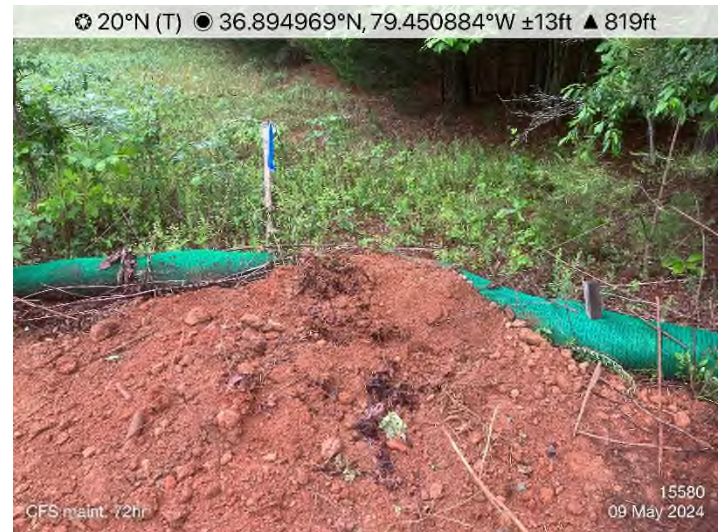
Figure 2: STA 15580+00 – CFS maintenance needed.

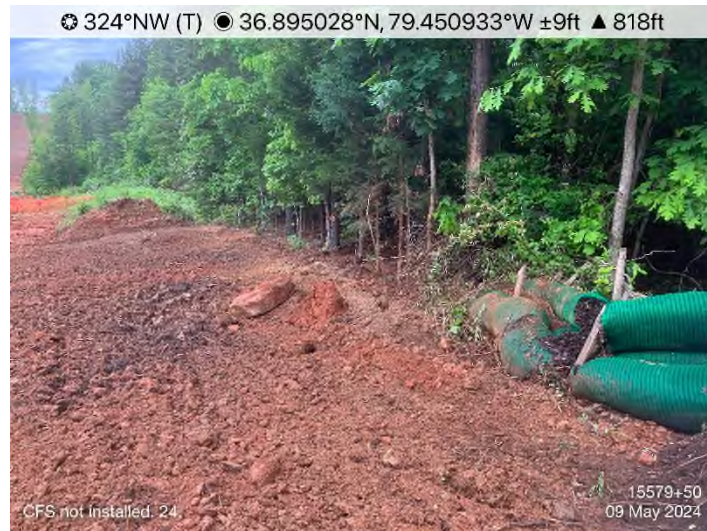
Figure 3: STA 15579+50 – CFS not installed, CFS repair needed.

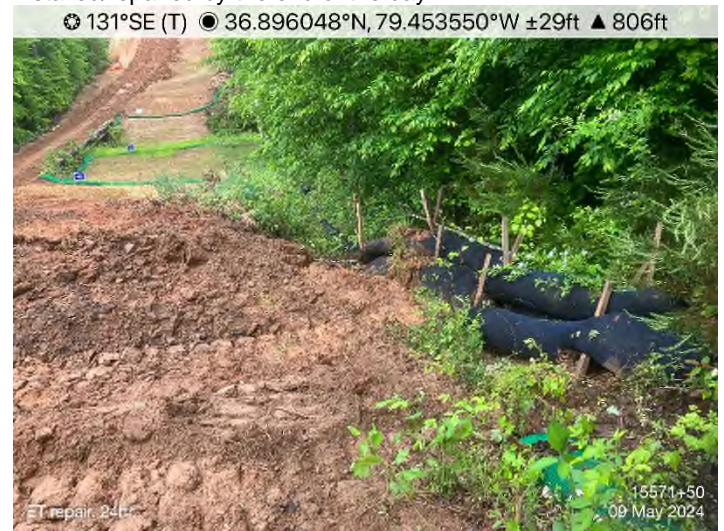
Figure 4: STA 15571+50 – Waterbar end-treatment not installed/repared by the end of the day.

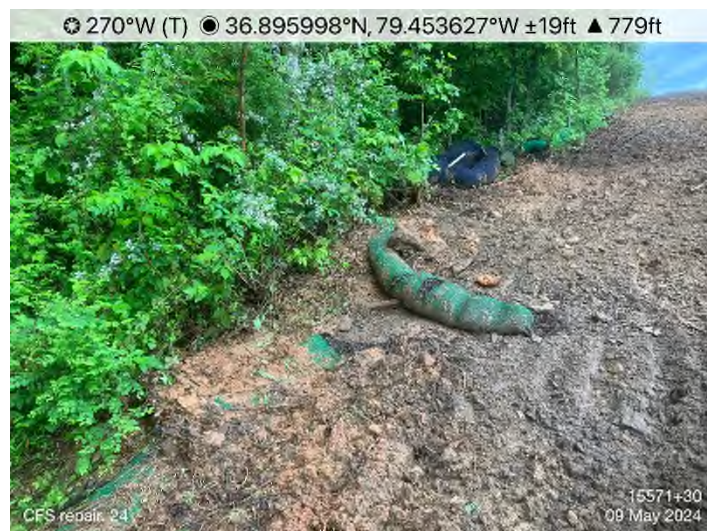
Figure 5: STA 15571+30 – CFS repair needed.

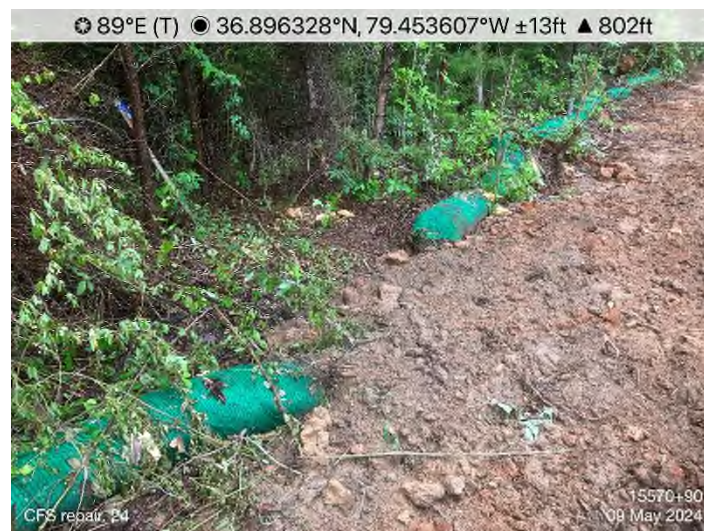
Figure 6: STA 15570+90 – CFS repair needed.

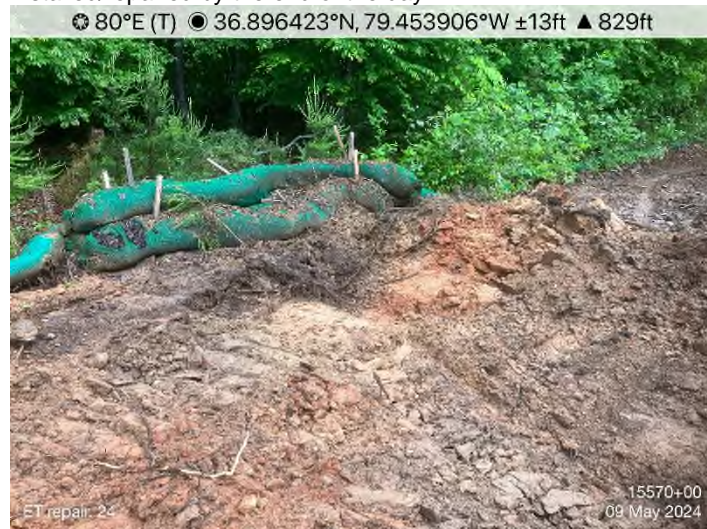
Figure 7: STA 15570+00 – Waterbar end-treatment not installed/repared by the end of the day.

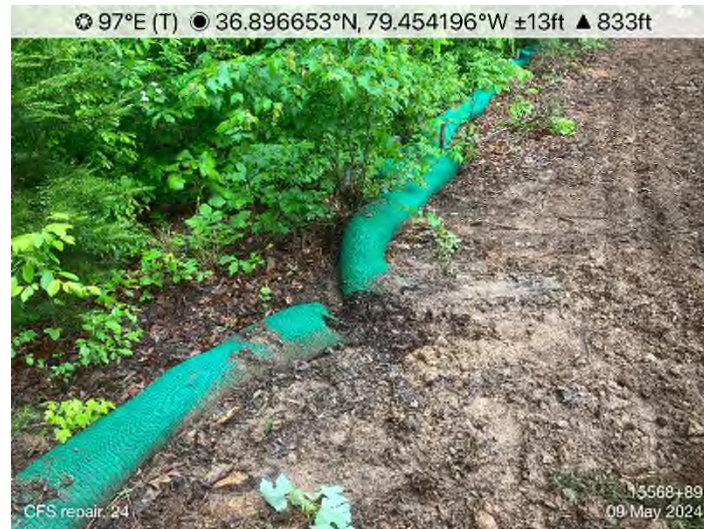
Figure 8: STA 15568+90 – CFS repair needed.

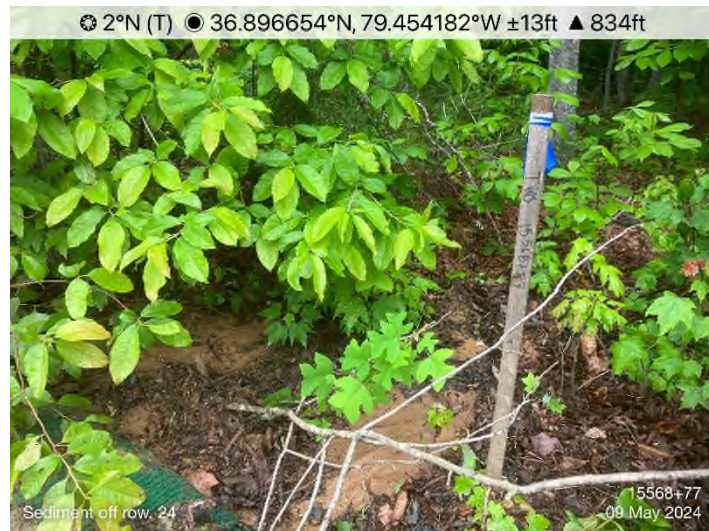
Figure 9: STA 15568+77 – Sediment off ROW. Retrieve and stabilize as needed.

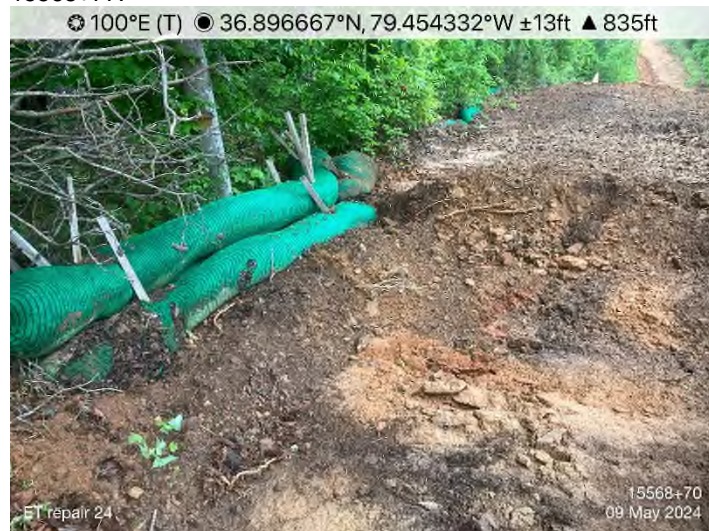
Figure 10: STA 15568+70 – Waterbar end-treatment not installed/repared by the end of the day causing SOR at STA 15568+77.

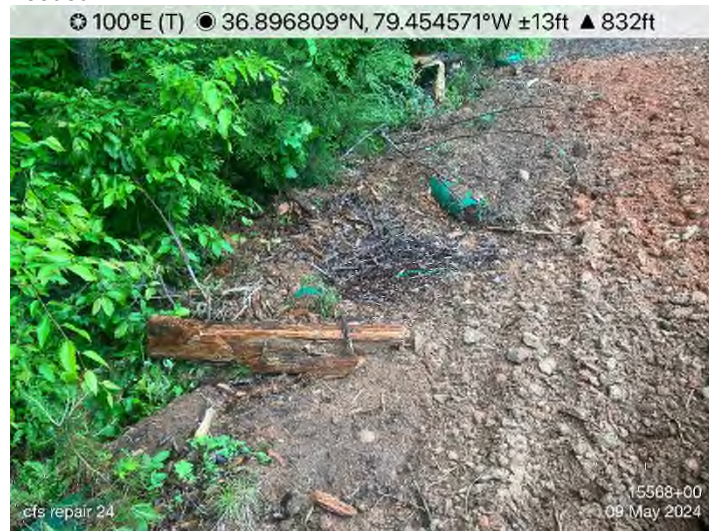
Figure 11: STA 15564+50 to STA 15568+00 - CFS repair needed.

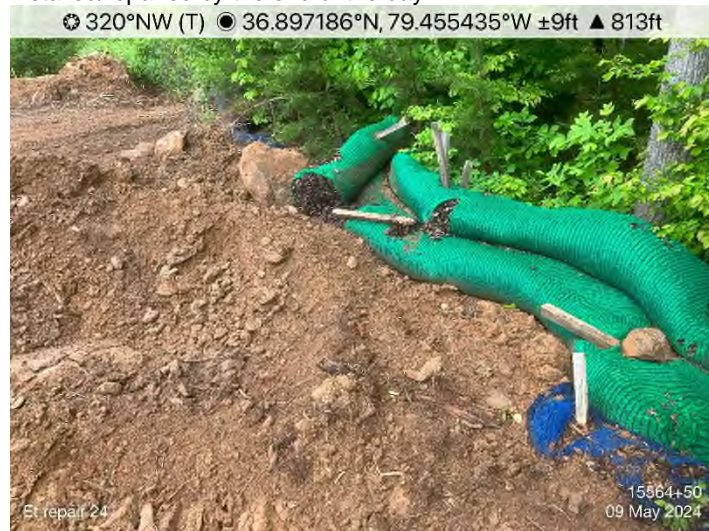
Figure 12: STA 15564+50 – Waterbar end-treatment not installed/repared by the end of the day.

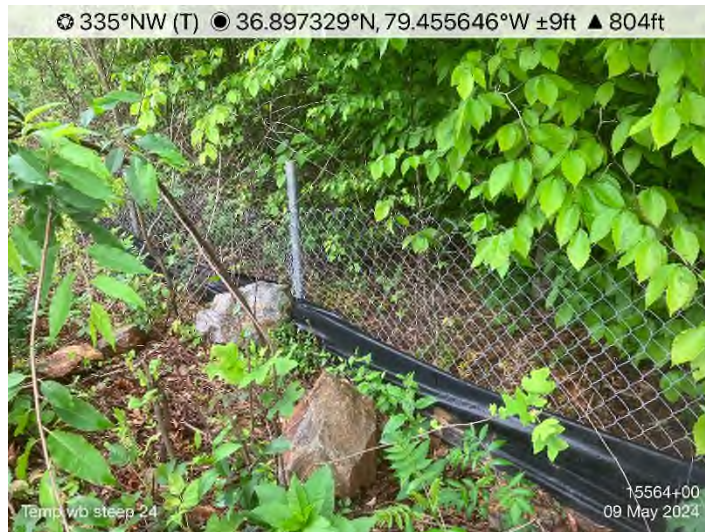
Figure 13: STA 15564+00 – SSF repair needed.

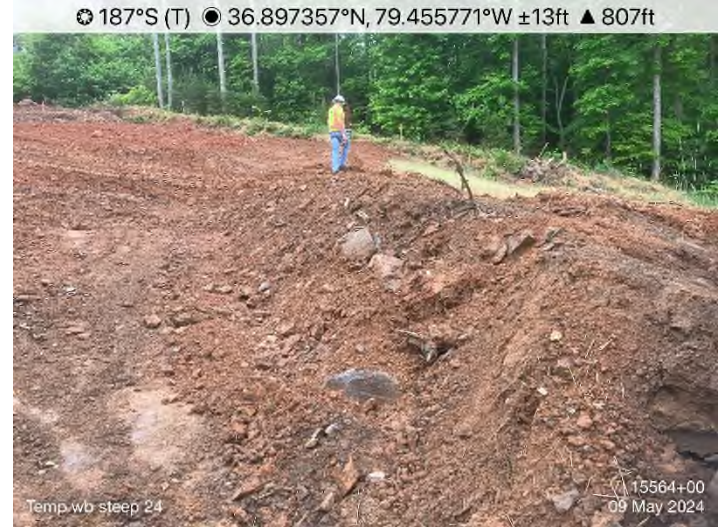
Figure 14: STA 15564+00 – Temp. WB improper install, too steep, not compacted. Install per specification.

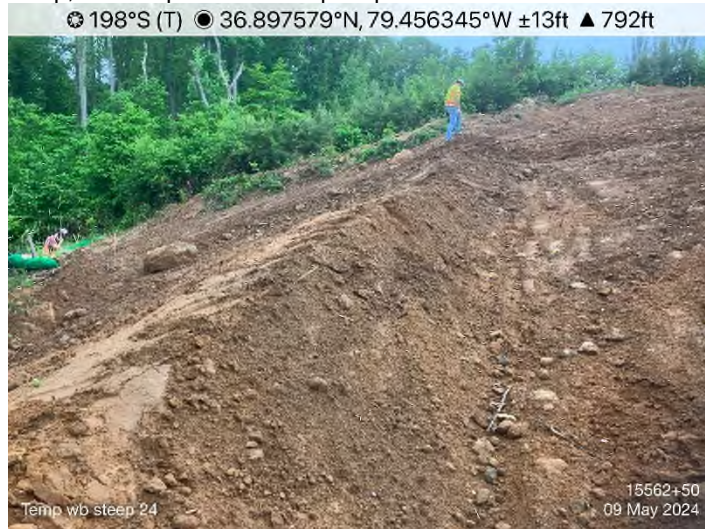
Figure 15: STA 15562+50 – Temp. WB improper install, too steep, not compacted. Install per specification.

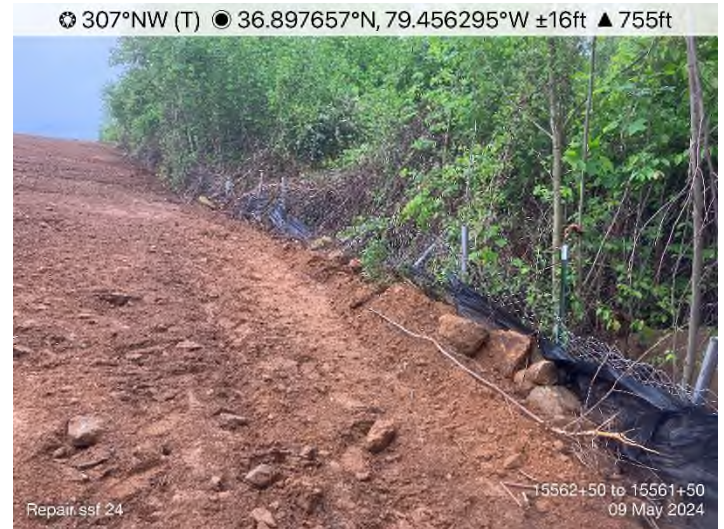
Figure 16: STA 15561+50 to STA 15562+50 – SSF repair needed.

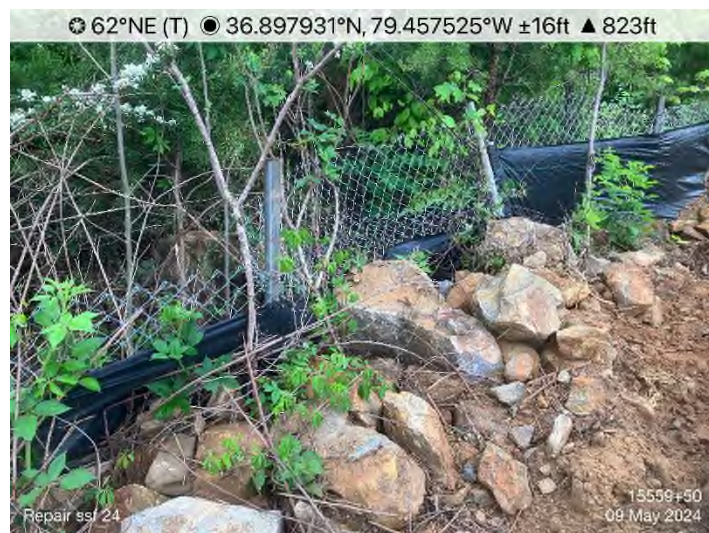
Figure 17: STA 15559+50 – SSF repair needed.

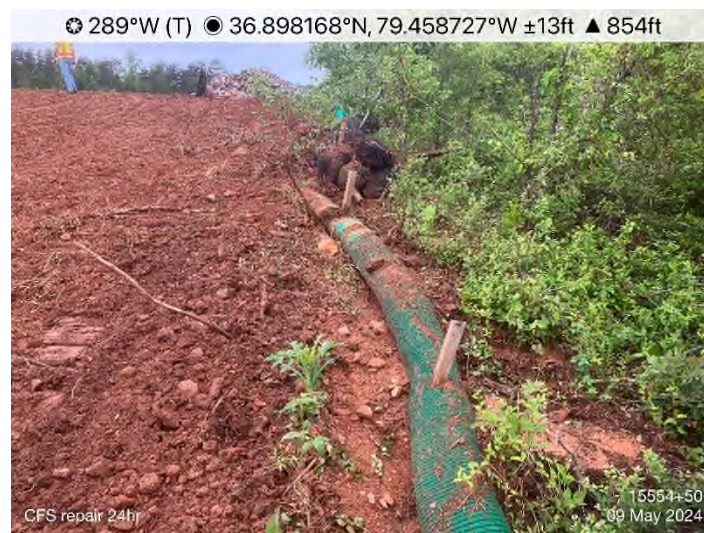
Figure 18: STA 15554+50 – CFS repair needed.

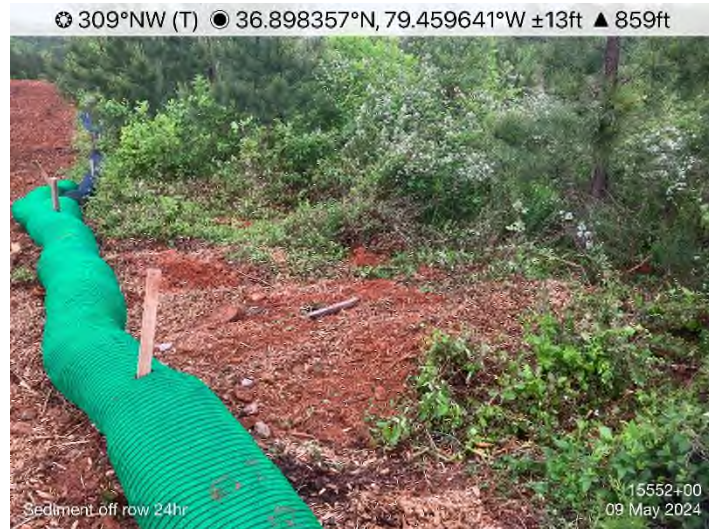
Figure 19: STA 15552+00 – Sediment off ROW from grading activities. Retrieve and stabilize as needed.

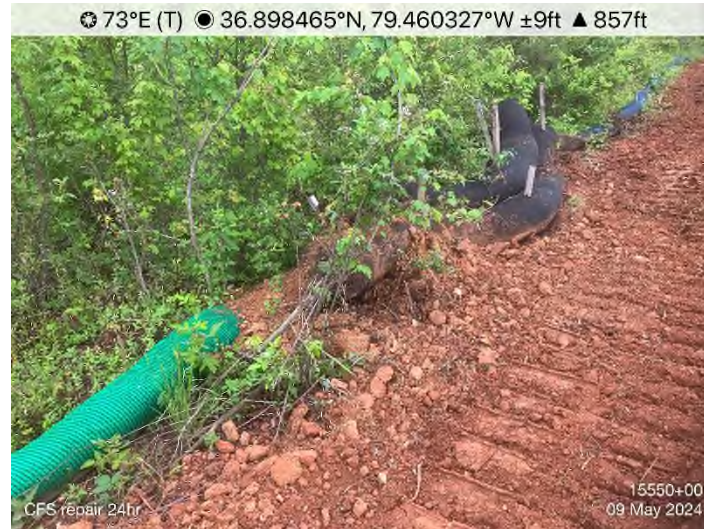
Figure 20: STA 15548 to STA 15550+00 – CFS repair needed.

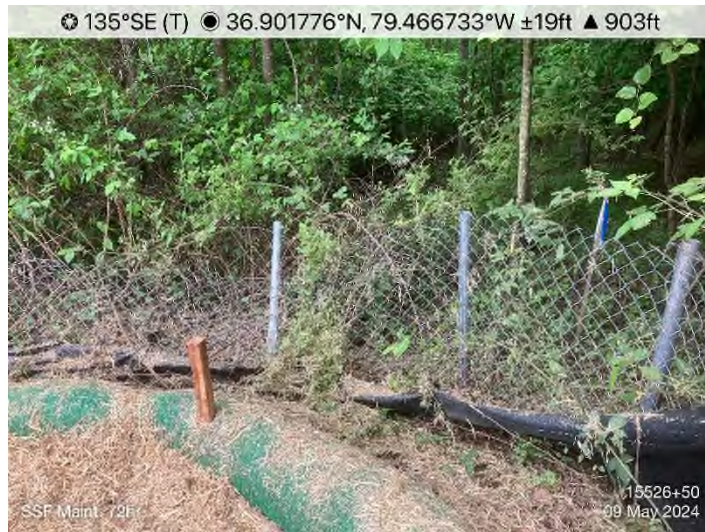
Figure 21: STA 15526+00 – SSF repair needed.

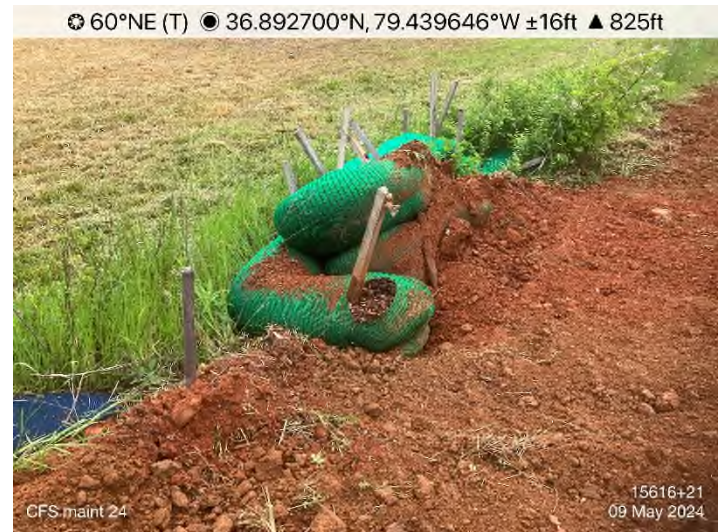
Figure 22: STA 15616+21 – CFS repair needed.

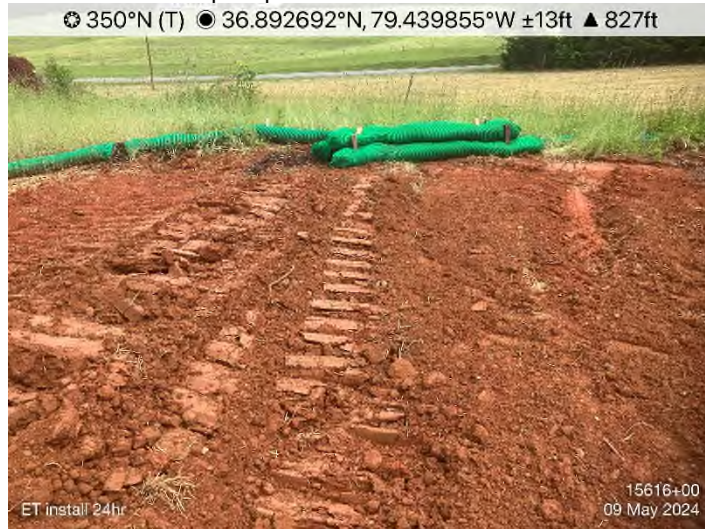
Figure 23: STA 15616+00 – Waterbar end-treatment improper installation. Install per specification.

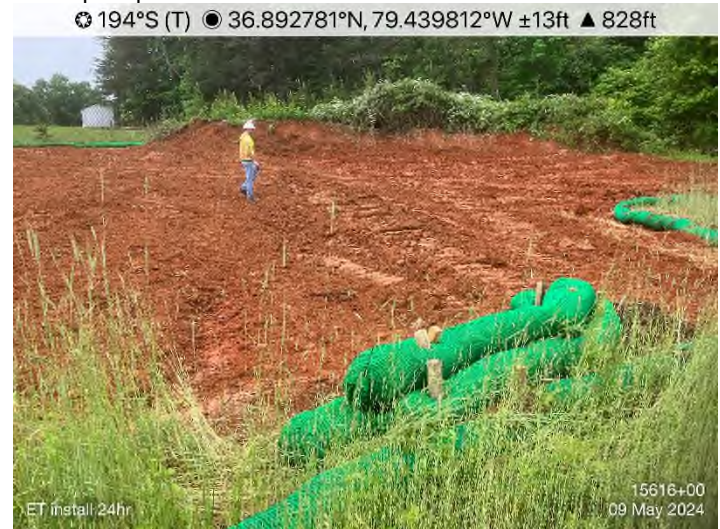
Figure 24: STA 15616+00 – Waterbar improper installation. Install per specification.

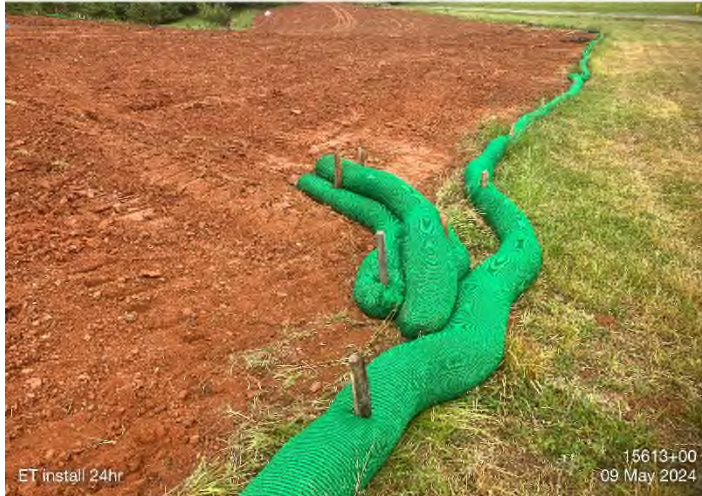
Figure 25: STA 15613+00 – Waterbar end-treatment improper installation. Install per specification.

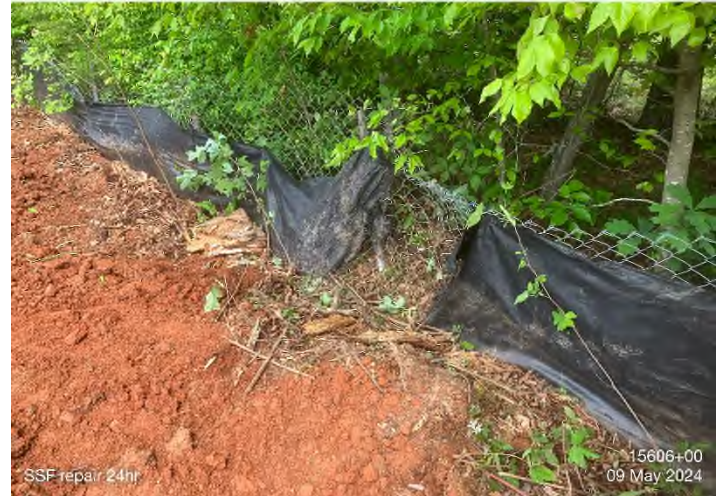
Figure 26: STA 15606+00 – SSF repair needed.

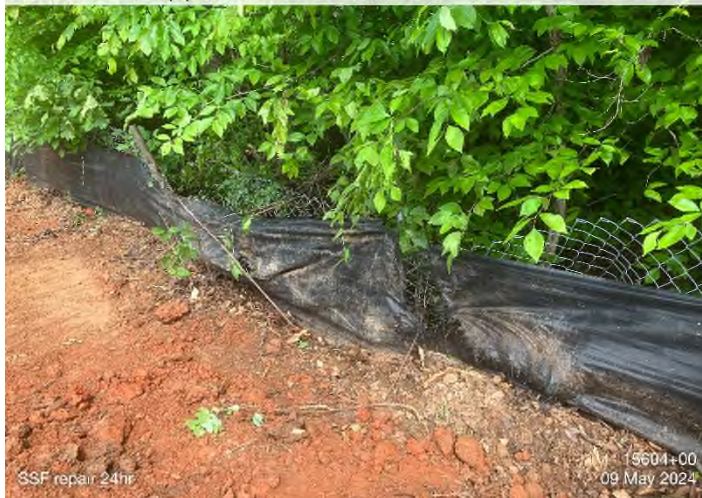
Figure 27: STA 15604+00 – SSF repair needed.

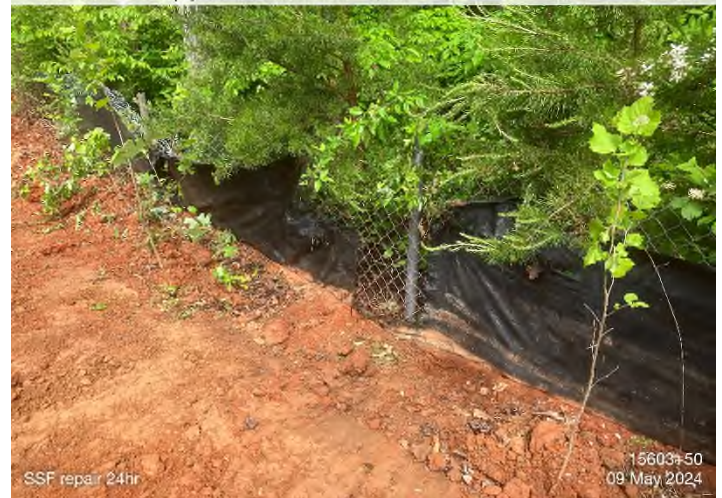
Figure 28: STA 15603+50 – SSF repair needed.

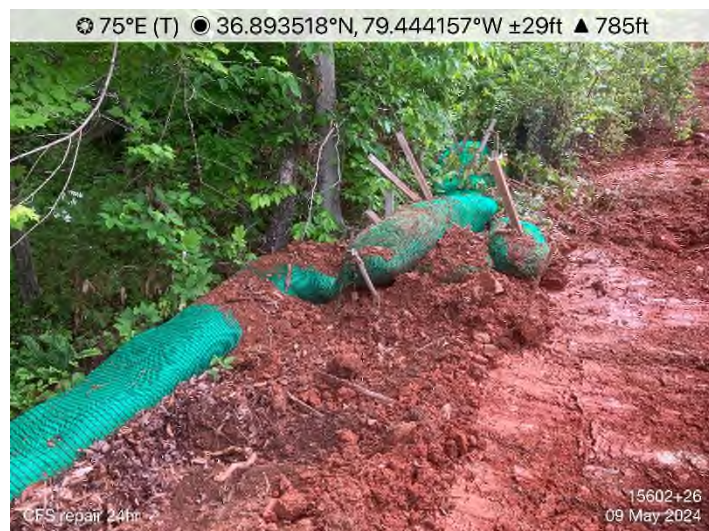
Figure 29: STA 15602+26 – CFS repair needed.

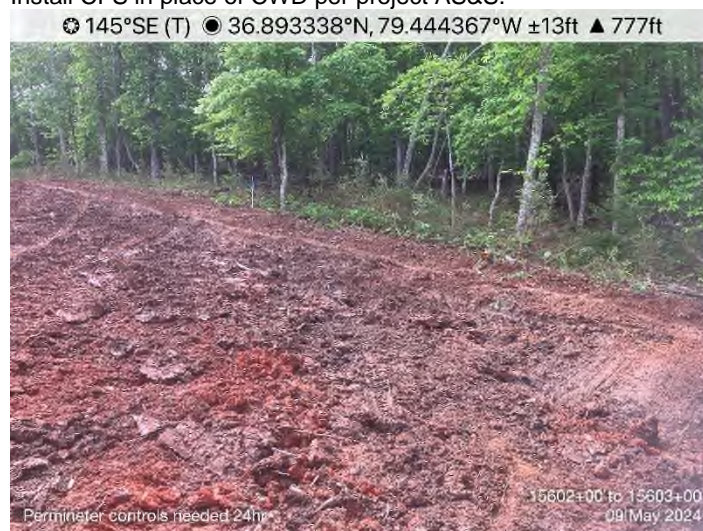
Figure 30: STA 15602+00 to 15603+00 – Controls not installed. Install CFS in place of CWD per project AS&S.

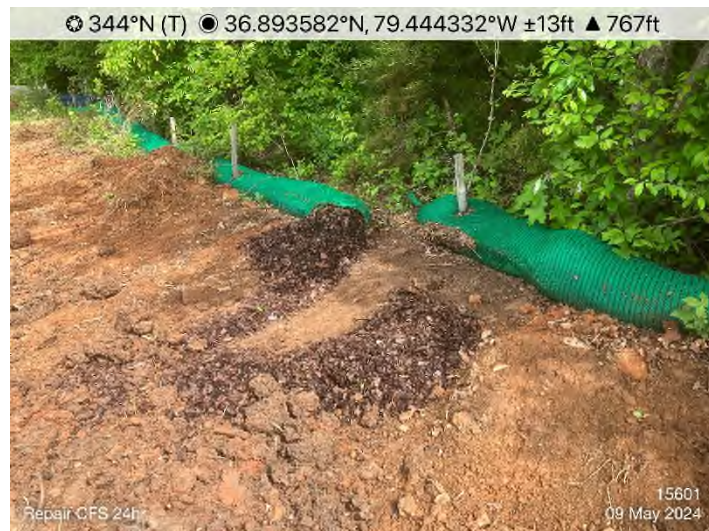
Figure 31: STA 15601+00 – CFS repair needed.
