## FIELD INSPECTION REPORT

<b>Project Name:</b>	Mountain Valley Pipeline	<b>Inspector:</b>	Marshall Willis
<b>Inspection Date:</b>	Wednesday, May 8, 2024	<b>Project Contact:</b>	Brian Clauto, Cory Chalmers
<b>Spread I:</b> Franklin County Pittsylvania County	STA 13437+75 – 13493+14 STA 14220+00 – 14231+00 STA 15430+00 – 15480+67 MVP-FR-293.02 MVP-FR-311	<b>Weather:</b>	Dry

## FIELD INSPECTION PHOTO LOG

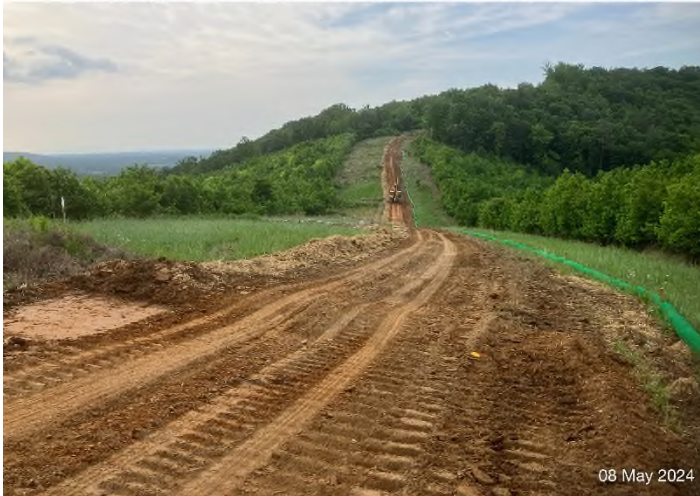
**Figure 1: STA 13441+00** – Controls in place and functioning properly.

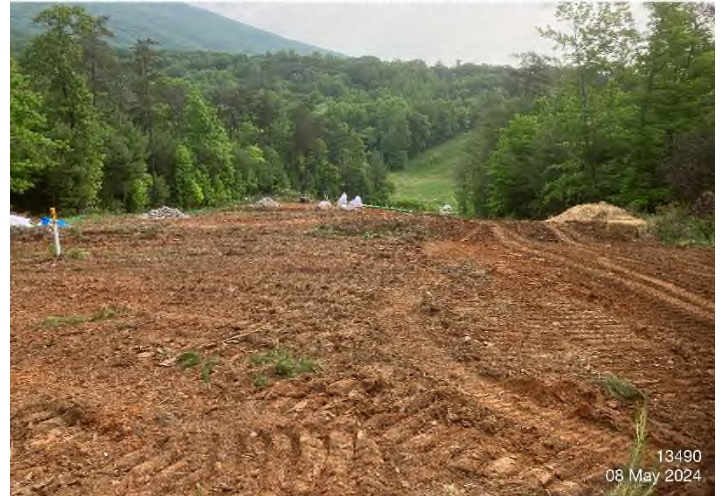
**Figure 2: STA 13490+00** – Controls in place and functioning properly.

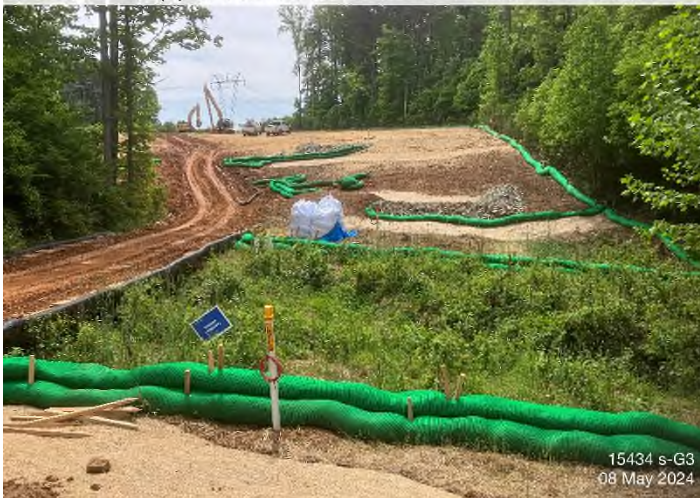
**Figure 3: Stream S-G3** – Controls in place and functioning properly.

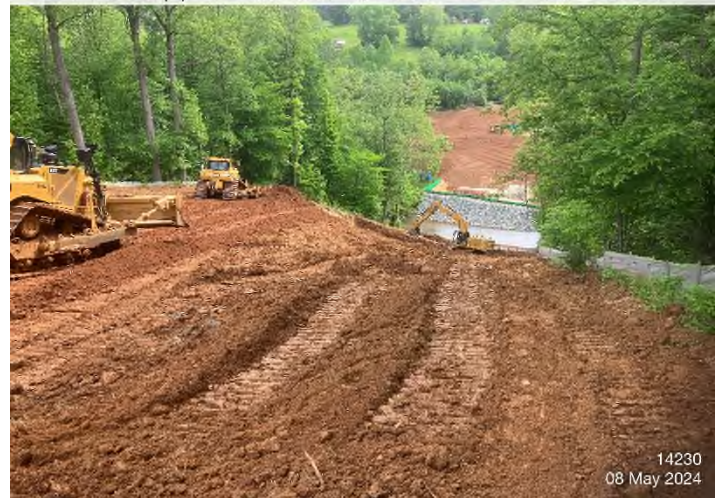
**Figure 4: STA 14230+00** – Controls in place and functioning properly.
