FIELD INSPECTION REPORT

Project Name:	Mountain Valley Pipeline	Inspector:	Marshall Willis
Inspection Date:	Tuesday, May 7, 2024	Project Contact:	Brian Clauto, Cory Chalmers
Spread H: Montgomery County	STA 12190+85 – 12204+00 STA 12135+53 – 12145+00 MVP-MN-272 MVP-MN-275	Weather:	Dry

FIELD INSPECTION PHOTO LOG

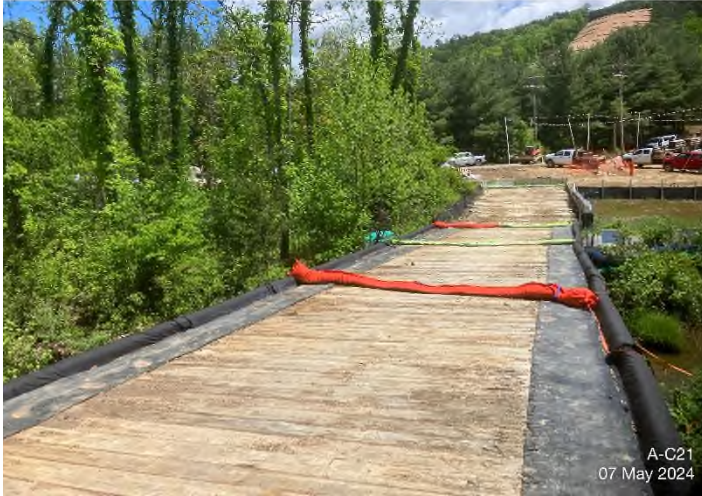
Figure 1: Stream S-C21 – Controls in place and functioning properly at Bradshaw Creek.

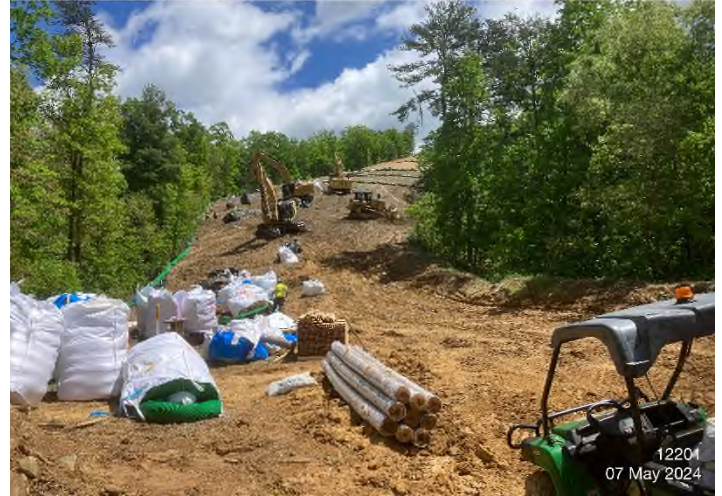
Figure 2: STA 12201+00 – Controls in place and functioning properly.

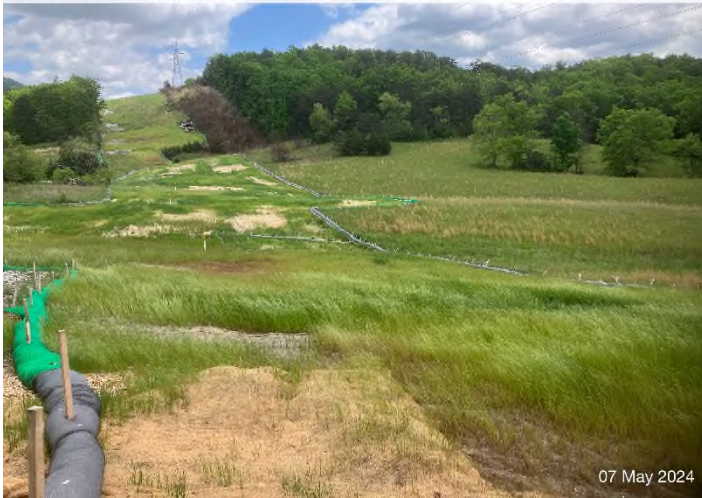
Figure 3: STA 12140+00 – Controls in place and functioning properly.

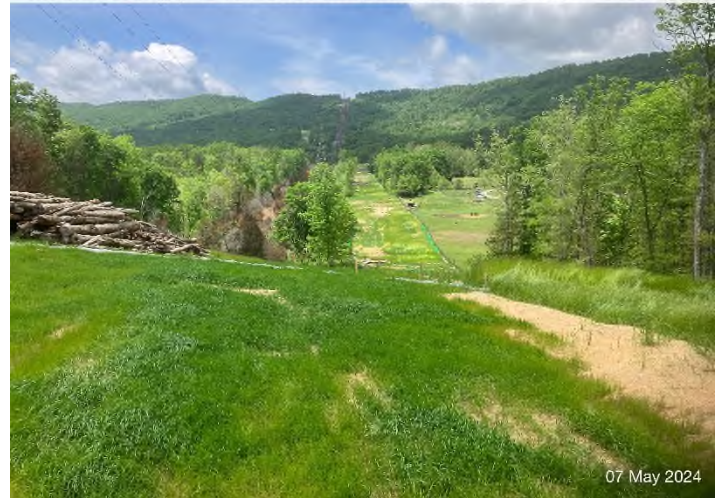
Figure 4: STA 12135+00 – Controls in place and functioning properly.
