Project Name:	Mountain Valley Pipeline	Inspector:	Matthew Grant
Inspection Date:	Monday, May 13, 2024	Project Contact:	Brian Clauto
Spread I: Franklin	Sta 13440, 13497-13498, 14235- 14250 FR 293.02, MLV AR32 ATWS 693, 350, 351, 351a	Weather:	Dry

FIELD INSPECTION PHOTO LOG

Project Name: Mountain Valley Pipeline

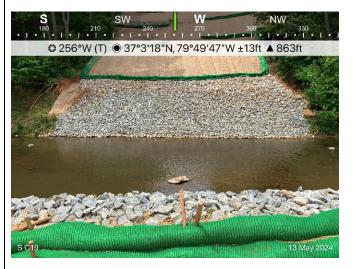
<u>Figure 2</u>: Designated crossing S-C19, ESC and permanent measures in place.

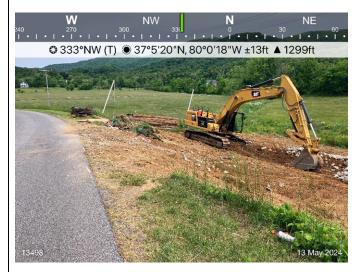
Figure 4: Near St 13498, CE was not in place.
