FIELD INSPECTION REPORT

Project Name:	Mountain Valley Pipeline	Inspector:	Marshall Willis
Inspection Date:	Friday, June 7, 2024	Project Contact:	Brian Clauto, Cory Chalmers
Spread I: Franklin County	STA 13541+66 – 13575+21	Weather:	Dry

FIELD INSPECTION PHOTO LOG

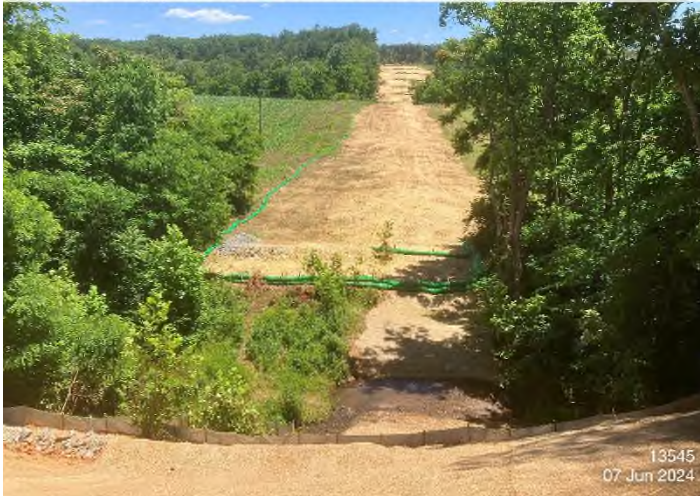
Figure 1: STA 13545+00 – Controls in place and functioning properly.

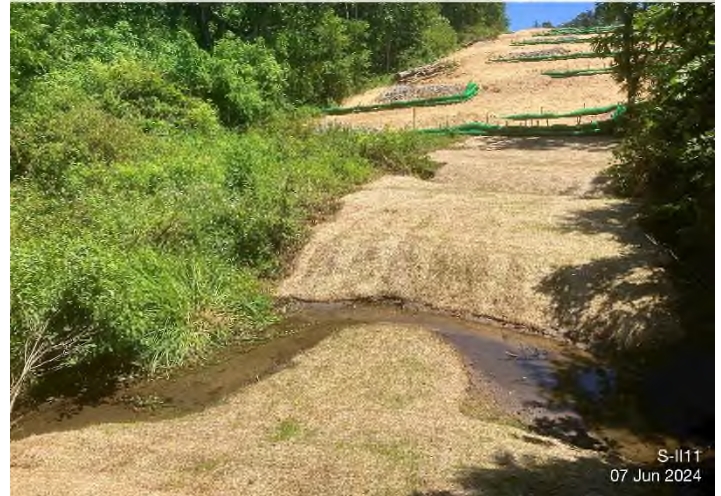
Figure 2: Stream S-II11/II12 – Controls in place and functioning properly.

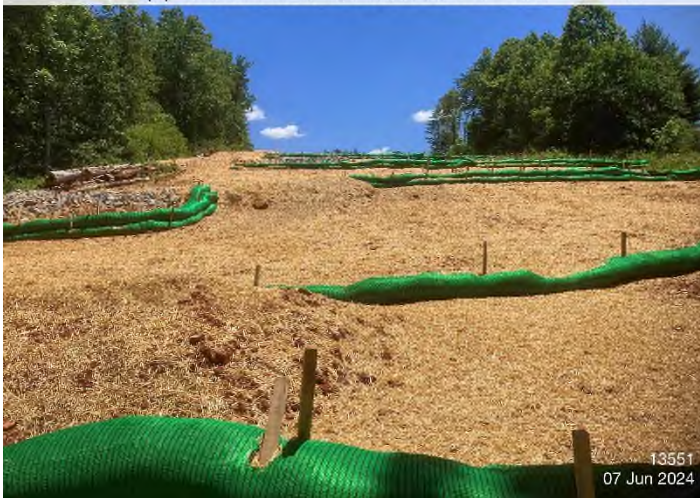
Figure 3: STA 13551+00 – Controls in place and functioning properly.

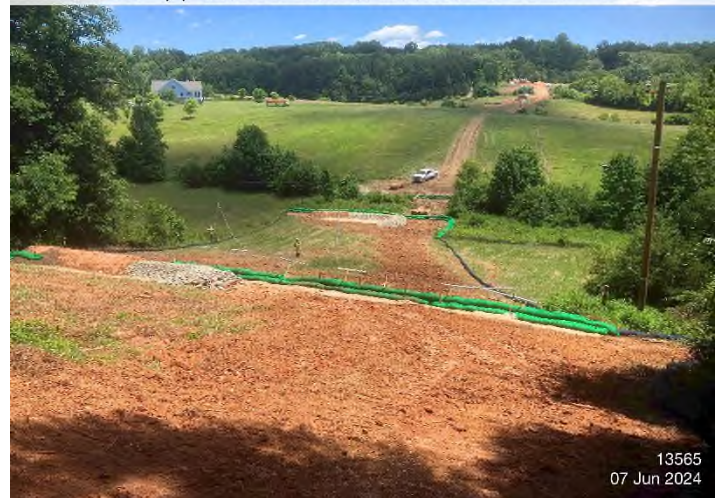
Figure 4: STA 13565+00 – Controls in place and functioning properly. Area actively undergoing final stabilization.
