## FIELD INSPECTION REPORT

Project Name:	Mountain Valley Pipeline	Inspector:	Marshall Willis
Inspection Date:	Thursday, May 30, 2024	Project Contact:	Brian Clauto, Cory Chalmers
Spread I: Franklin County	STA 13437+75 – 13541+66 MVP-FR-293.02	Weather:	Dry

## FIELD INSPECTION PHOTO LOG

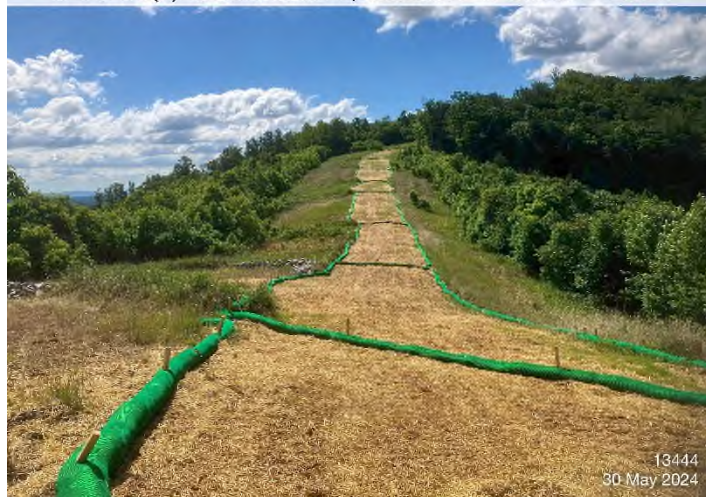
**Figure 1: STA 13444+00** – Controls in place and functioning properly.

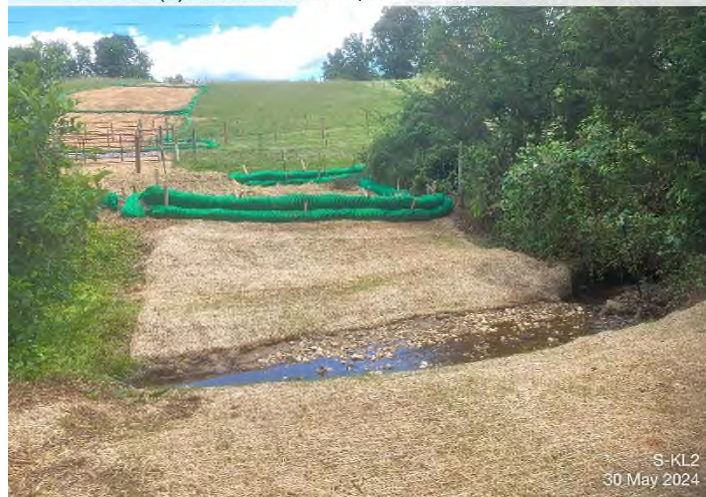
**Figure 2: Stream S-KL2** – Controls in place and functioning properly.

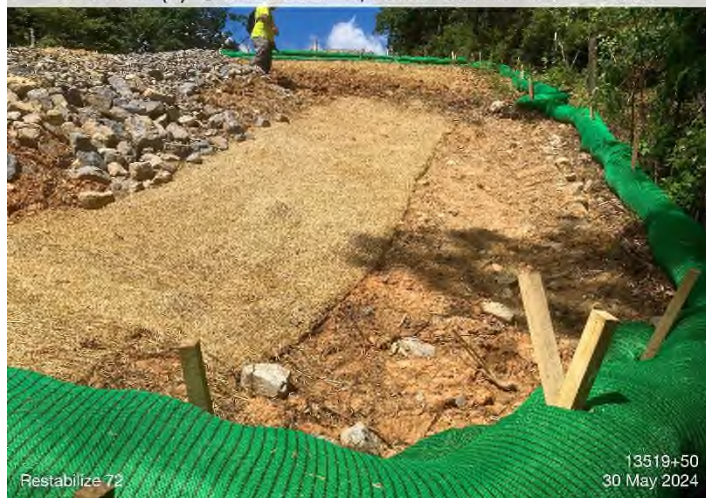
**Figure 3: STA 13519+50** – Restabilize denuded area at final grade.

Restabilize 72

- STA 13519+50: Re-stabilize denuded area.
- STA 13533+00: Re-stabilize denuded area.

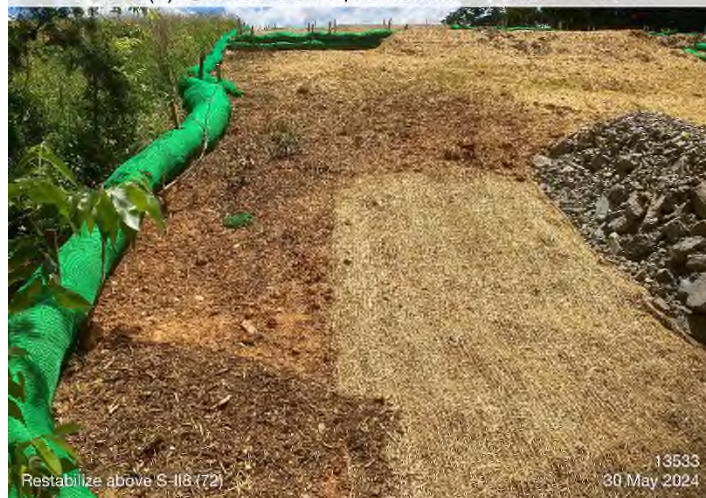
**Figure 4: STA 13533+00** – Restabilize denuded area at final grade.

Restabilize above S-118 (72)
