FIELD INSPECTION REPORT

| Project Name: | Mountain Valley Pipeline | Inspector: | Marshall Willis |
| Inspection Date: | Tuesday, May 21, 2024 | Project Contact: | Brian Clauto, Cory Chalmers |
| Spread I: Franklin County | STA 13435+00 – 13450+00 STA 13530+00 – 13550+00 MVP-FR-293.02 | Weather: | Dry |

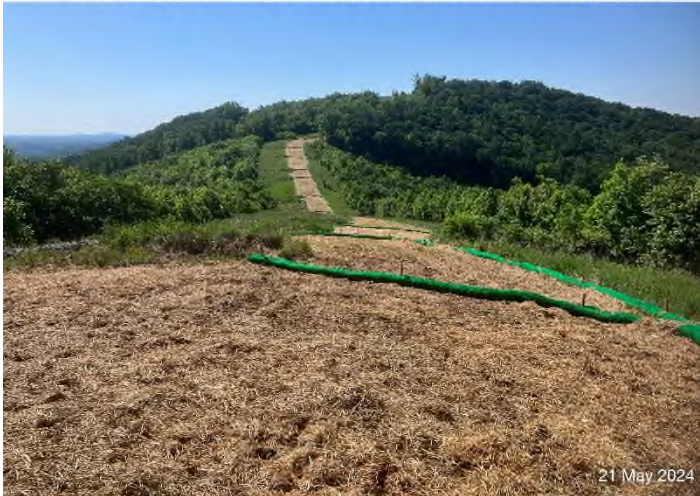
Figure 1: STA 13441+00 – Controls in place and functioning properly.

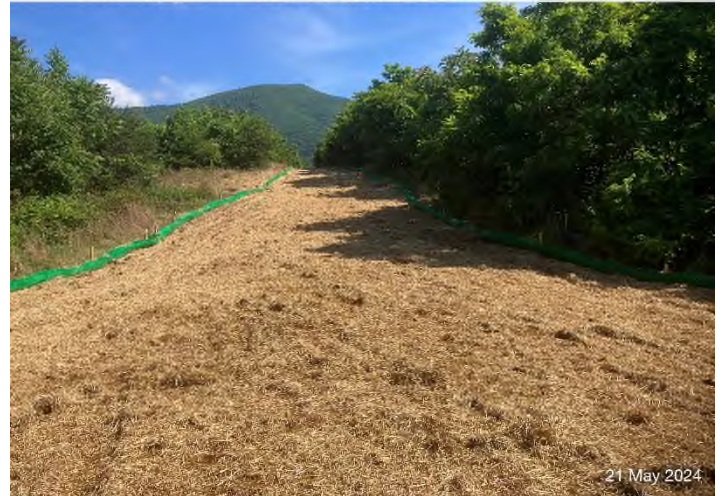
Figure 2: MVP-FR-293.02 – Controls in place and functioning properly.

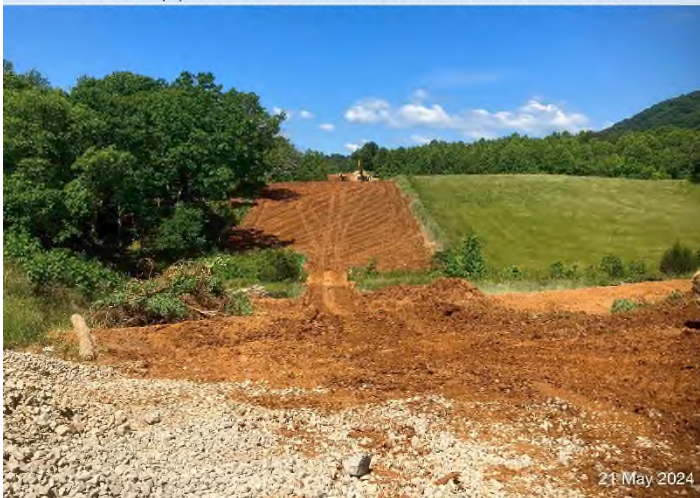
Figure 3: STA 13541+00 – Controls in place and functioning properly.
