## FIELD INSPECTION REPORT

<b>Project Name:</b>	Mountain Valley Pipeline	<b>Inspector:</b>	Marshall Willis
<b>Inspection Date:</b>	Wednesday, May 22, 2024	<b>Project Contact:</b>	Brian Clauto, Cory Chalmers
<b>Spread H: Roanoke County</b>	STA 12955+00 – 12960+00 STA 12915+00 – 12938+00 MVP-RO-287 MVP-RO-286	<b>Weather:</b>	Dry

## FIELD INSPECTION PHOTO LOG

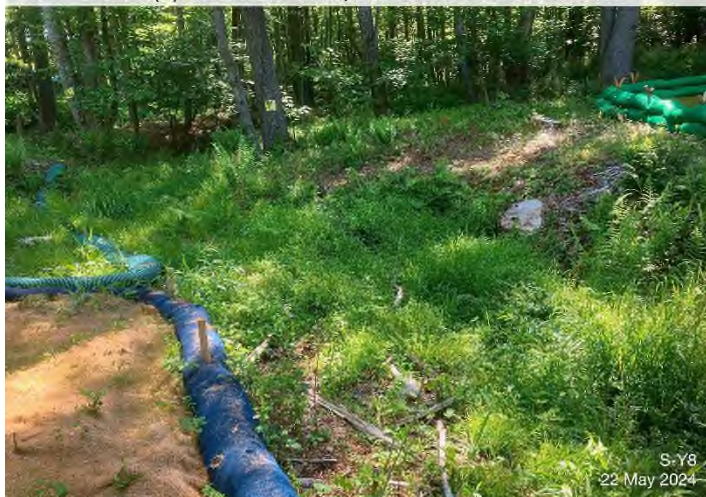
**Figure 1: Stream S-Y8** – Controls in place and functioning properly.

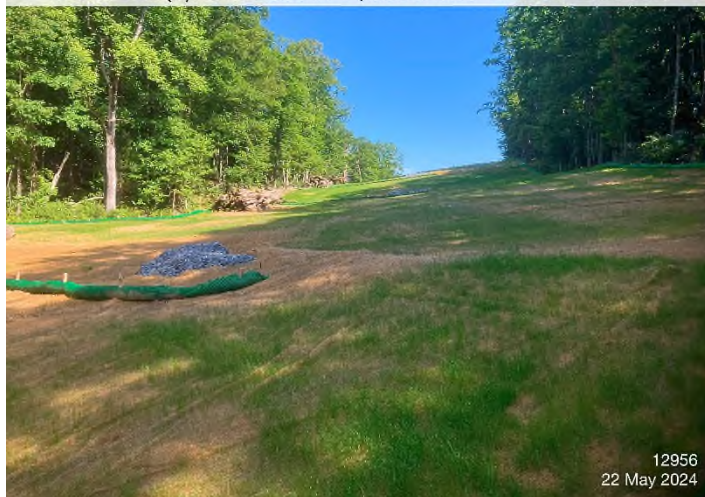
**Figure 2: STA 12956+00** – Controls in place and functioning properly.

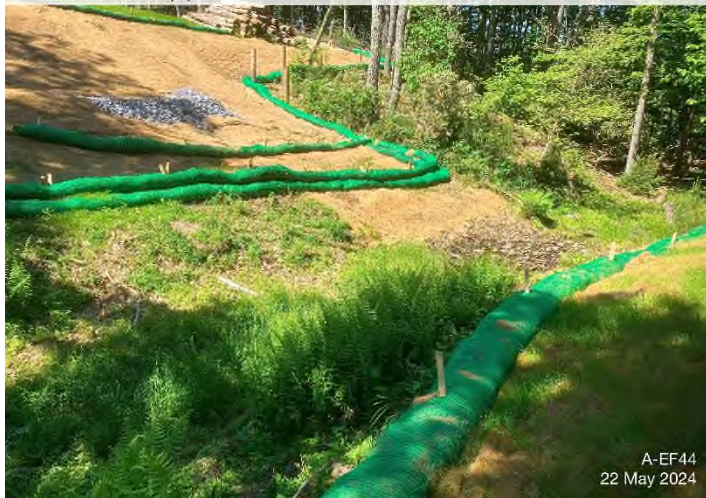
**Figure 3: Stream S-EF44** – Controls in place and functioning properly.

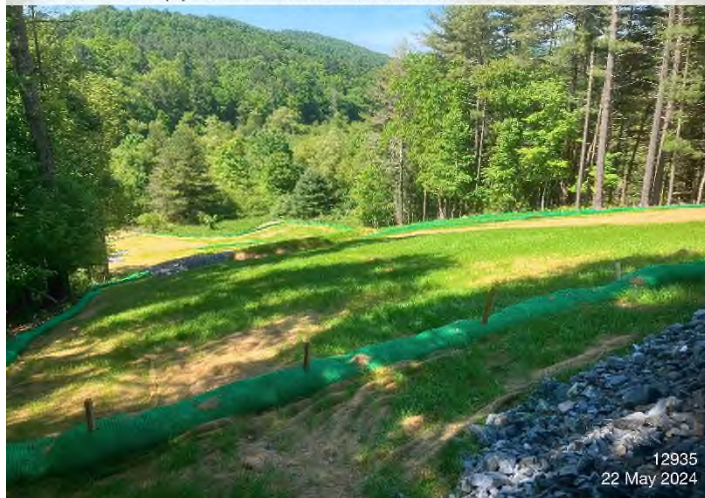
**Figure 4: STA 12935+00** – Controls in place and functioning properly.
