FIELD INSPECTION REPORT

Project Name:	Mountain Valley Pipeline	Inspector:	Marshall Willis
Inspection Date:	Thursday, June 6, 2024	Project Contact:	Brian Clauto, Cory Chalmers
Spread H: Montgomery County	STA 12186+92 – 12201+00 STA 12409+03 – 12437+00 MVP-MN-274/275 MVP-MN-279.02	Weather:	Dry

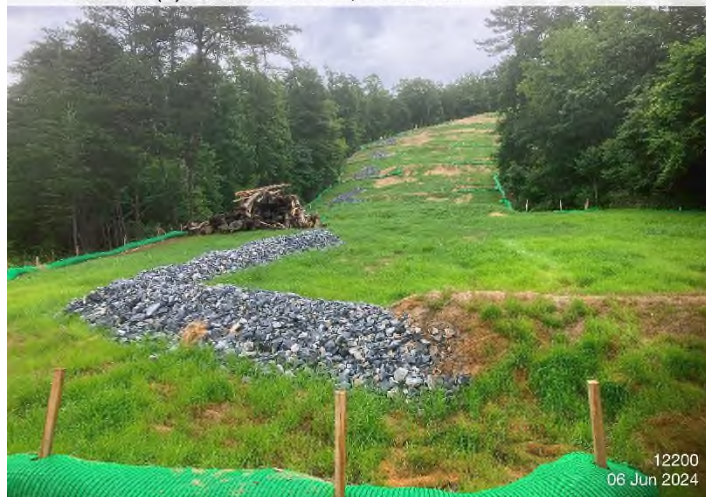
Figure 1: STA 12200+00 – Controls in place and functioning properly.

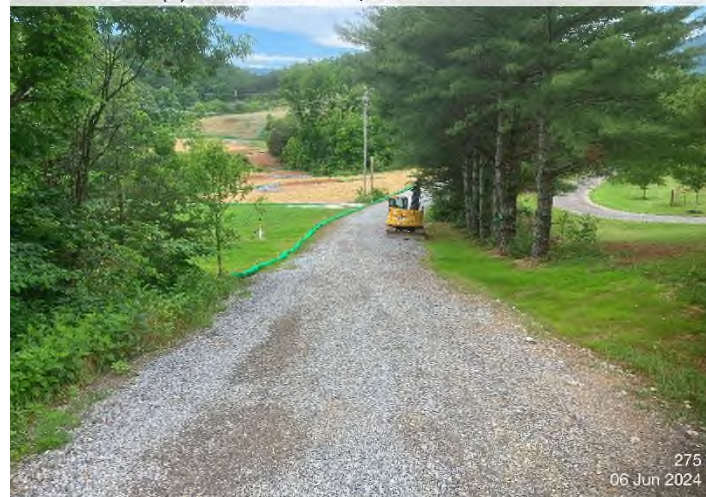
Figure 2: MVP-MN-275 – Controls in place and functioning properly.

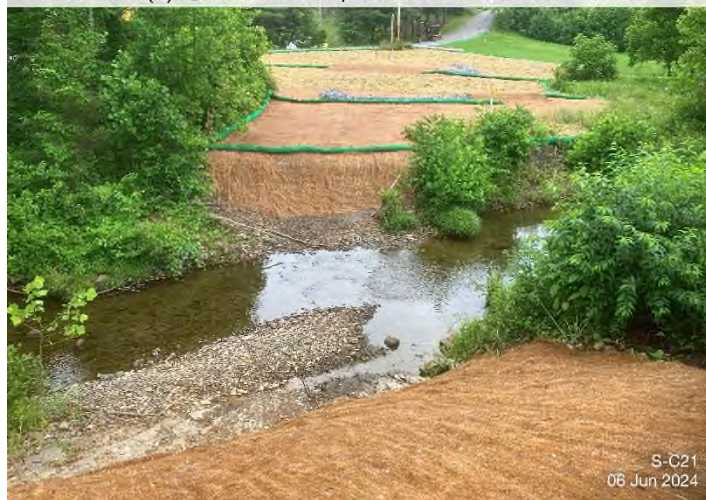
Figure 3: Stream S-C21 – Controls in place and functioning properly.

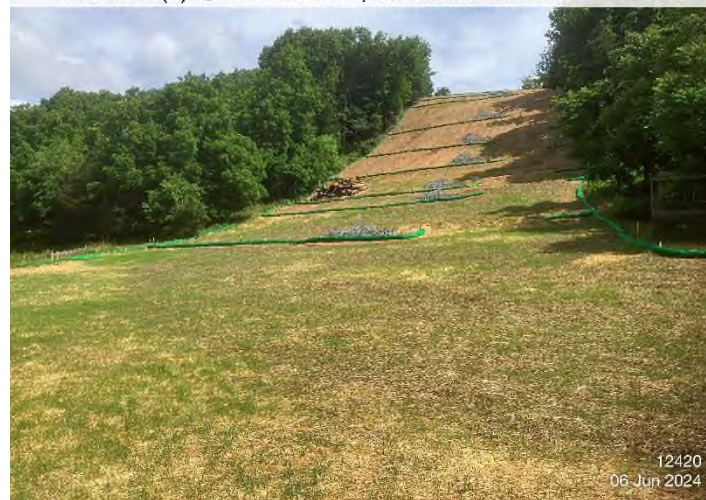
Figure 4: STA 12420+00 – Controls in place and functioning properly.
