## FIELD INSPECTION REPORT

| Project Name: | Mountain Valley Pipeline | Inspector: | Marshall Willis |
| Inspection Date: | Thursday, June 27, 2024 | Project Contact: | Brian Clauto, Cory Chalmers |
| Spread I:<br>Franklin County | STA 13575+21 – 13644+82 | Weather: | Dry |

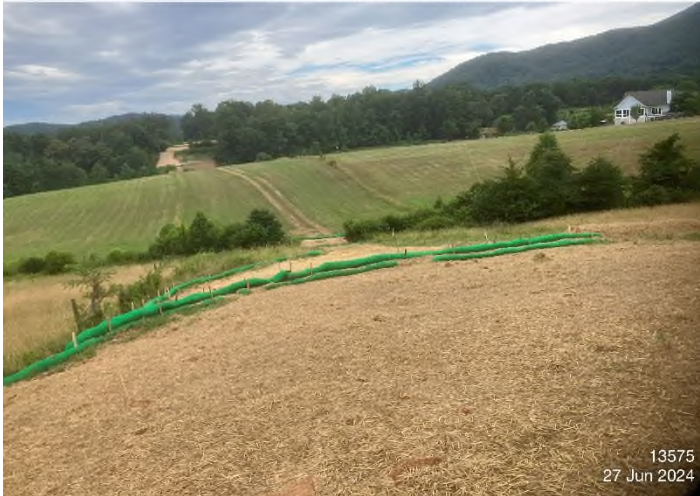
**Figure 1: STA 13575+00** – Controls in place and functioning properly.

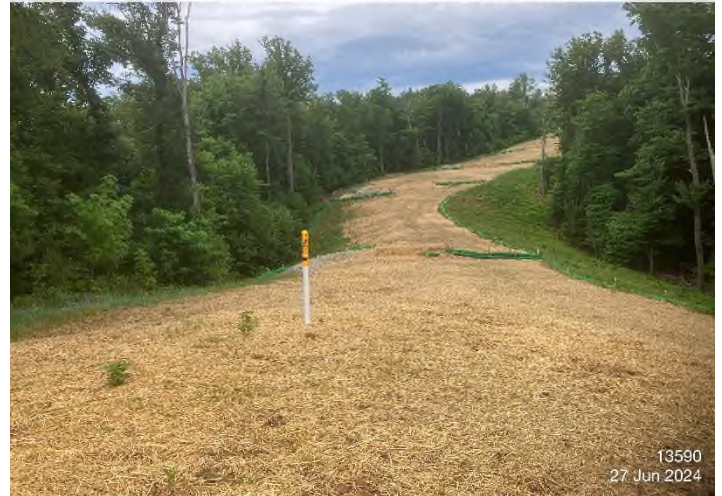
**Figure 2: STA 13590+00** – Controls in place and functioning properly.

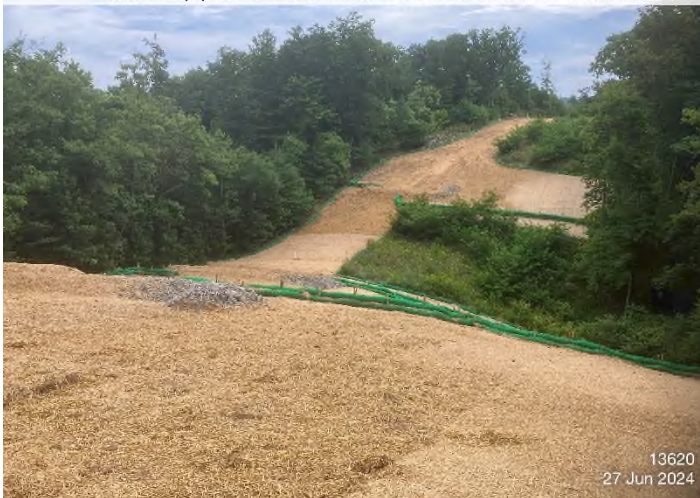
**Figure 3: STA 13620+00** – Controls in place and functioning properly.

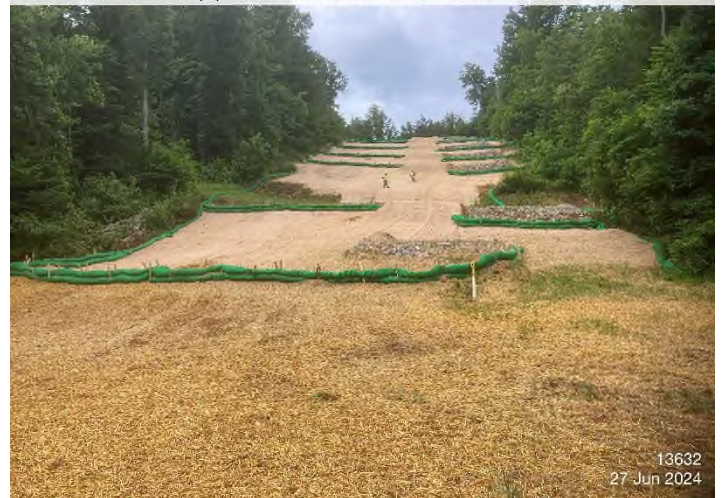
**Figure 4: STA 13632+00** – Controls in place and functioning properly.
