FIELD INSPECTION REPORT

Project Name:	Mountain Valley Pipeline	Inspector:	Marshall Willis			
Inspection Date:	Monday, June 10, 2024	Project Contact:	Brian Clauto, Cory Chalmers			
Spread I: Franklin County	STA 13575+21 - 13644+82 STA 14272+62 - 14311+57 MVP-FR-313	Weather:	Dry

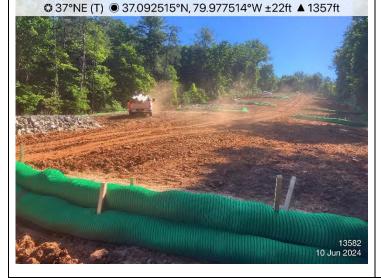
Figure 3: **STA 13582+00** – Controls in place and functioning properly.
