# FIELD INSPECTION REPORT

| Project Name: | Mountain Valley Pipeline | Inspector: | Matthew Grant |
| Inspection Date: | Monday, June 24, 2024 | Project Contact: | Brian Clauto |
| Spread H: Montgomery | Sta 12370-12409<br>ATWS 724 | Weather: | Dry |

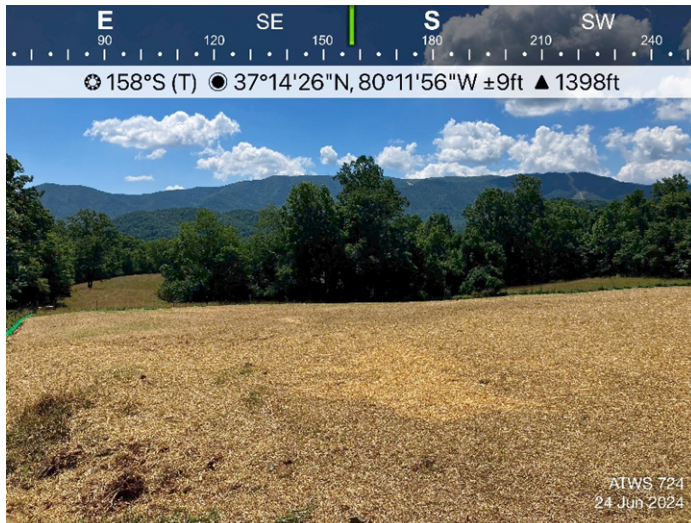
**Figure 1:** ATWS 724, ESC's devices in place.

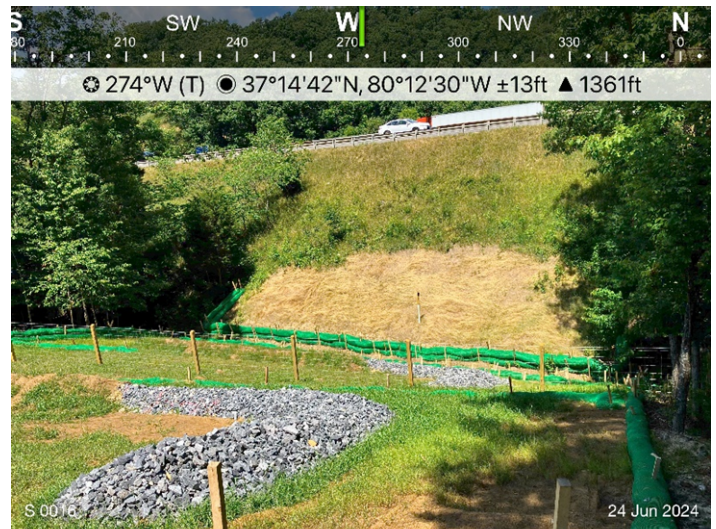
**Figure 2:** Designated Crossings S-0016, ESC's devices and permanent waterbars are in place.

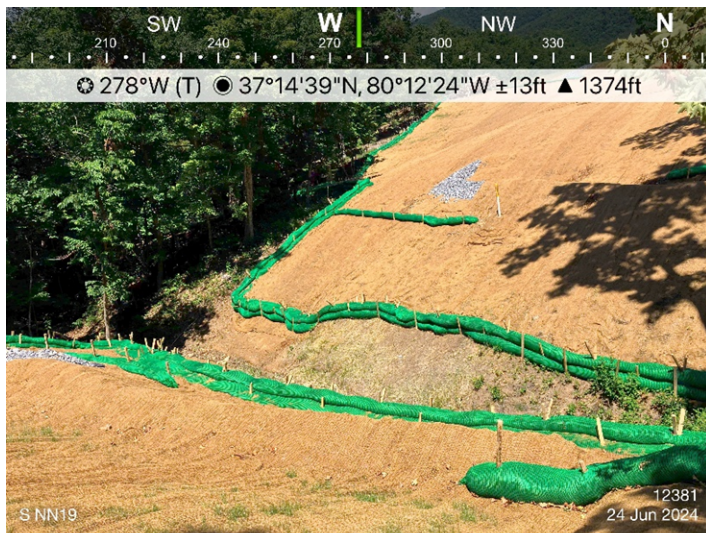
**Figure 3:** Designated crossing S-NN19, ESC's devices and permanent waterbars are in place.

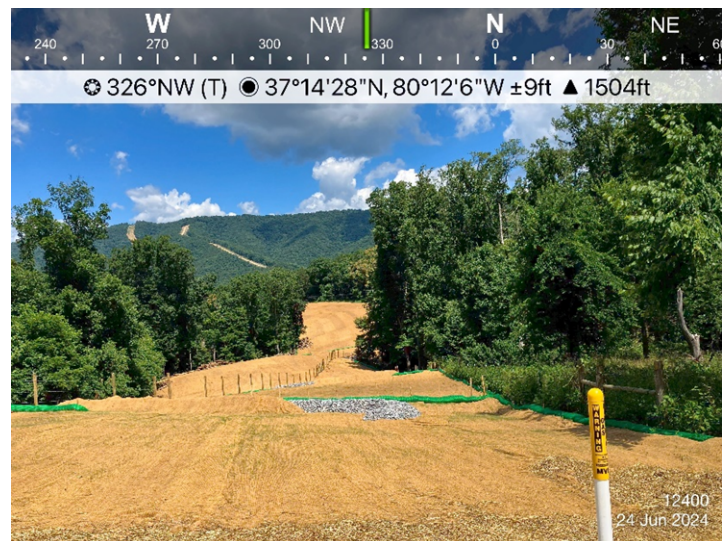
**Figure 4:** Sta 12400, ESC and permanent waterbars are in place.
