## FIELD INSPECTION REPORT

| <b>Project Name:</b> | Mountain Valley Pipeline | <b>Inspector:</b> | Marshall Willis |
| <b>Inspection Date:</b> | Monday, June 24, 2024 | <b>Project Contact:</b> | Brian Clauto, Cory Chalmers |
| <b>Spread H:<br/>Montgomery County</b> | STA 12000+00 – 12036+00<br>STA 12374+00 – 12410+00<br>MVP-MN-268/268.01<br>MVP-MLV-AR-27 | <b>Weather:</b> | Dry |

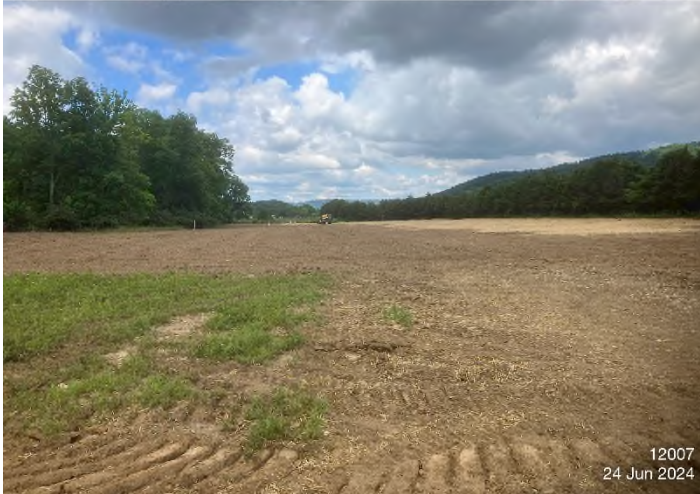
**Figure 1: STA 12007+00** – Controls in place and functioning properly.

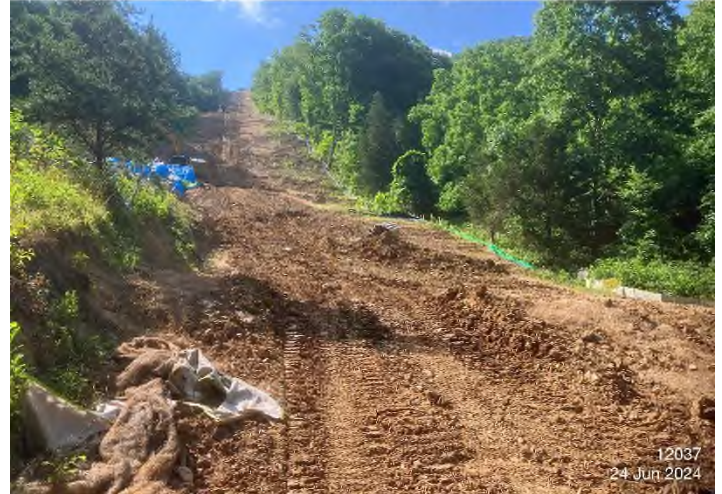
**Figure 2: STA 12037+00** – Controls in place and functioning properly.

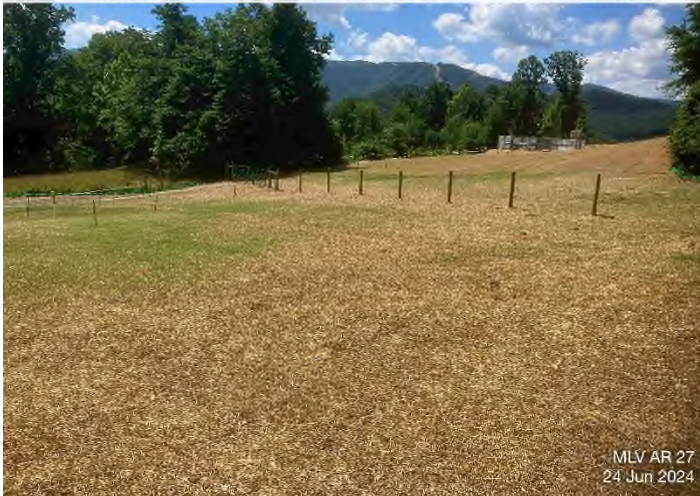
**Figure 3: MLV-27** – Controls in place and functioning properly.

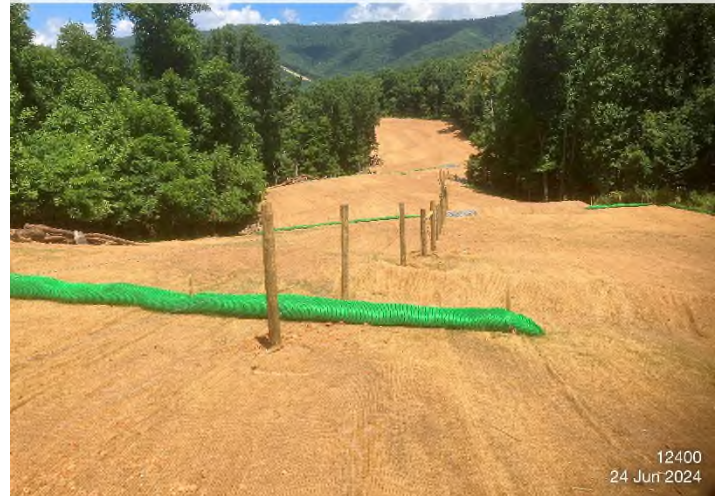
**Figure 4: STA 12400+00** – Controls in place and functioning properly.
