FIELD INSPECTION REPORT

Project Name:	Mountain Valley Pipeline	Inspector:	Matthew Grant
Inspection Date:	Tuesday, July 2, 2024	Project Contact:	Brian Clauto
Spread I: Franklin Pittsylvania	Sta 16025 AR PI 343.01 MLV 31, Transco Station, H-602	Weather:	Dry

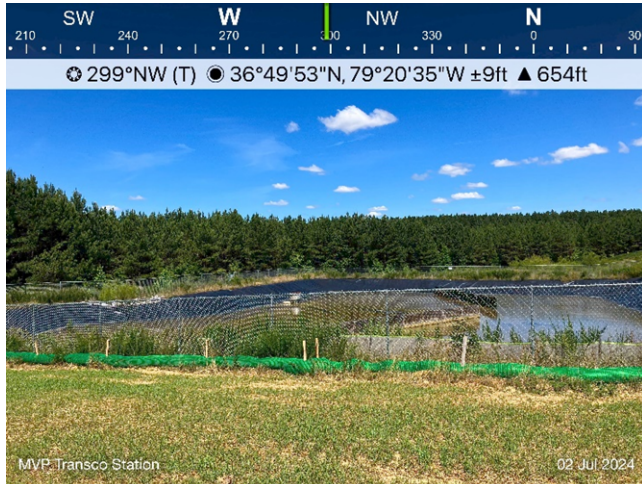
Figure 1: MVP Transco Station, temp basin in place.

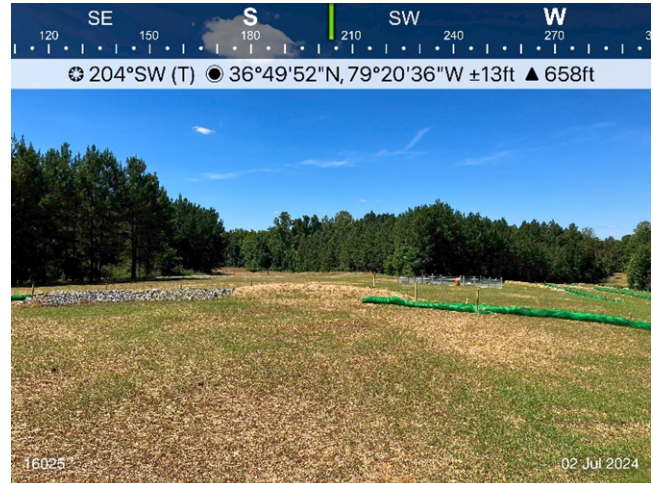
Figure 2: Sta 16025, ESC and permanent water bars are in place.

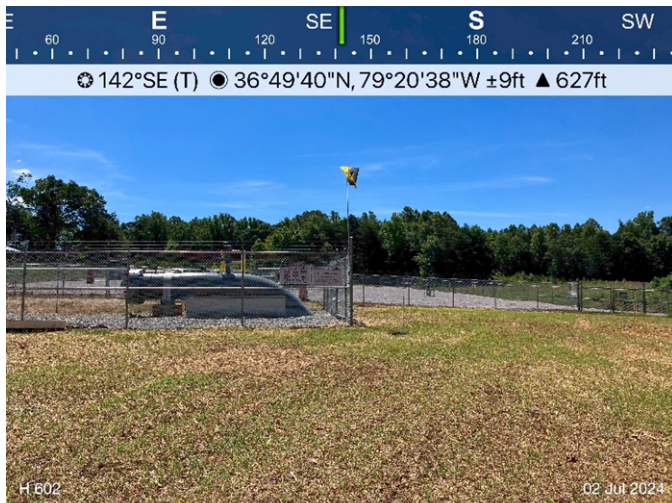
Figure 3: Station H-602, stabilization in place.
