FIELD INSPECTION REPORT

Project Name:	Mountain Valley Pipeline	Inspector:	Marshall Willis
Inspection Date:	Thursday, July 11, 2024	Project Contact:	Brian Clauto, Cory Chalmers
Spread I: Pittsylvania County	STA 15205+00 – 15257+00 MVP-PI-328	Weather:	Dry

FIELD INSPECTION PHOTO LOG

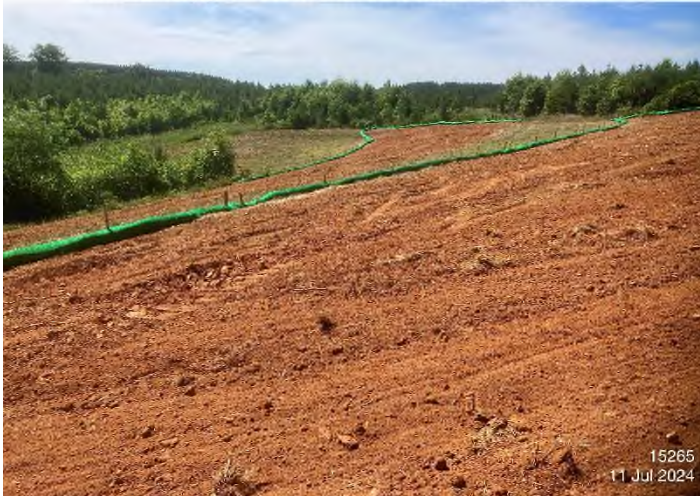
Figure 1: STA 15256+00 – Controls in place and functioning properly.

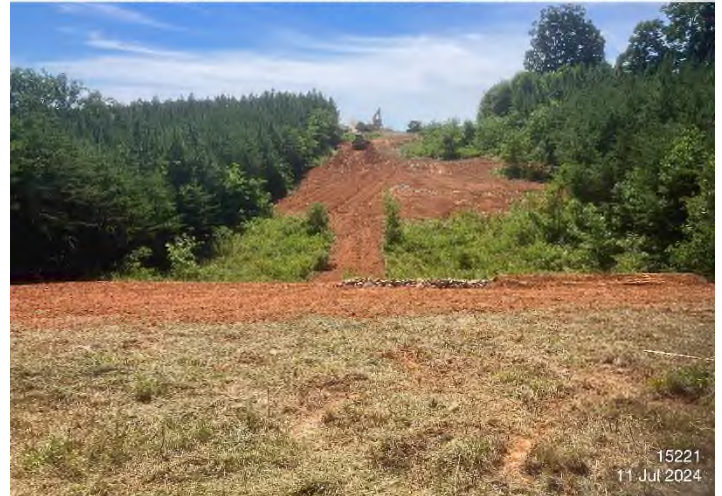
Figure 2: STA 15221+00 – Controls in place and functioning properly.

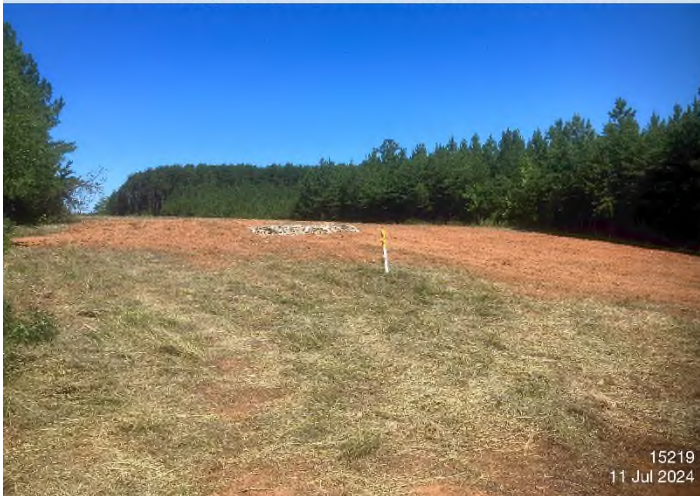
Figure 3: STA 15219+00 – Controls in place and functioning properly.

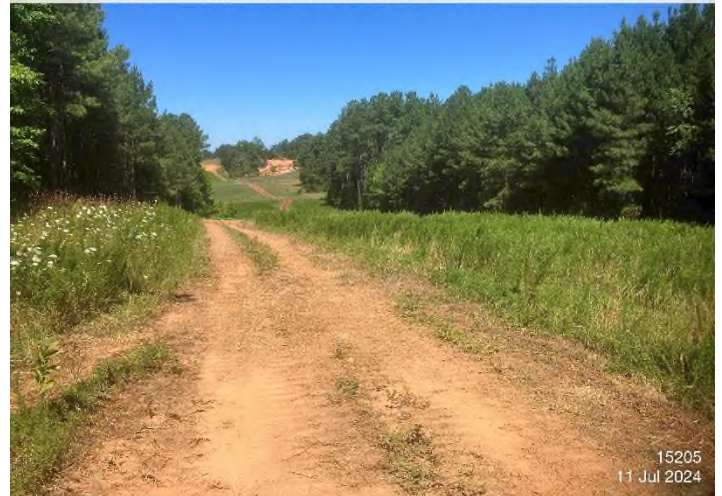
Figure 4: STA 15205+00 – Controls in place and functioning properly.
