## FIELD INSPECTION REPORT

| <b>Project Name:</b> | Mountain Valley Pipeline | <b>Inspector:</b> | Marshall Willis |
| <b>Spread H:<br/>Franklin County</b> | STA 13140+00 – 13197+55<br>MVP-FR-292<br>MVP-FR-292.02 | <b>Weather:</b> | Dry |

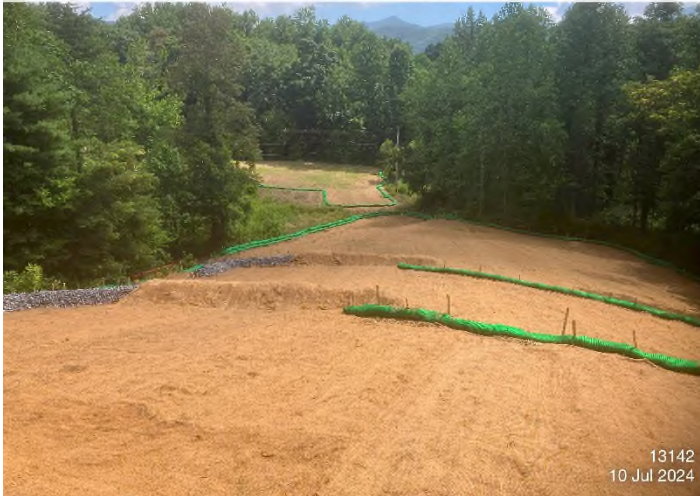
**Figure 1: STA 13142+00** – Controls in place and functioning properly.

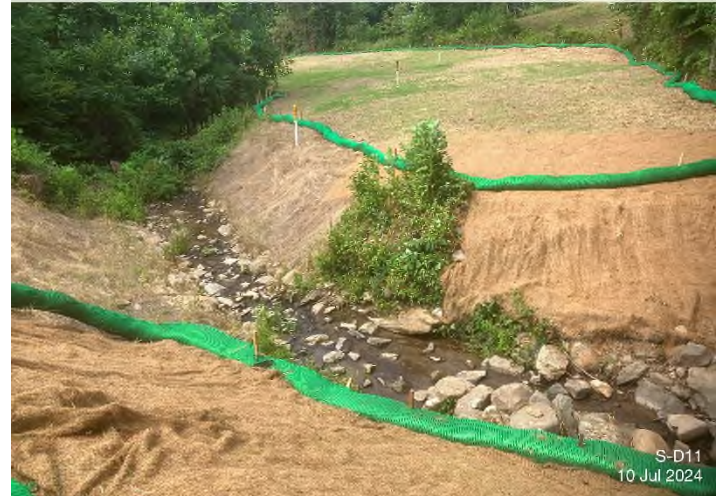
**Figure 2: Stream S-D11** – Controls in place and functioning properly.

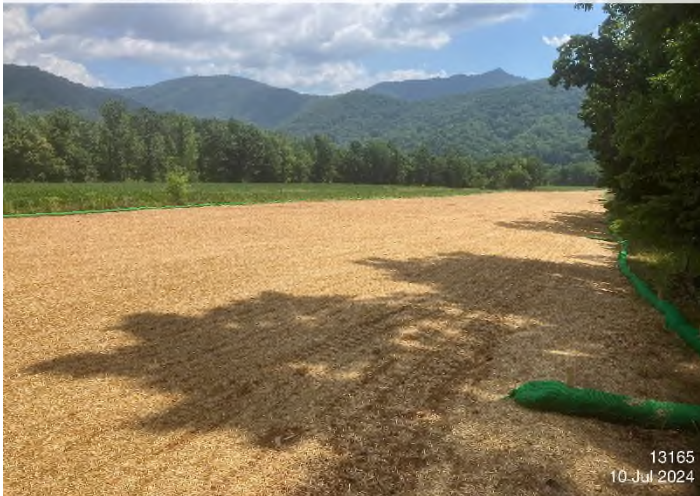
**Figure 3: STA 13165+00** – Controls in place and functioning properly.

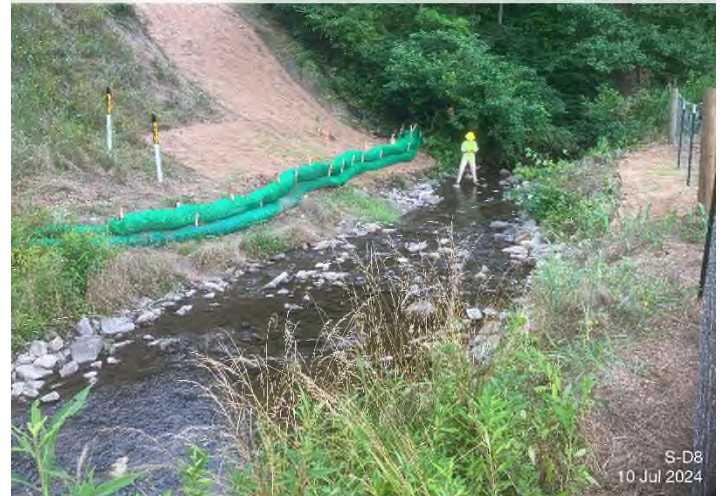
**Figure 4: Stream S-D8** – Controls in place and functioning properly.
