FIELD INSPECTION REPORT

Project Name:	Mountain Valley Pipeline	Inspector:	Marshall Willis
Inspection Date:	Wednesday, July 3, 2024	Project Contact:	Brian Clauto, Cory Chalmers
Spread G: Giles County	STA 10505+00 – 10537+00 MVP-GI-234 MVP-GI-235 MVP-GI-236	Weather:	Dry

FIELD INSPECTION PHOTO LOG

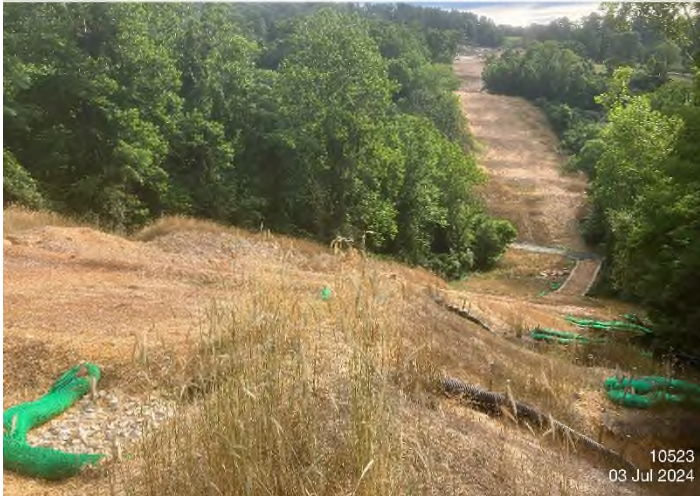
Figure 1: STA 10523+00 – Controls in place and functioning properly.

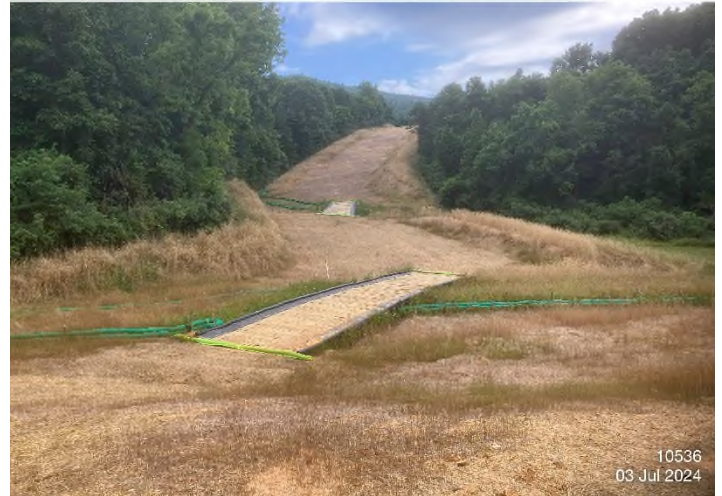
Figure 2: STA 10536+00 – Controls in place and functioning properly.

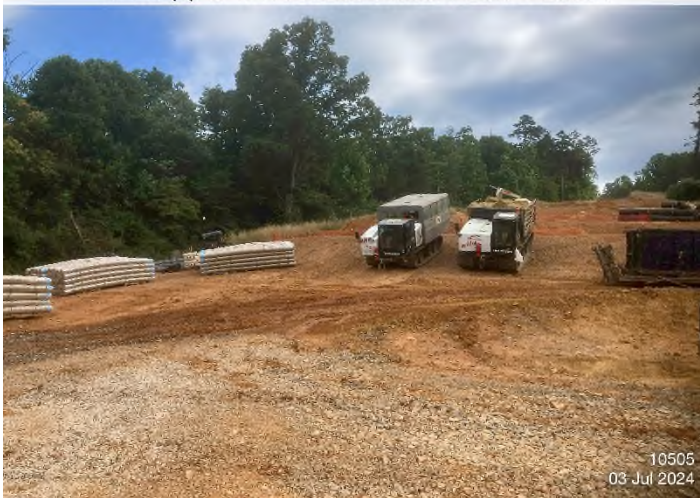
Figure 3: STA 10505+00 – Controls in place and functioning properly.

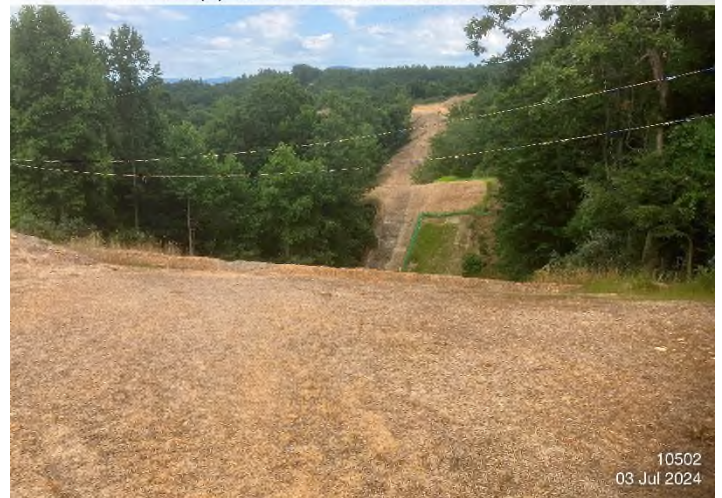
Figure 4: STA 10502+00 – Controls in place and functioning properly.
