## FIELD INSPECTION REPORT

<b>Project Name:</b>	Mountain Valley Pipeline	<b>Inspector:</b>	Marshall Willis
<b>Inspection Date:</b>	Monday, July 1, 2024	<b>Project Contact:</b>	Brian Clauto, Cory Chalmers
<b>Spread H: Roanoke County</b>	STA 12725+00 – 12743+00 STA 12990+00 – 12995+00 MVP-RO-288 MVP-RO-287 MVP-RO-281	<b>Weather:</b>	Dry

## FIELD INSPECTION PHOTO LOG

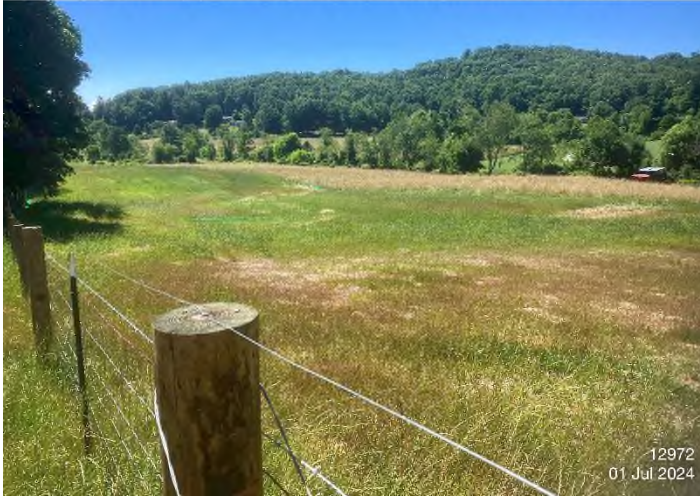
**Figure 1: STA 12972+00** – Controls in place and functioning properly.

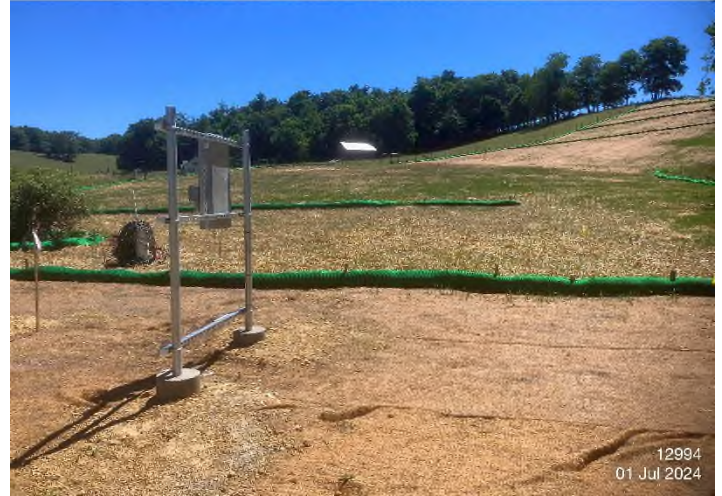
**Figure 2: STA 12994+00** – Controls in place and functioning properly.

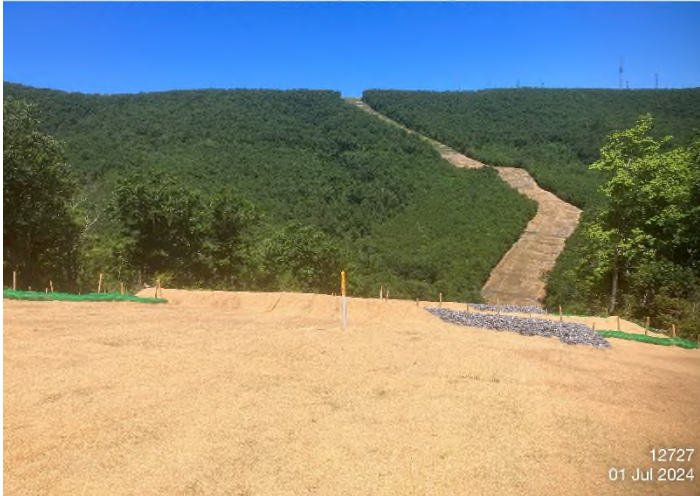
**Figure 3: STA 12727+00** – Controls in place and functioning properly.

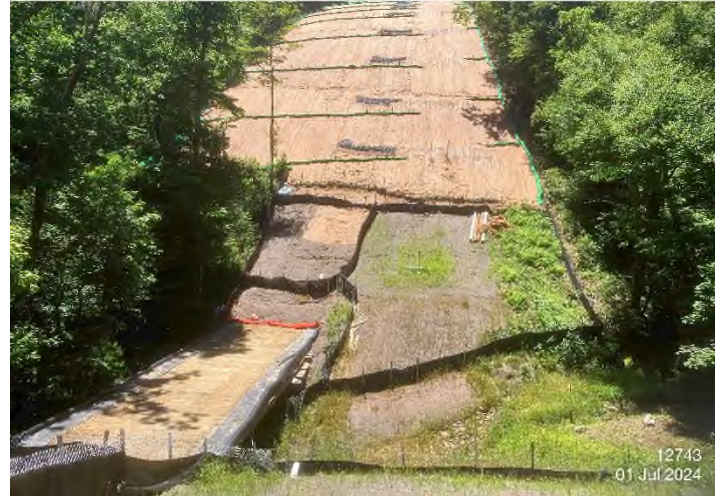
**Figure 4: STA 12743+00** – Controls in place and functioning properly.
