## FIELD INSPECTION REPORT

<b>Project Name:</b>	Mountain Valley Pipeline	<b>Inspector:</b>	Marshall Willis
<b>Inspection Date:</b>	Monday, July 15, 2024	<b>Project Contact:</b>	Brian Clauto, Cory Chalmers
<b>Spread I: Franklin County</b>	STA 14310+00 – 14311+00 MVP-FR-313.01 MVP-FR-315 STA 14524+00 – 14525+00	<b>Weather:</b>	Dry

# FIELD INSPECTION PHOTO LOG

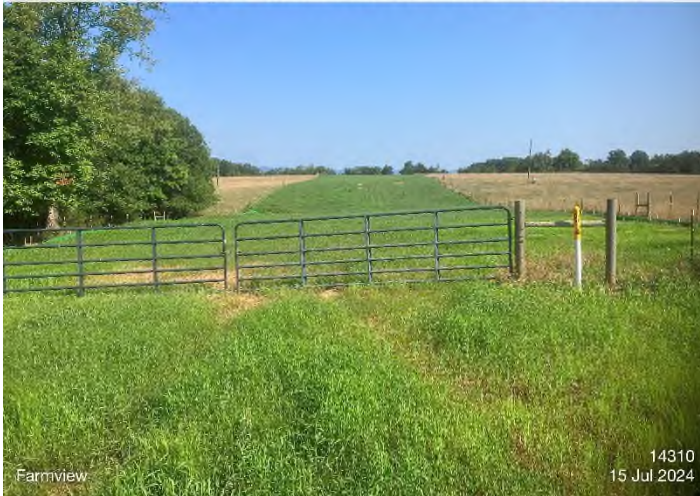
**Figure 1: STA 14310+00** – Controls in place and functioning properly.

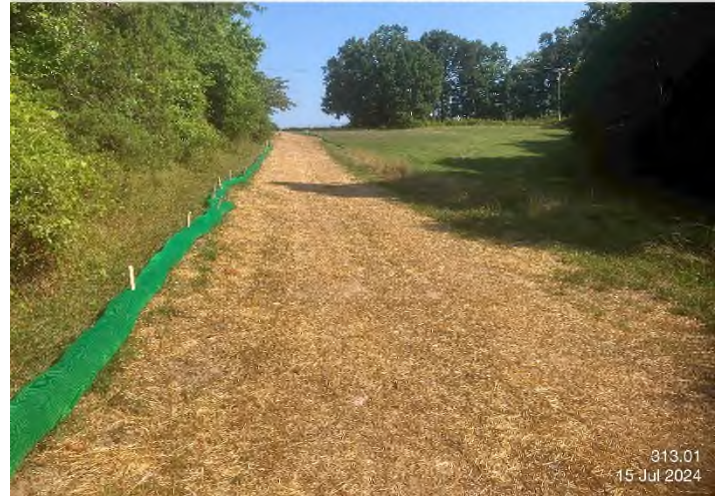
**Figure 2: MVP-FR-313.01** – Controls in place and functioning properly.

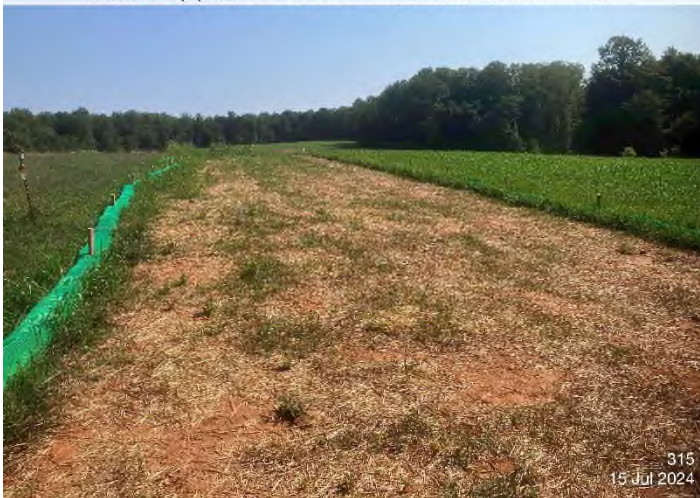
**Figure 3: MVP-FR-315** – Controls in place and functioning properly.

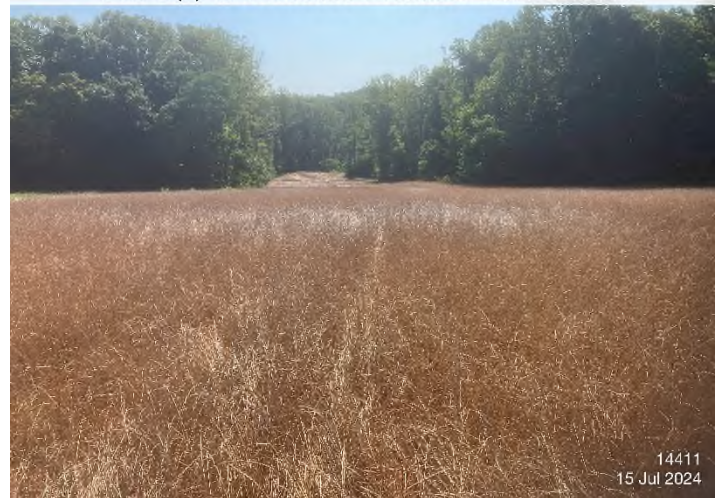
**Figure 4: STA 14411+00** – Controls in place and functioning properly.
