STANDARDS & SPECIFICATIONS SITE INSPECTION REPORT LEVEL 1 (FIELD REPORT)

Project Name:	Mountain Valley Pipeline	S&S Program:	Mountain Valley Pipeline (SS027)
Inspector:	Matthew Grant	Inspection Date:	Wednesday, July 24, 2024
Project Contact:	Cory Chalmers Brian Clauto	Project Contact Email:	cchalmers@equitransmidstream.com bclauto@equitransmidstream.com
Spread I: Franklin County	STA 14756- STA 14766 ATWS 372, 373, 1389	Site Conditions:	Wet

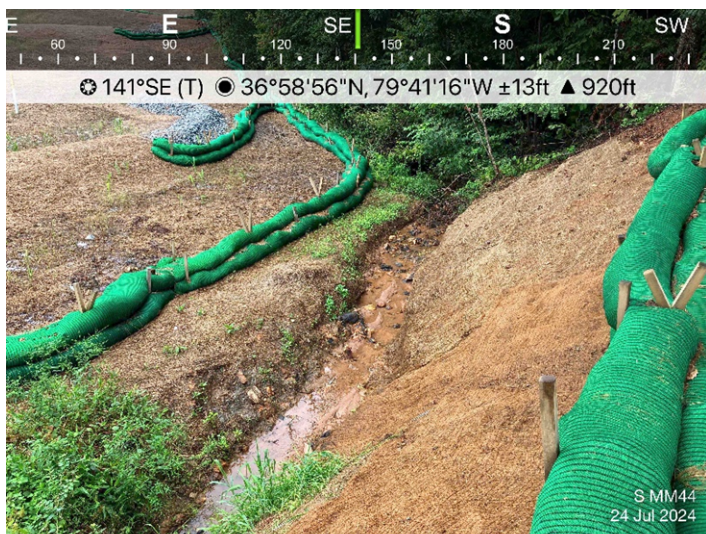
Fig. 1

Comments: Inspected the following resources: S-MM44
Impacted stream previously reported on 7/19/24

Description: Designated Crossing S-MM44, stream impacted reported on 7/19/24.

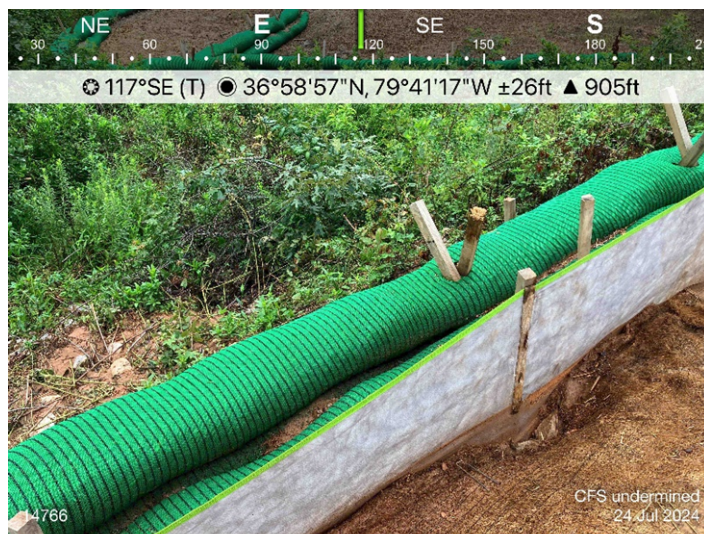
Fig. 2

Description: CFS and P1 has been undermined.

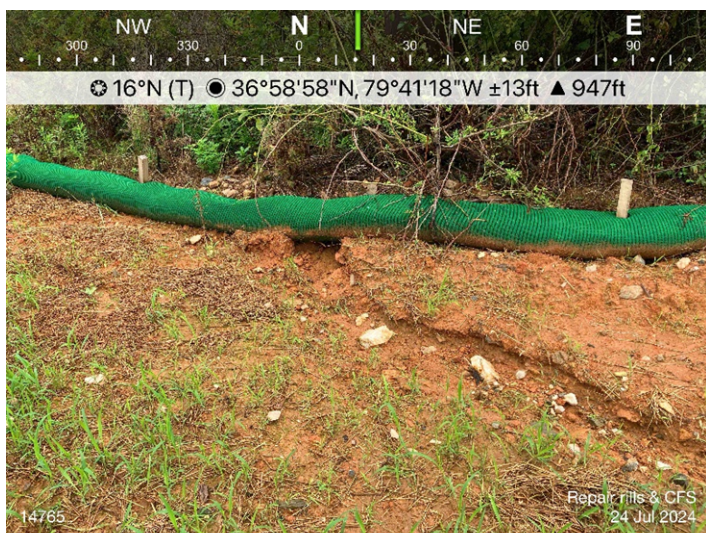
Fig. 3

Description: STA 14756, repair rills and repair CFS.

- Sta 14765 Repair rills and CFS
- Sta 14766 Repair CFS and silt fence

Corrective Action: Maintain and install all controls per the approved S&S.

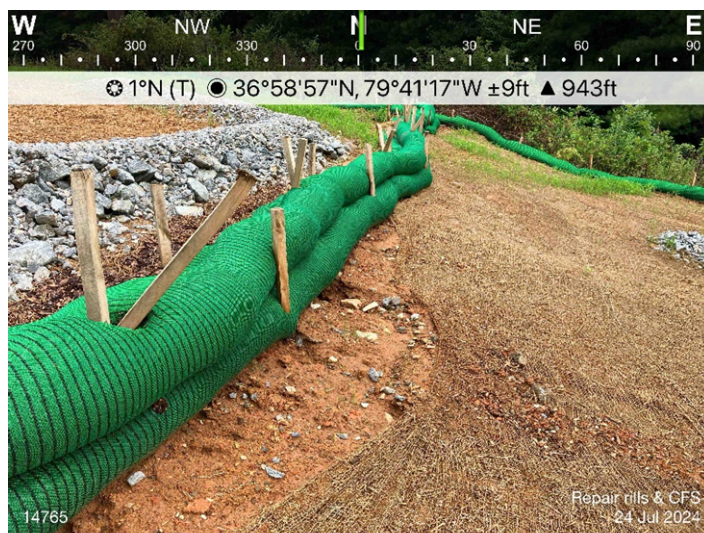
Fig. 4

Description: STA 14756, repair undermined CFS.
