# STANDARDS & SPECIFICATIONS SITE INSPECTION REPORT LEVEL 1 (FIELD REPORT)

| Project Name: | Mountain Valley Pipeline | S&S Program: | Mountain Valley Pipeline (SS027) |
| Spread I:<br>Franklin County | STA 13415+51 – STA 13496+87<br>MVP-FR-293.02 | Site Conditions: | Dry |

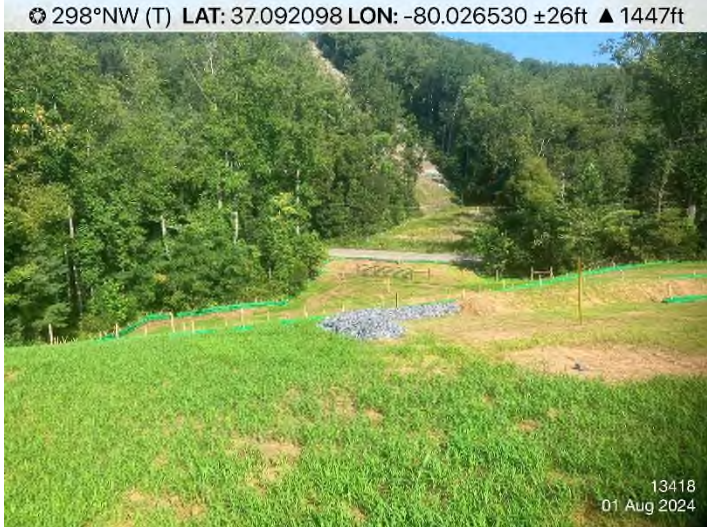
Fig. 1  
STA 13418+00: Controls in place and functioning properly.

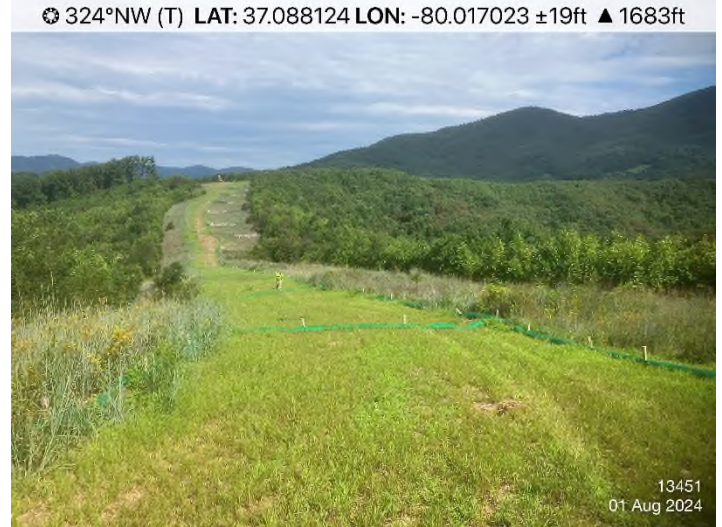
Fig. 2  
STA 13451+00: Controls in place and functioning properly.

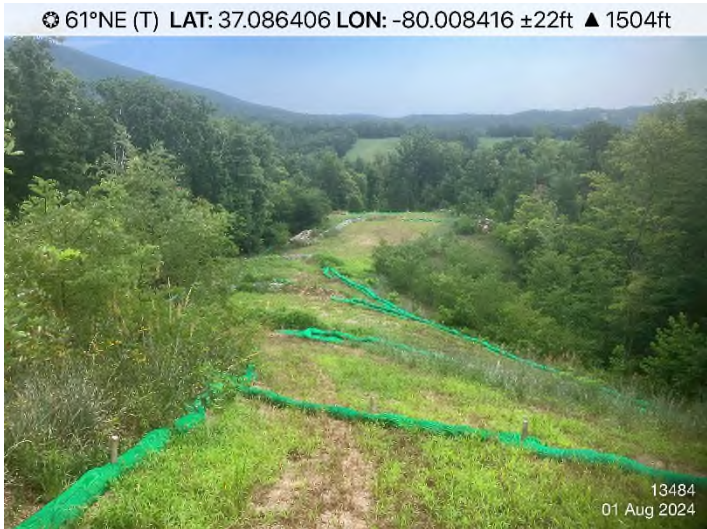
Fig. 3  
STA 13484+00: Controls in place and functioning properly.

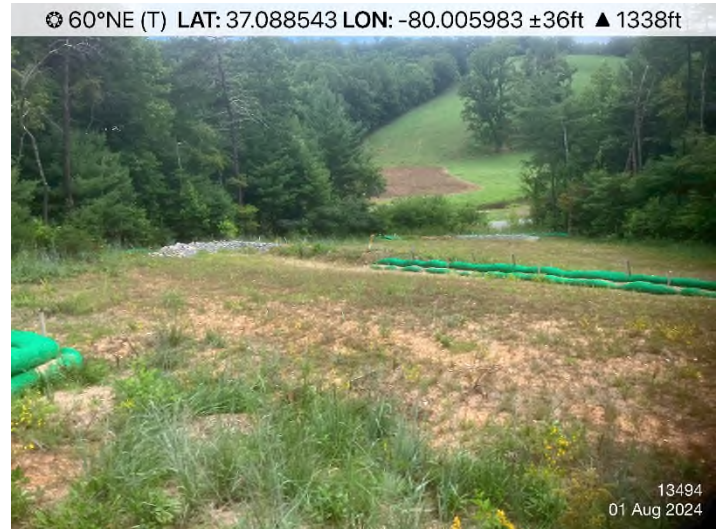
Fig. 4  
STA 13494+00: Controls in place and functioning properly.
