# STANDARDS & SPECIFICATIONS SITE INSPECTION REPORT LEVEL 1 (FIELD REPORT)

| Project Name: | Mountain Valley Pipeline | S&S Program: | Mountain Valley Pipeline (SS027) |
| Inspector: | Marshall Willis | Inspection Date: | Wednesday, July 31, 2024 |
| Spread I:<br>Franklin County | STA 14272+62 – STA 14345+53<br>MVP-FR-313<br>MVP-FR-313.01 | Site Conditions: | Dry |

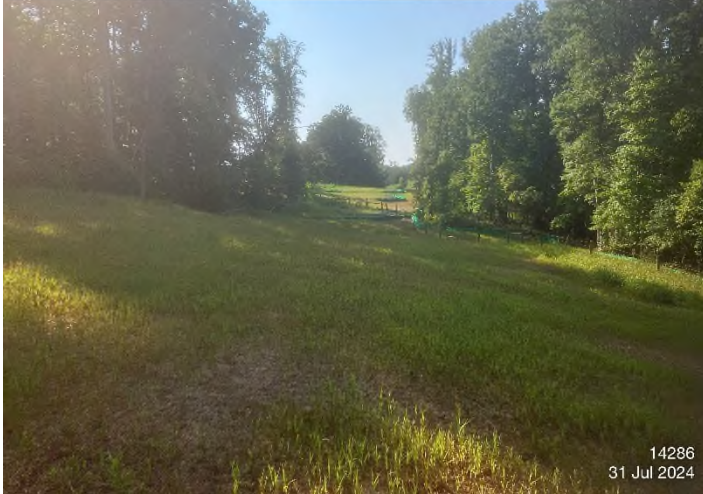
Fig. 1

**STA 14286+00:** Controls in place and functioning properly.

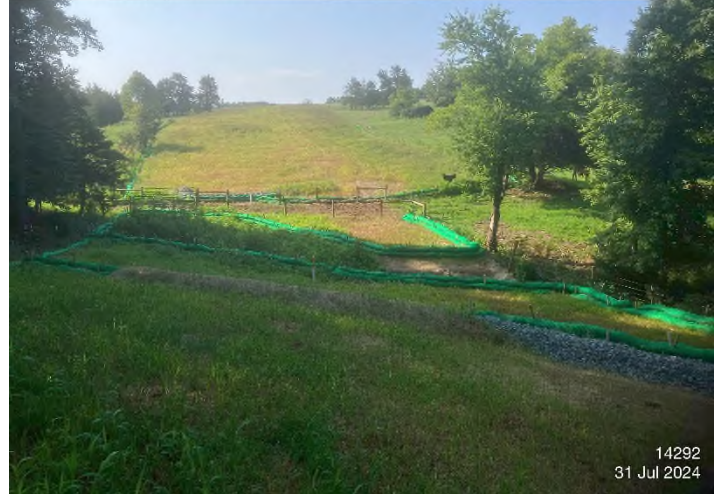
Fig. 2

**STA 14292+00:** Controls in place and functioning properly.

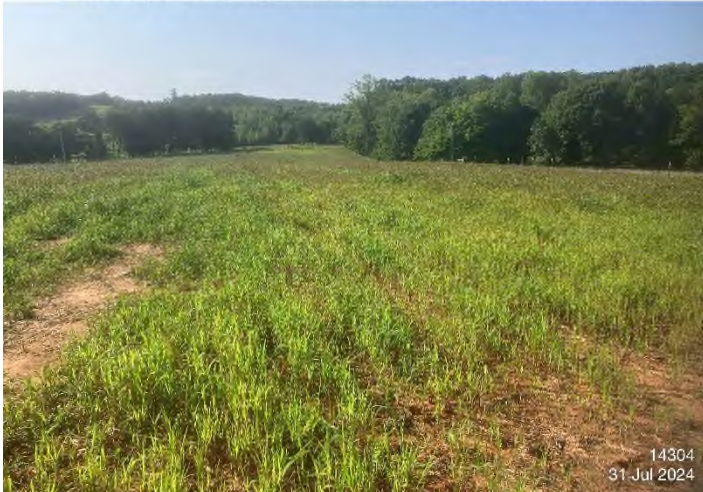
Fig. 3

**STA 14304+00:** Controls in place and functioning properly.

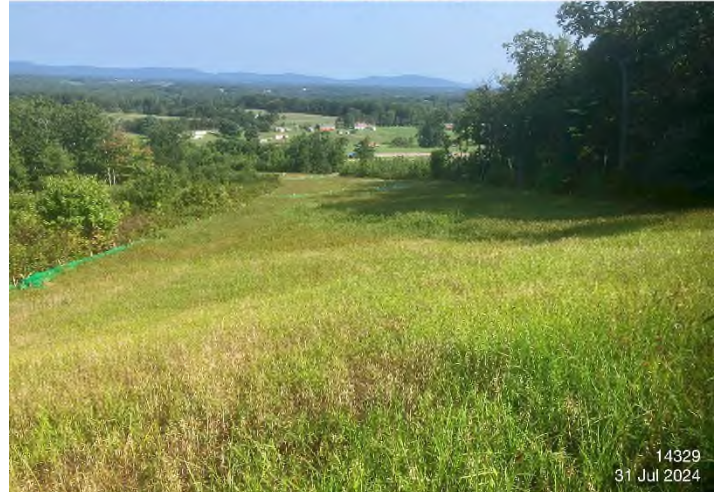
Fig. 4

**STA 14329+00:** Controls in place and functioning properly.
