STANDARDS & SPECIFICATIONS SITE INSPECTION REPORT LEVEL 1 (FIELD REPORT)

Project Name:	Mountain Valley Pipeline	S&S Program:	Mountain Valley Pipeline (SS027)
Inspector:	Matthew Grant	Inspection Date:	Wednesday, August 14, 2024
Project Contact:	Cory Chalmers Brian Clauto	Project Contact Email:	cchalmers@equitransmidstream.com bclauto@equitransmidstream.com
Spread I: Franklin County	STA 13648-13748, 13788 ATWS 569A, 1067, 1261, 1262, MLV 30 FR 300	Site Conditions:	Dry

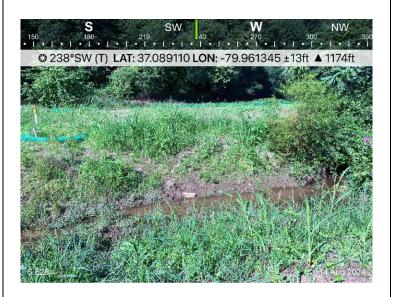
Fig. 1
Description: Designated Crossing S-E28, ECD's are in place.

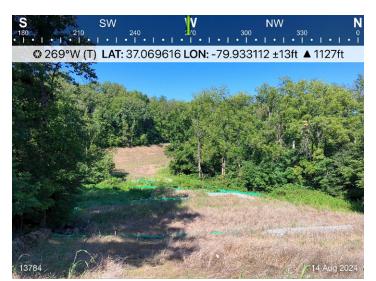
Fig. 2 Description: Sta 13748, ECD's are in place.

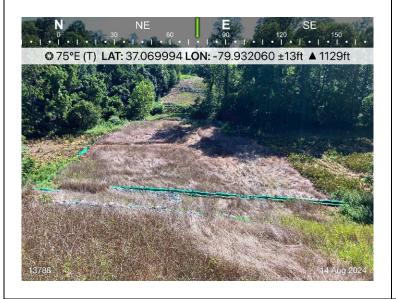
Fig. 3 Description: Sta 13788, ECD's are in place.

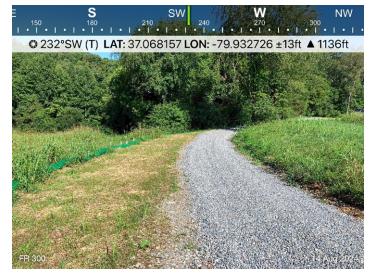
Fig. 4 Description: FR300, ECD's remain in place.
