STANDARDS & SPECIFICATIONS SITE INSPECTION REPORT

LEVEL 1 (FIELD REPORT)

Project Name:	Mountain Valley Pipeline	S&S Program:	Mountain Valley Pipeline (SS027)			
Inspector:	Marshall Willis	Inspection Date:	Thursday, August 29, 2024			
Project Contact:	Cory Chalmers Brian Clauto	Project Contact Email:	cchalmers@equitransmidstream.com bclauto@equitransmidstream.com			
Spread I: Pittslyvania County Franklin County	STA 14692+00 - STA 14705+00 STA 15113+00 - STA 15142+66	Site Conditions:	Dry

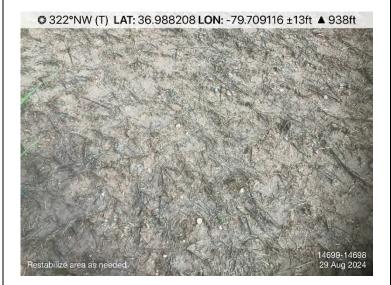
Fig. 1 **STA 14698+00 to 14699+00:** Restabilize area as needed.

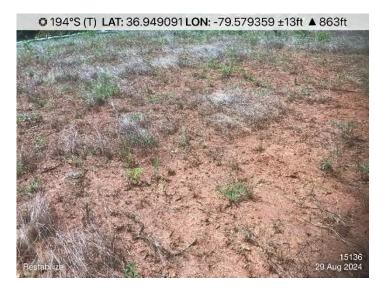
Fig. 2 **STA 15136+00 to 15139+00:** Restabilize area as needed.

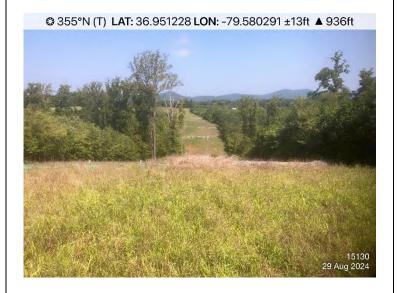
Fig. 3 **STA 15130+00:** Controls in place and functioning properly.

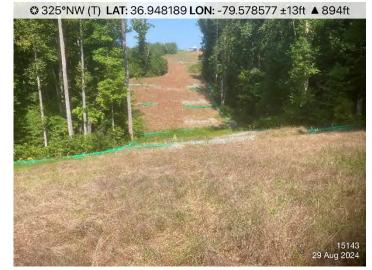
Fig. 4

STA 15143+00: Controls in place and functioning properly.
