STANDARDS & SPECIFICATIONS SITE INSPECTION REPORT LEVEL 1 (FIELD REPORT)

Project Name:	Mountain Valley Pipeline	S&S Program:	Mountain Valley Pipeline (SS027)
Inspector:	Marshall Willis	Inspection Date:	Wednesday, August 14, 2024
Project Contact:	Cory Chalmers Brian Clauto	Project Contact Email:	cchalmers@equitransmidstream.com bclauto@equitransmidstream.com
Spread I: Franklin County	STA 13811+81 – STA 13853+45 MVP-FR-302 MVP-FR-303.01	Site Conditions:	Dry

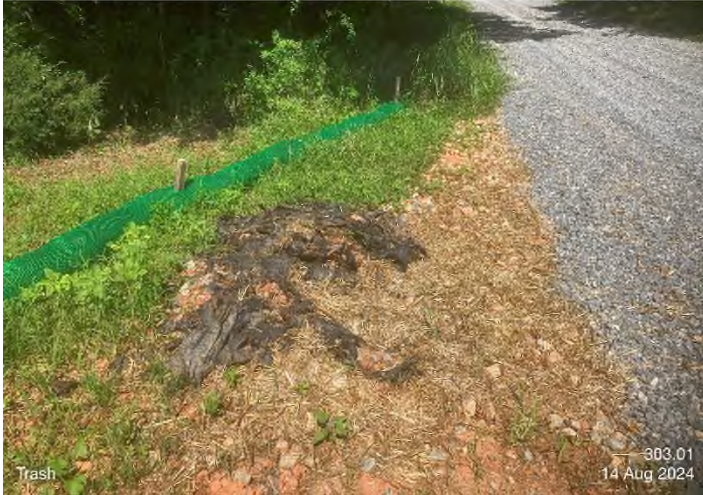
Fig. 1

MVP-FR-303.01: Remove and properly dispose of construction debris.

Corrective Action: Remove and properly dispose of construction debris.

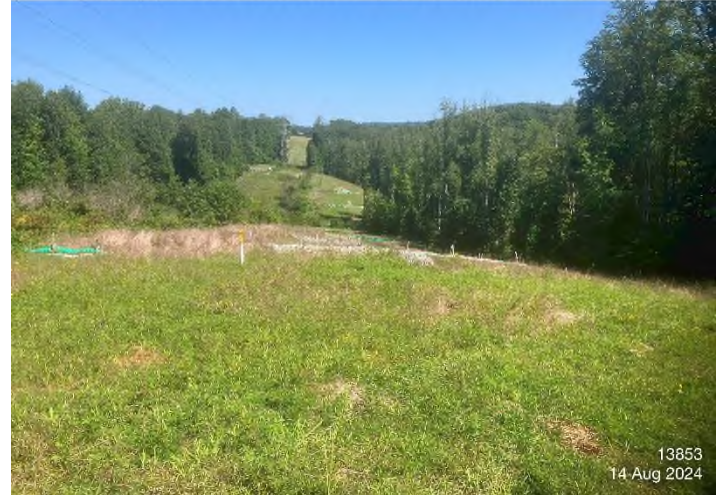
Fig. 2

STA 13853+00: Controls in place and functioning properly.

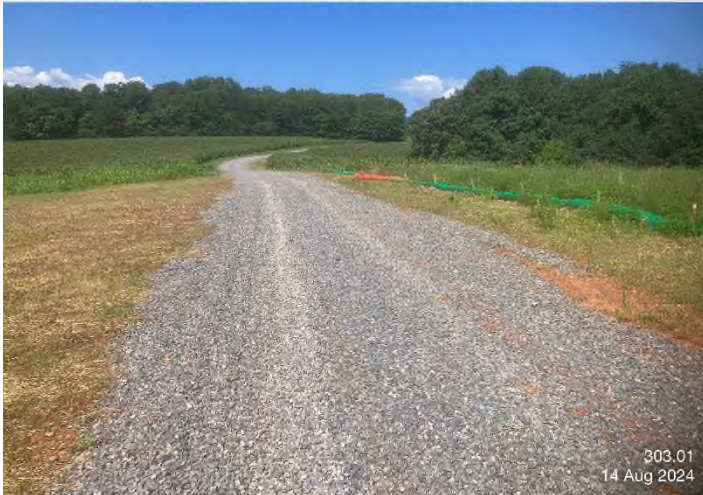
Fig. 3

MVP-FR-303.01: Controls in place and functioning properly.

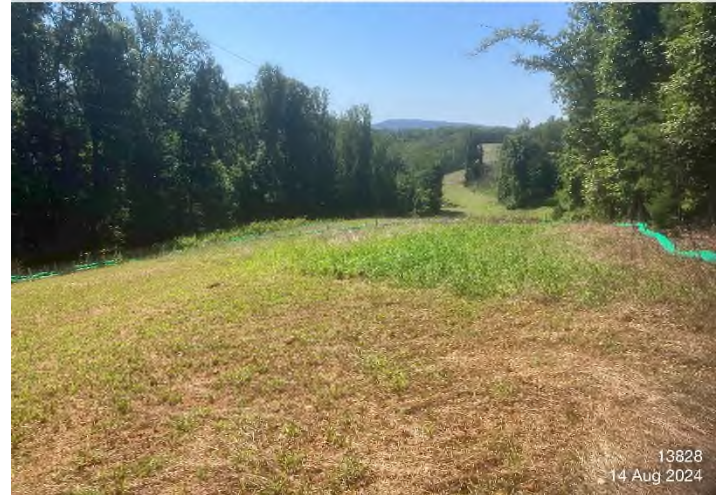
Fig. 4

STA 13828+00: Controls in place and functioning properly.
