STANDARDS & SPECIFICATIONS SITE INSPECTION REPORT LEVEL 1 (FIELD REPORT)

Project Name:	Mountain Valley Pipeline	S&S Program:	Mountain Valley Pipeline (SS027)
Inspector:	Marshall Willis	Inspection Date:	Tuesday, August 13, 2024
Project Contact:	Cory Chalmers Brian Clauto	Project Contact Email:	cchalmers@equitransmidstream.com bclauto@equitransmidstream.com
Spread H: Roanoke County	STA 12636+00 – STA 12657+00 MVP-RO-279.01	Site Conditions:	Dry

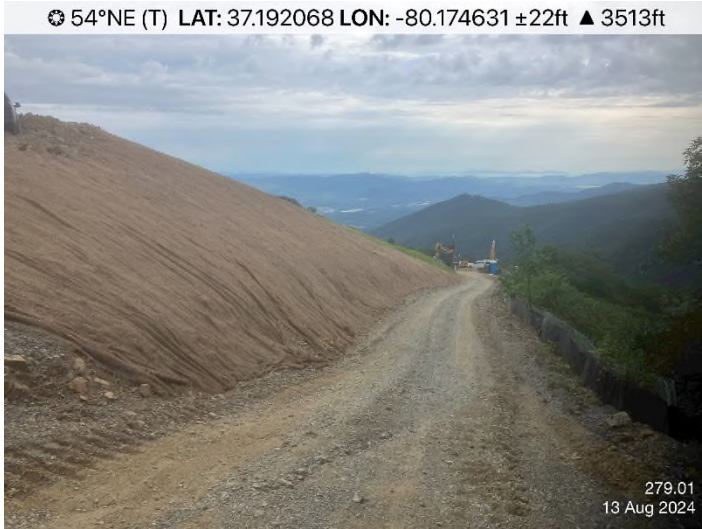
Fig. 1
MVP-RO-279.01: Controls in place and functioning properly.

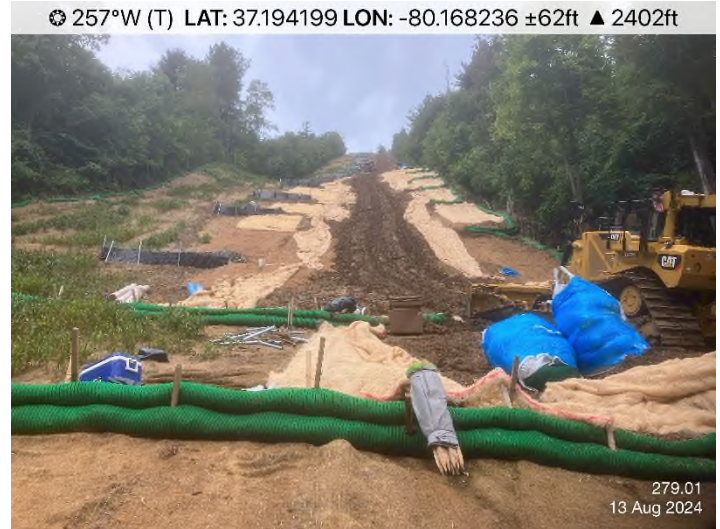
Fig. 2
STA 12655+00: Controls in place and functioning properly.

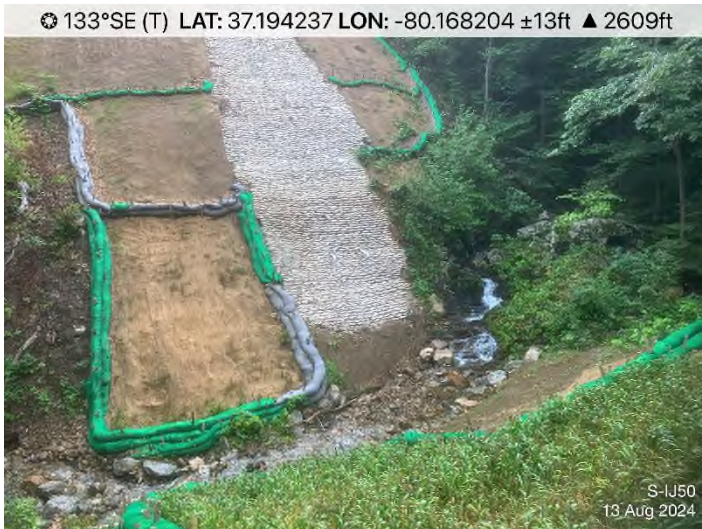
Fig. 3
Stream S-IJ50: Controls in place and functioning properly above S-IJ50.

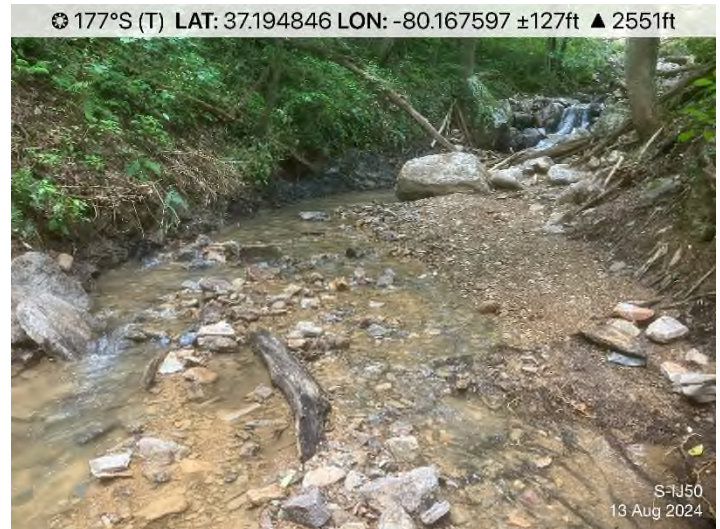
Crews are actively working to retrieve sediment discharged to S-IJ50.

Fig. 4
Stream S-J50: Sediment impacting S-IJ50. Crews actively working to retrieve sediment.
