# STANDARDS & SPECIFICATIONS SITE INSPECTION REPORT LEVEL 1 (FIELD REPORT)

Project Name:	Mountain Valley Pipeline	S&S Program:	Mountain Valley Pipeline (SS027)
Inspector:	Matthew Grant	Inspection Date:	Tuesday, August 27, 2024
Project Contact:	Cory Chalmers Brian Clauto	Project Contact Email:	cchalmers@equitransmidstream.com bclauto@equitransmidstream.com
Spread I: Franklin County	STA 14650- STA 14657+20 ATWS 367, 533	Site Conditions:	Dry

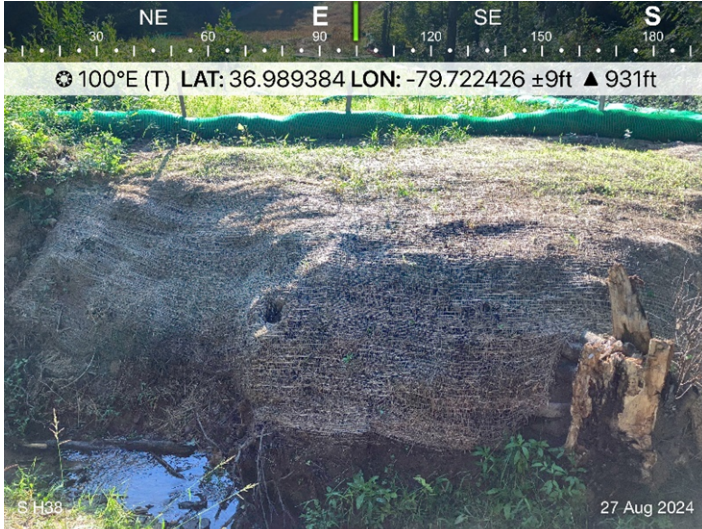
Fig. 1

Description: Designated Crossing S-H38, bank has been repaired and blanket has been reinstalled.

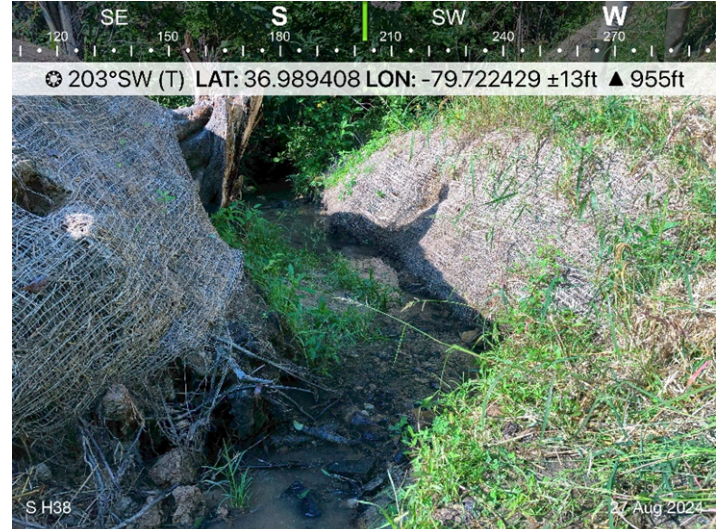
Fig. 2

Description: Designated Crossing S-H38, bank has been repaired and blanket has been reinstalled.

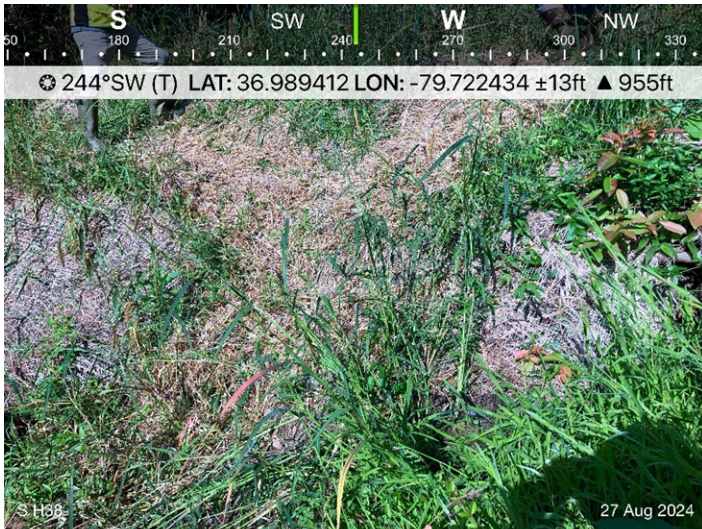
Fig. 3

Description: Designated crossing S-H38, additional mulch has been applied.
