STANDARDS & SPECIFICATIONS SITE INSPECTION REPORT LEVEL 1 (FIELD REPORT)

Project Name:	Mountain Valley Pipeline	S&S Program:	Mountain Valley Pipeline (SS027)
Inspector:	Matthew Grant	Inspection Date:	Wednesday, September 11, 2024
Project Contact:	Cory Chalmers Brian Clauto	Project Contact Email:	cchalmers@equitransmidstream.com bclauto@equitransmidstream.com
Spread H: Franklin County Montgomery County	STA13320-13319, 13317-13315, 13194-13187, 13198, 13262+81- 13260, 12545 ATWS 1055 MLV 29, FR293.01, MN278.01	Site Conditions:	Dry

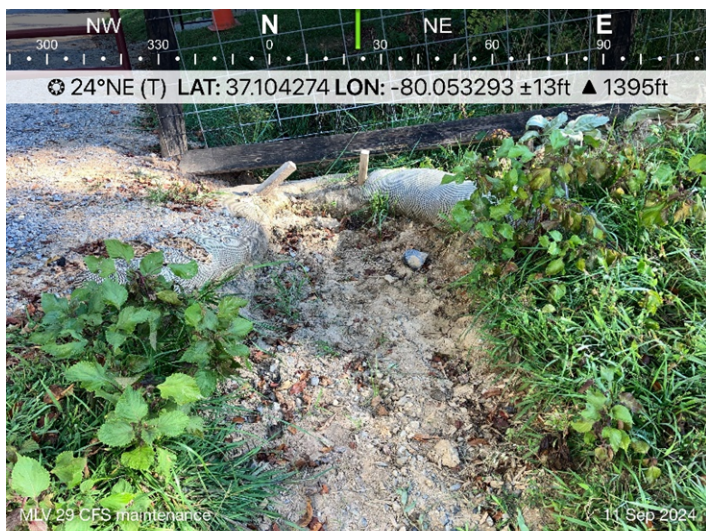
Fig. 1

- MLV29 ditch line CFS requires maintenance.

Description: MLV AR29 CFS requires maintenance.

Corrective Action: Maintain and install all controls per the approved S&S.

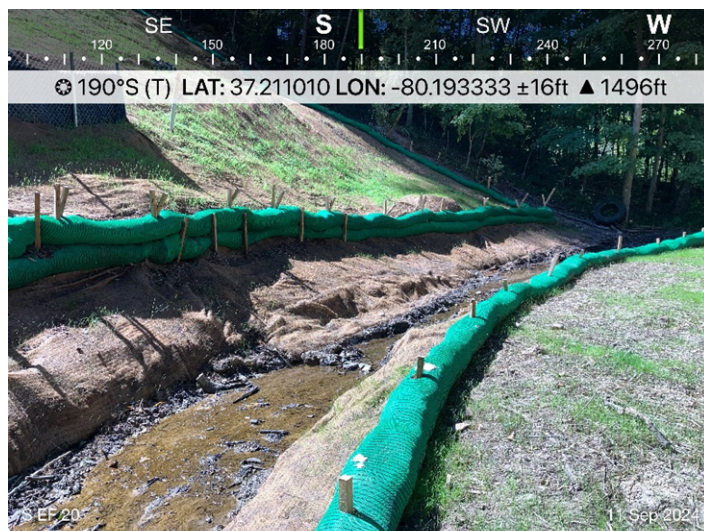
Fig. 2

Description: Designated stream S-EF20, ESC is in place.

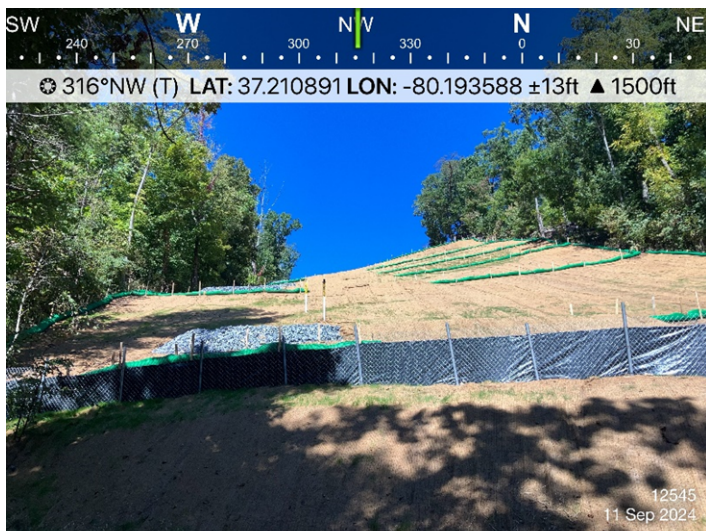
Fig. 3

Description: Sta 12545, permanent waterbars and ESC is in place.

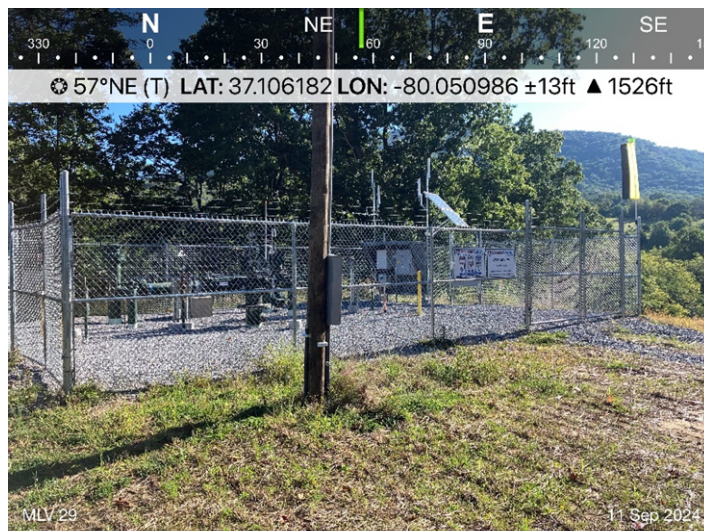
Fig. 4

Description: MLV 29 stabilization is in place.
