## STANDARDS & SPECIFICATIONS SITE INSPECTION REPORT LEVEL 1 (FIELD REPORT)

Project Name:	Mountain Valley Pipeline	S&S Program:	Mountain Valley Pipeline (SS027)
Inspector:	Matthew Grant	Inspection Date:	Tuesday, September 10, 2024
Project Contact:	Cory Chalmers Brian Clauto	Project Contact Email:	cchalmers@equitransmidstream.com bclauto@equitransmidstream.com
Spread G:	STA 10858-10930	Site Conditions:	Dry

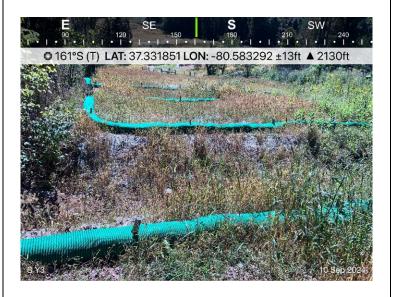
Fig. 1
Description: Designated Crossing S-Y3, ESC is in place.

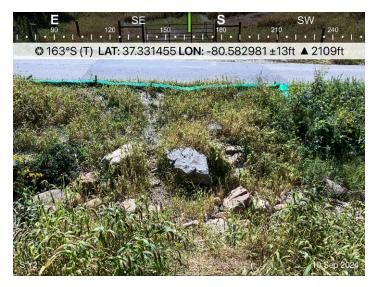
Fig. 2
Description: Designated Crossing S-Y2, ESC is in place.

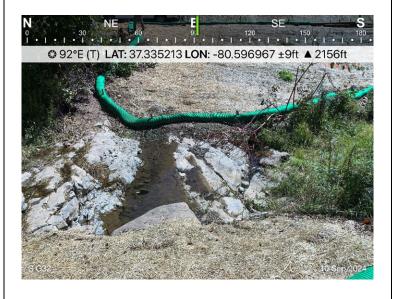
Fig. 3
Description: Designated crossing S-G32, ESC is in place.
